Claydon I/C North

(/A14//181.10//) SMIS Structure Key: 9942

Principal Inspection

Principal Inspection Report for Claydon I/C North (/A14//181.10//)
(Authorised)

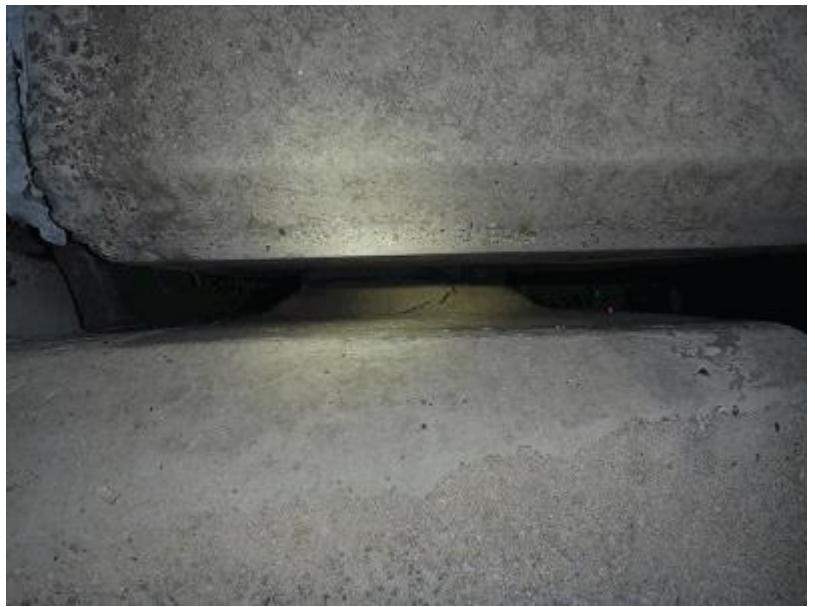
| Defect Type | Cr - Crack of uncertain origin or a combination of causes | | |
| Severity | D3 - Moderate: Defect is probably causing damage to element or structure, or is likely to do so in the near future | | |
| Comments | An obvious crack was noted in the Western most bearing plinth of the North pier. Monitor crack at future inspections. | | |
| Cause | Vandal Action | Certainty | Medium |

Crack to bearing plinth on North pier

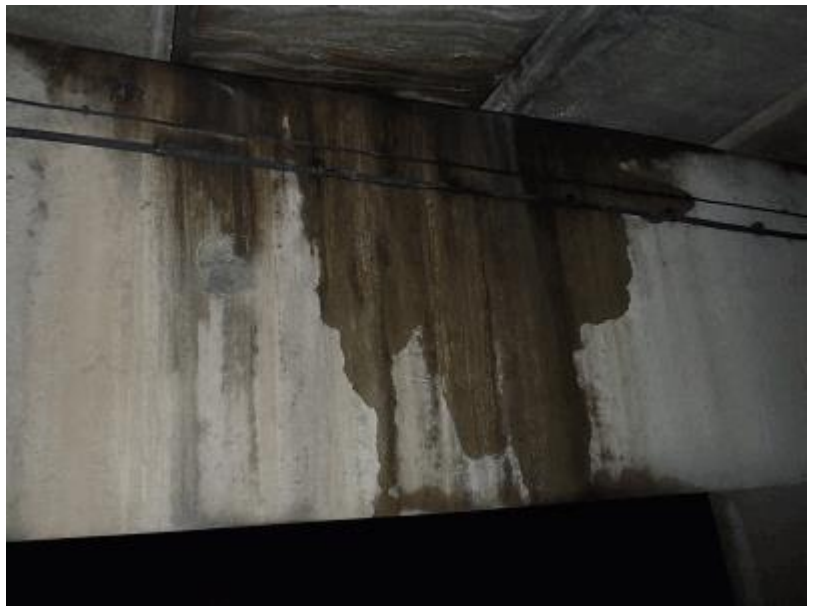
| Comments | The portal piers are heavily stained with algal deposit and scaling. Water seepage is evident on the pier cross beam. | | |
| Comment on Cause | Joint failure above supports. | | |
| Cause | The central reserve drainage gully may also have failed. | | |

Water staining at historic site of algal staining, North pier

| Comments | Investigate cause of water seepage. If joints are found to leak repair joints. Note the defect is likely to occur at the interface of the phased joint replacement works near the central reserve. In addition, the longitudinal joint between the two bridge decks may be the cause of water seepage. In addition to the above joint repairs will be required as a consequence of resurfacing works. | | |

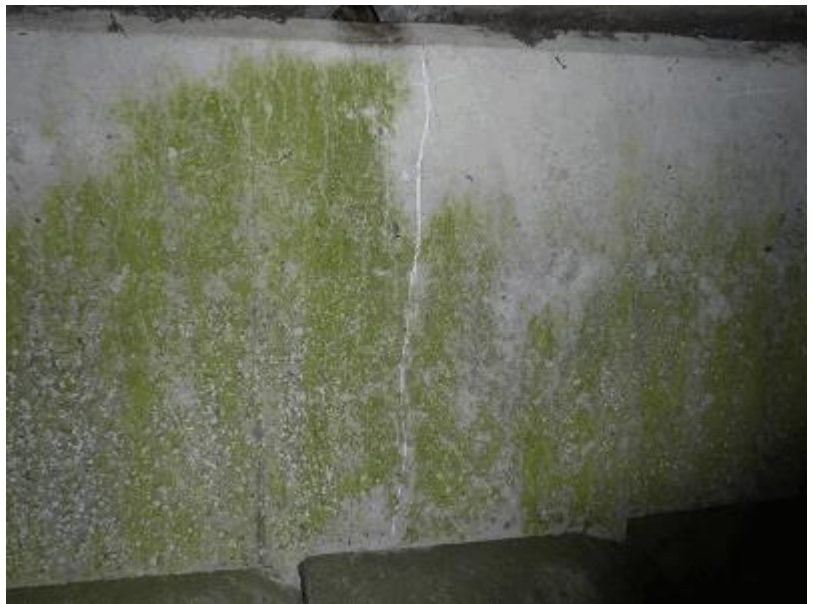
Algal staining to the South bankseat wall

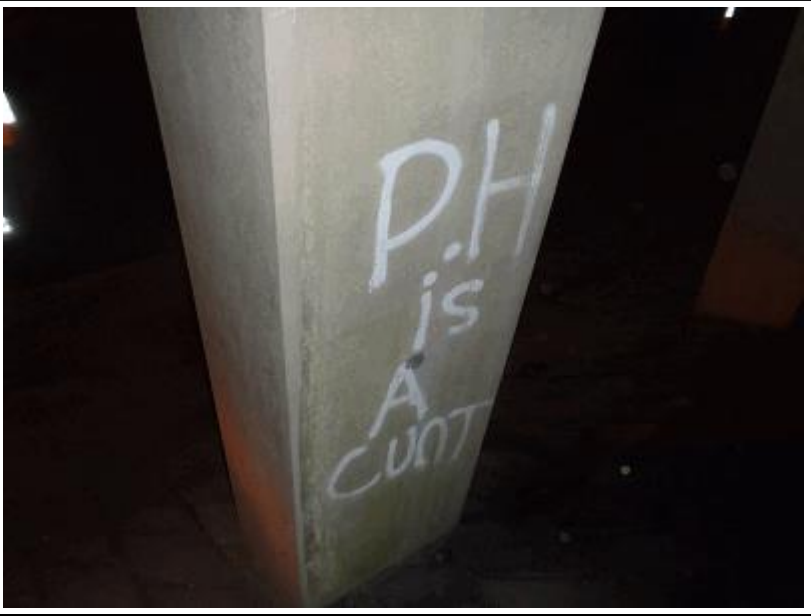
| Defect Type | Graf - Graffiti |
| Severity | A4 - Defect in offensive condition |

Offensive graffiti to South pier column

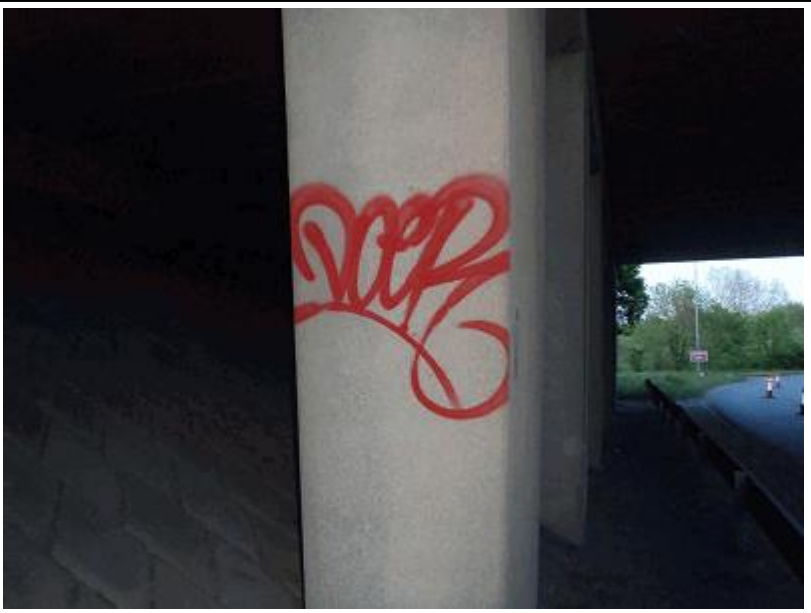
Graffiti to North pier column

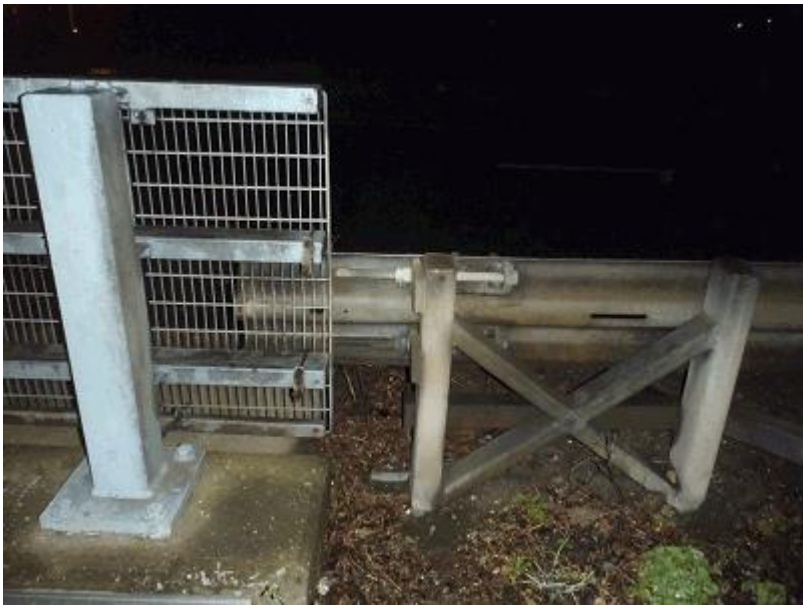
| Severity | D3S - Moderate: Defect may present a danger to the public in the near future | | |
| Cause | Construction Issue | Certainty | High |
| Comment on Cause | No connection between parapet and approaching safety barrier, Southwest | | |

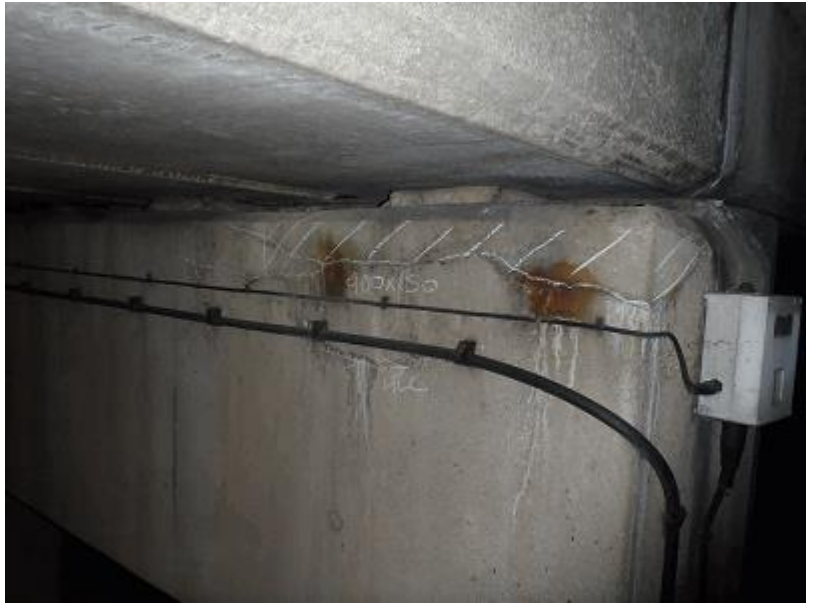
| Comments | Areas of delaminated concrete were noted to the bankseat walls and pier crossheads. | | |
| Cause | Moisture Ingress | Certainty | High |
| Comment on Cause | Water is likely penetrating the deck joints resulting in corrosion to reinforcement of elements directly beneath. | | |

Delaminated concrete and rust staining to the East end of the North pier crosshead

| Comments | Repair areas of delaminated concrete caused by reinforcement corrosion. | | |

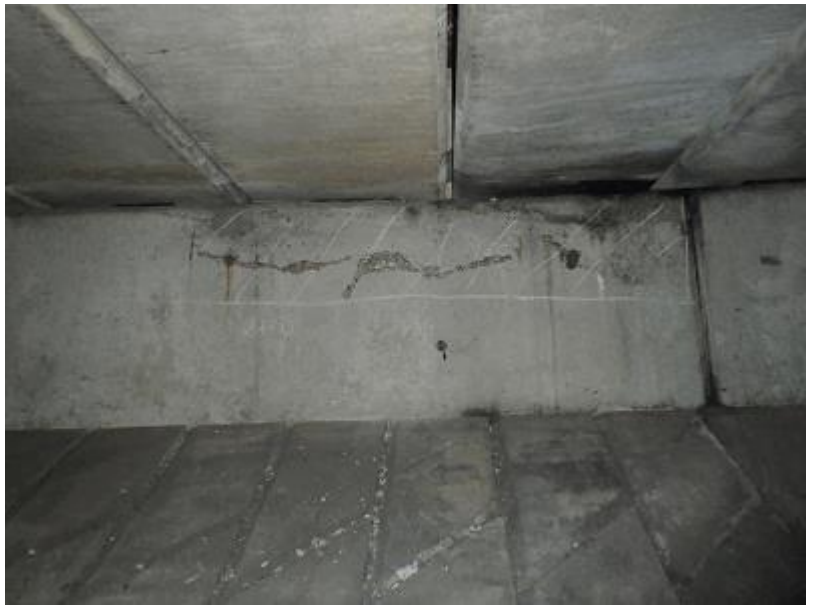
Delaminated concrete to the North bankseat

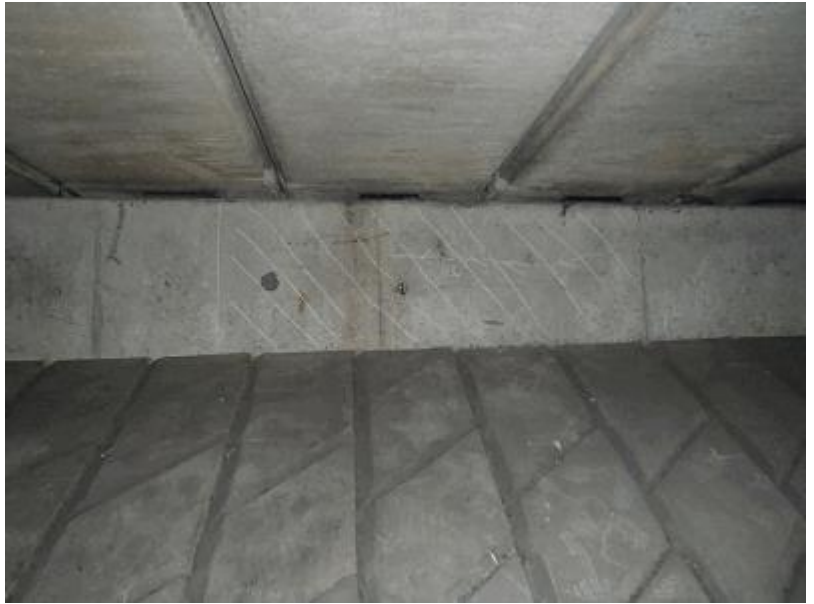
Delaminated concrete to the North bankseat

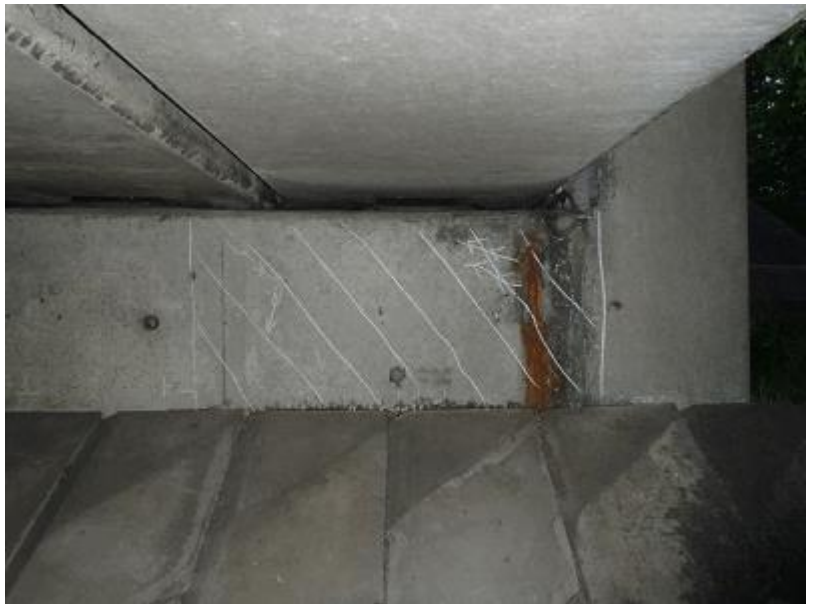
Delaminated concrete to the East end of the North bankseat

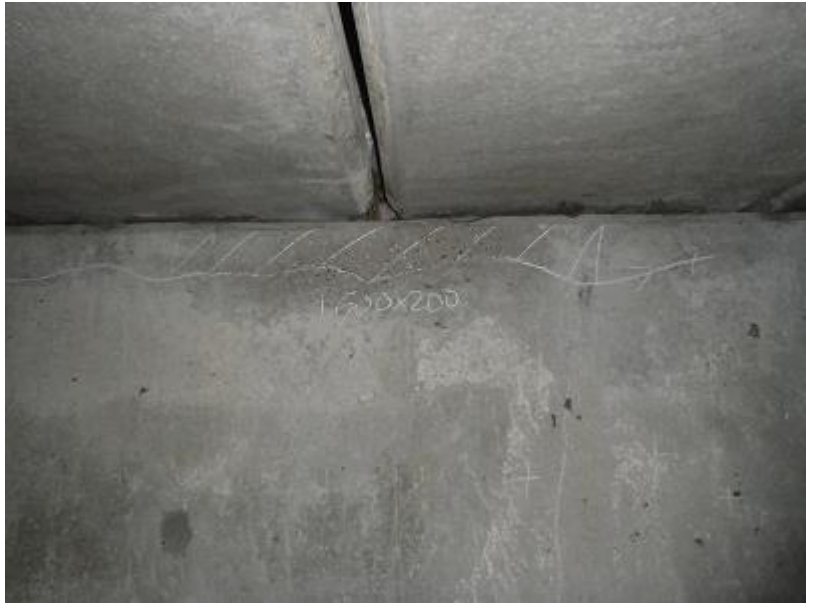
Delaminated concrete to the South bankseat

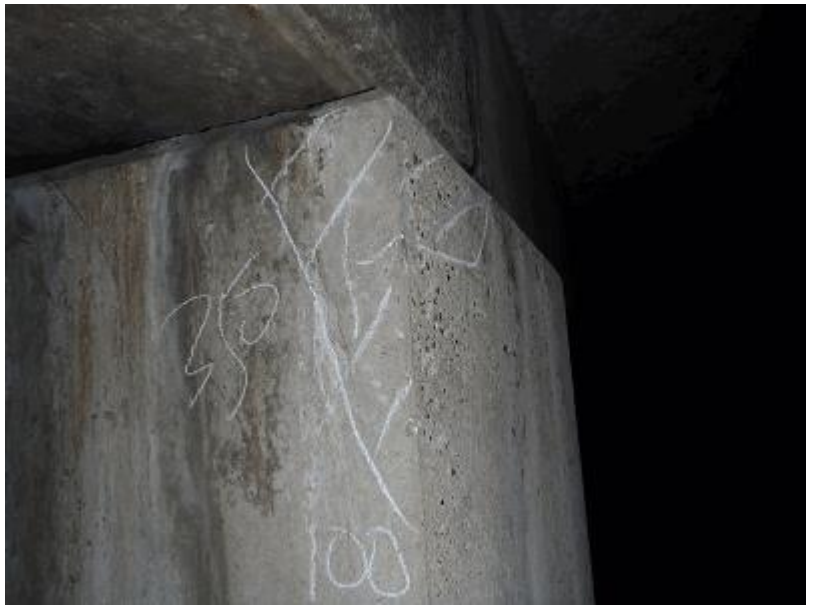
Delaminated concrete to the East end of the South pier crosshead

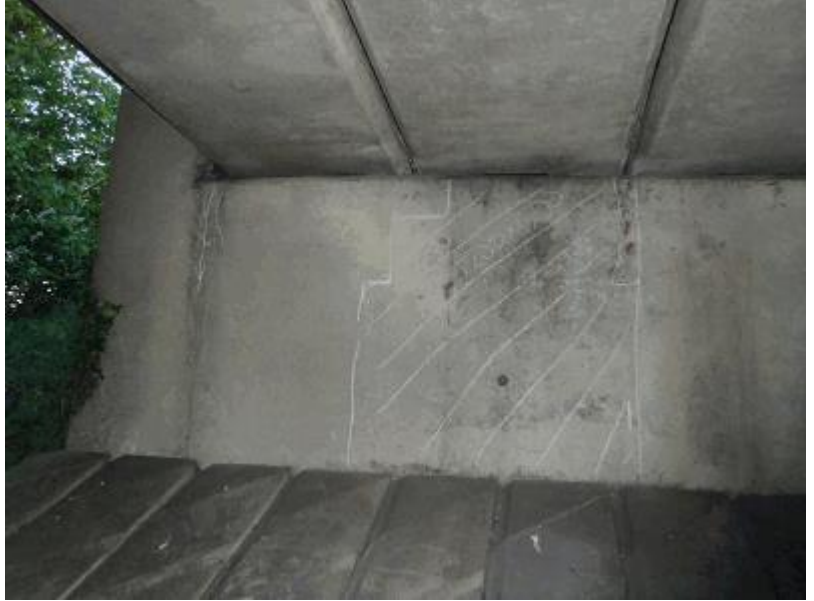
Delaminated concrete to the West end of the North bankseat

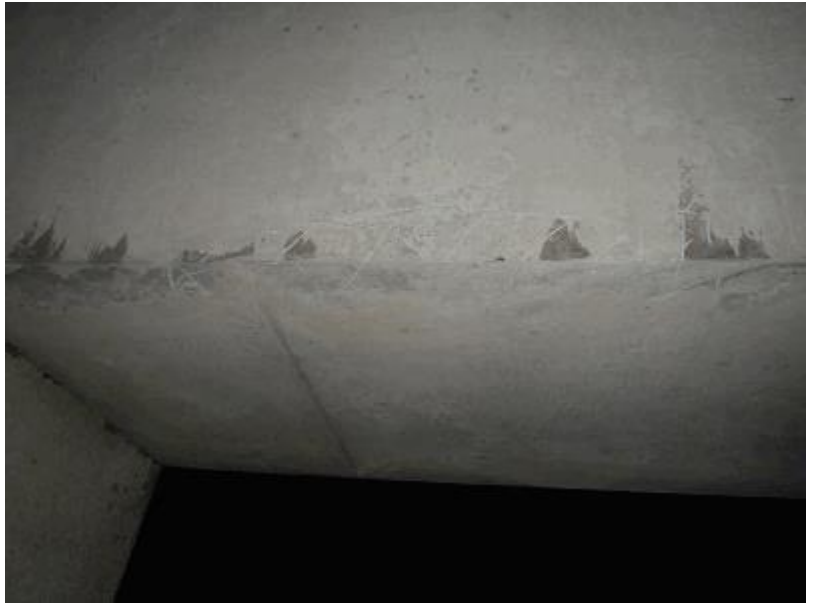
Delaminated concrete to soffit of South pier crosshead

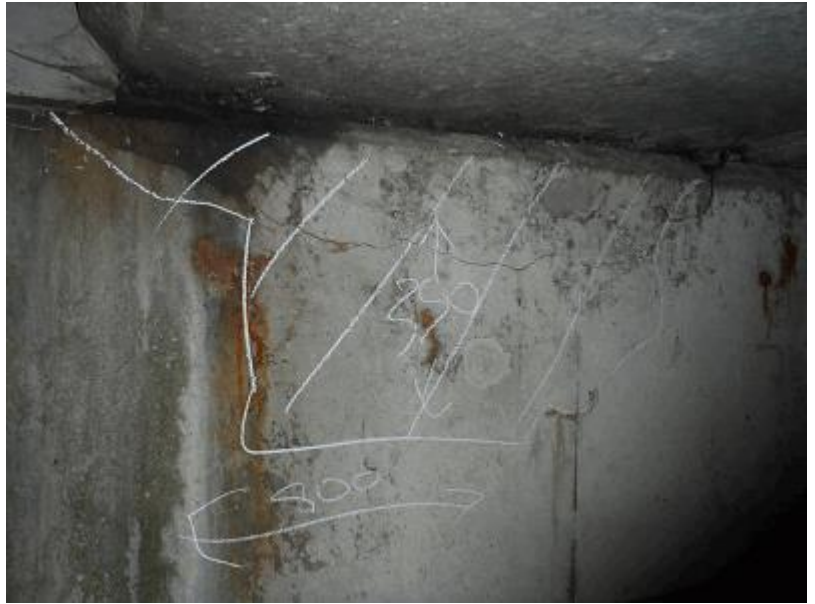
Delaminated concrete to the East end of the South bankseat

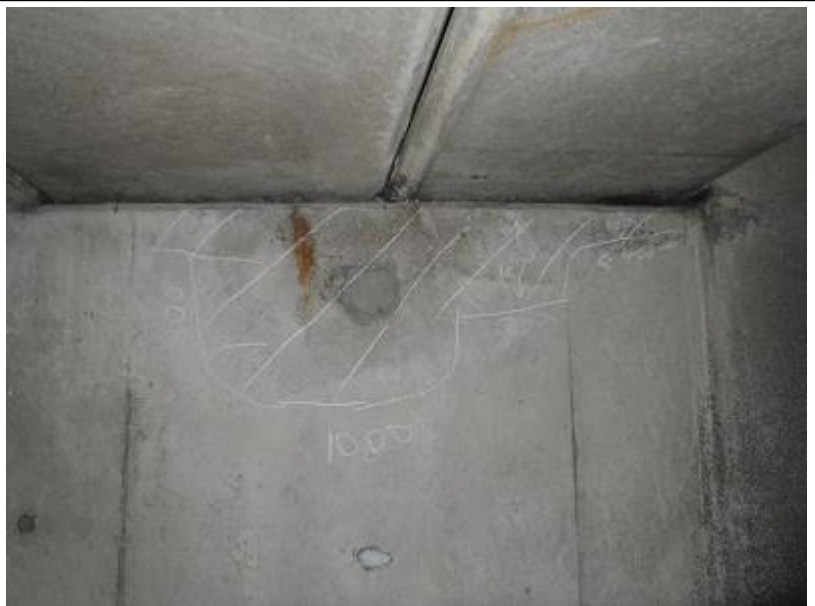
Severity D2 - Minor: Defect is unlikely to be causing damage to the element or structure now or unlikely to do so in the near future

Comments The South abutment, a number of cracks were noted which are showing damp and rust staining. Delaminated concrete is common adjacent to these cracks. Cracking also noted in the North bankseat wall.

Cracking to West end of South bankseat wall surrounded by delaminated concrete

| Comments | Investigate cause of longitudinal crack to South abutment. If crack is stable, resin inject to prevent corrosion to reinforcement | | |

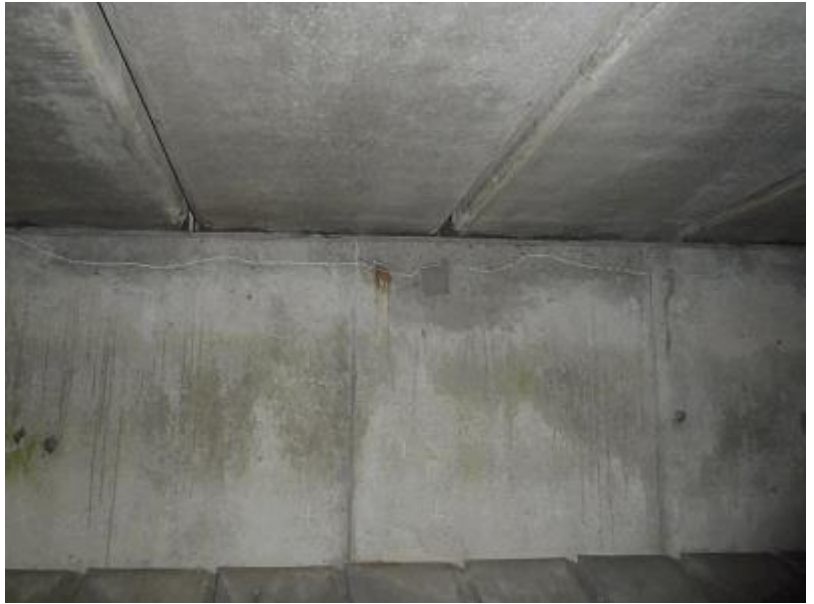
Cracking to South bankseat wall
with rust staining present

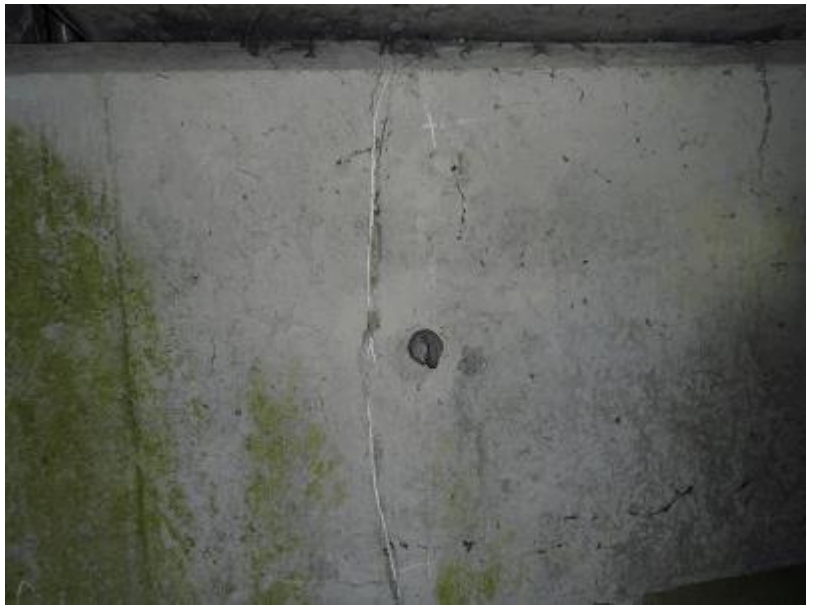
Vertical crack towards East end of
the South bankseat wall

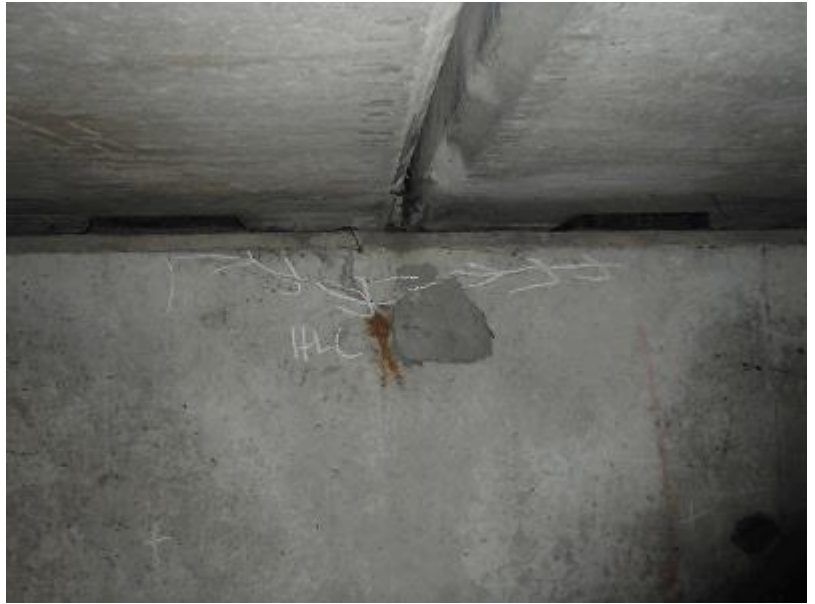
Cracking and rust staining to the North bankseat

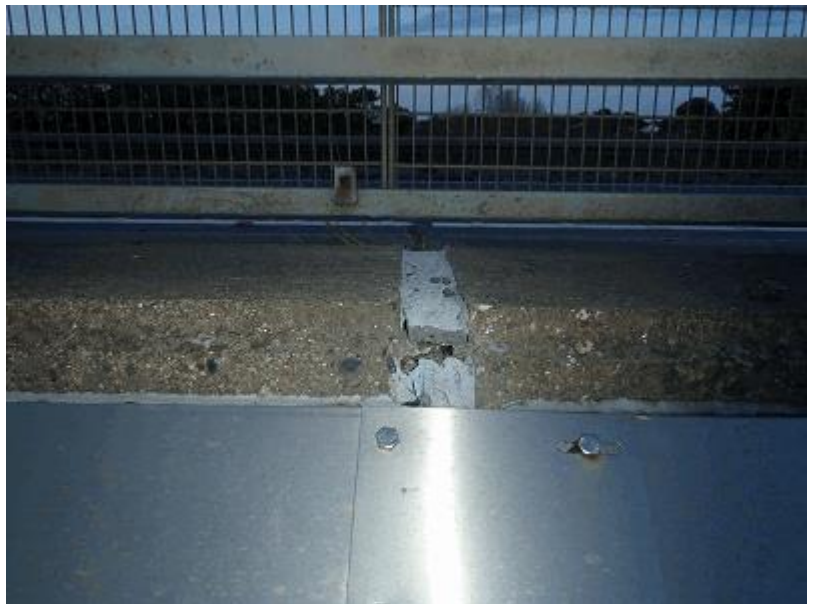
Comments The polysulphide joints sealant have degraded and are debonding.

Damage to seal at West end of the North pier

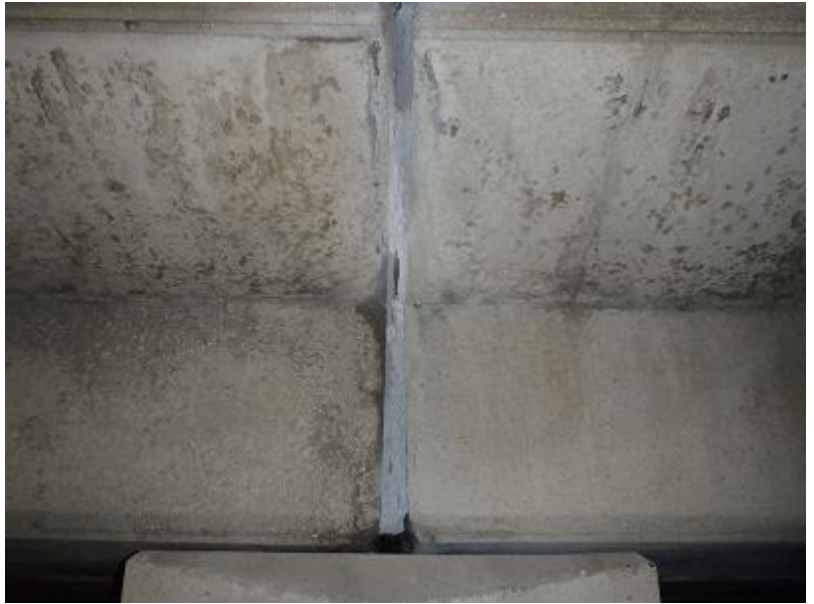
Cracking to sealant above the South pier, West end

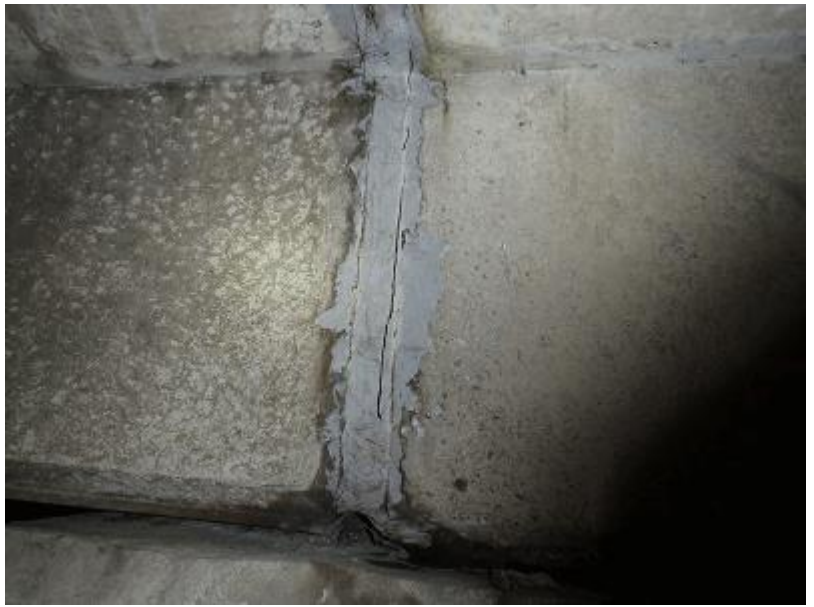
Failed seal at East end of South pier

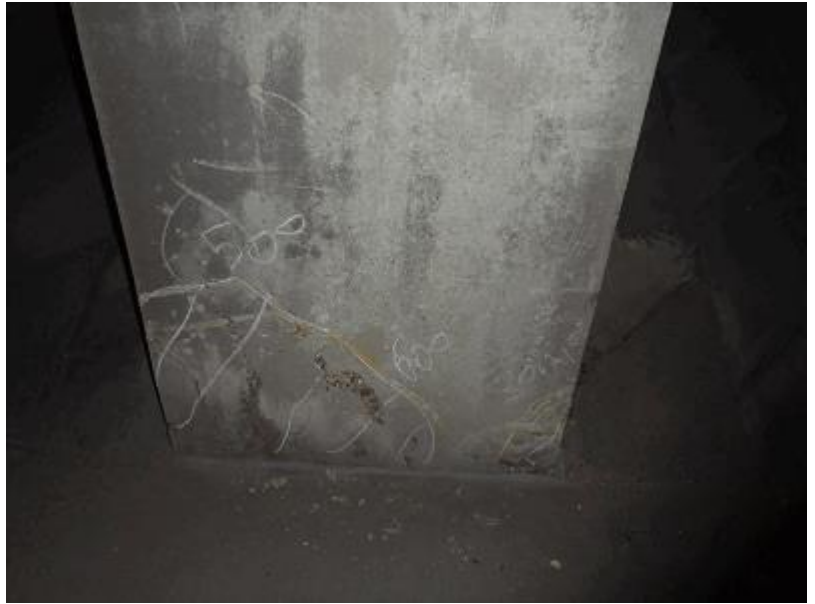
| Comments | North piers, at the base of the fifth column from the west, two areas of spalling (approx 300mm long x 100mm wide and 20mm deep) and a crack 400mm long and 0.55mm wide. There is corrosive staining in the vicinity of the spall. Delamination now extends to 600x500mm. Other areas of delaminated concrete were noted to pier bases. |

Delaminating and spalling concrete to base of North pier columns

| Comments | Undertake minor concrete repair to areas of spalling. | | |

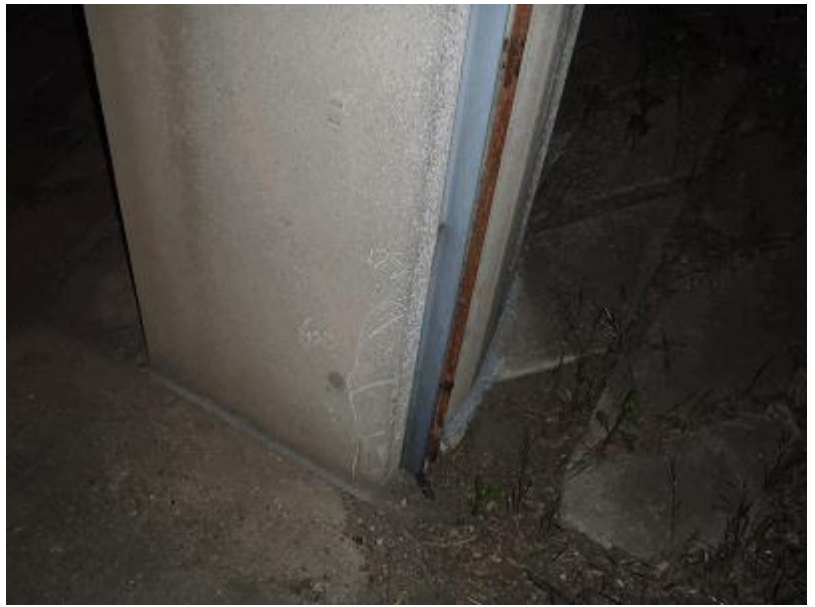
Delaminated concrete to East column of North pier

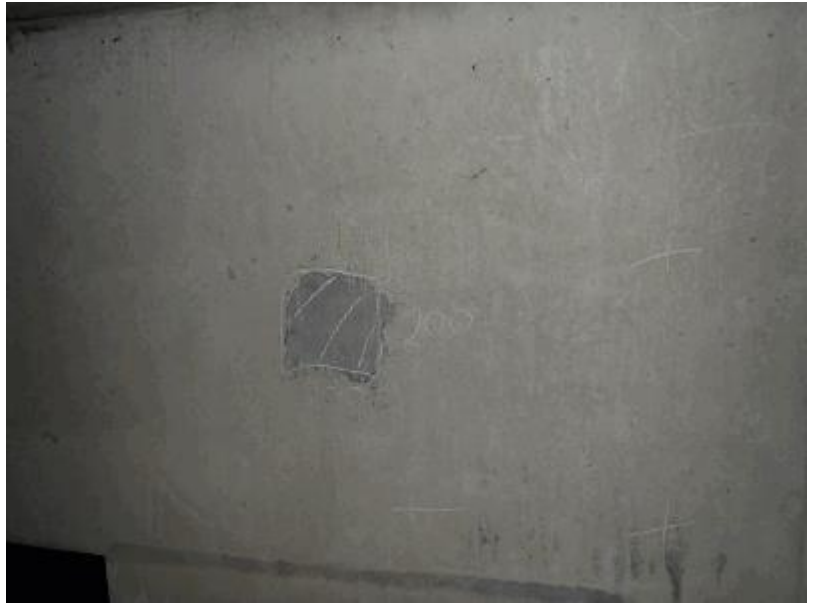
| Comments | A number of repairs at core hole testing locations to pier crossheads have failed, sounding hollow when hit with inspection hammer. |

Typical failed repair, North pier

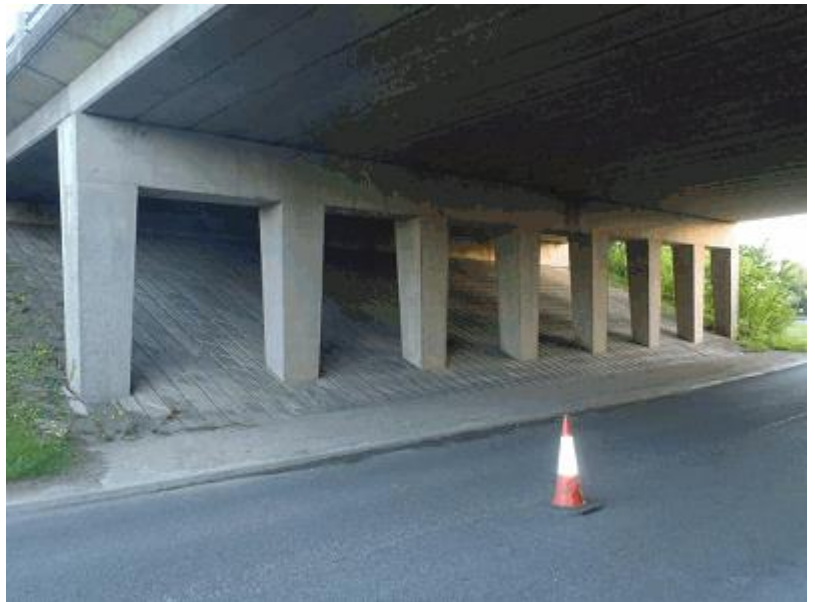
| Comments | There is no safety fence protection to the south pier portal. | |

No safety barrier protection to South pier

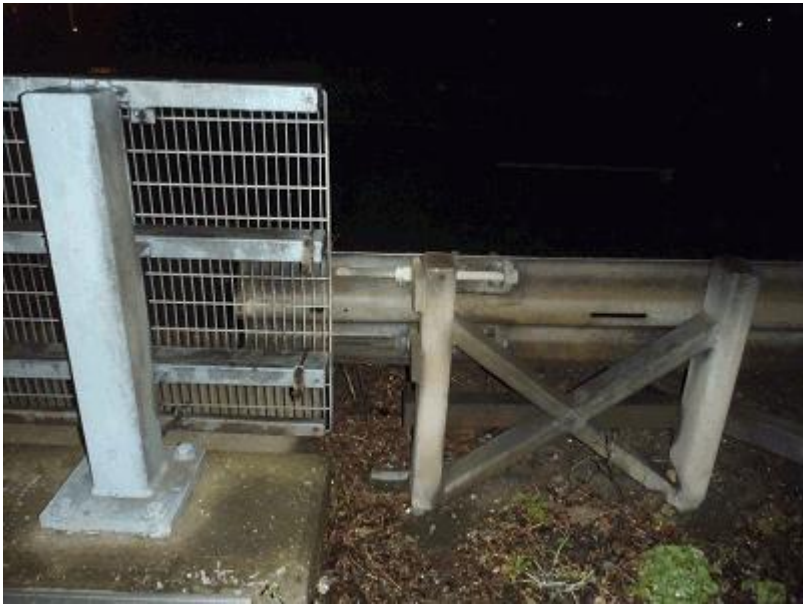
| Severity | D3S - Moderate: Defect may present a danger to the public in the near future | | |
| Cause | Construction Issue | Certainty | High |
| | No connection between parapet and approaching safety barrier, Southwest | | |

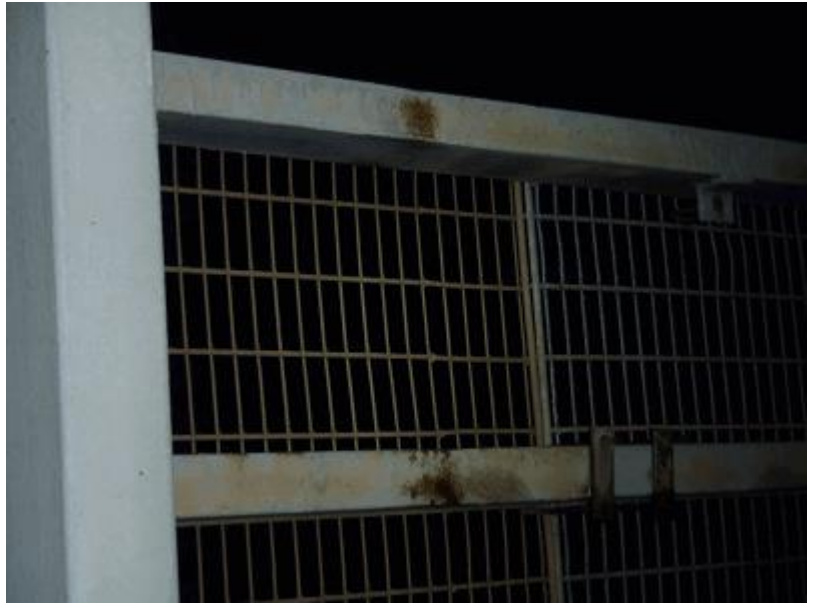
| Comments | The parapet rails and posts are subject to loss and general deterioration of the paint system. The infill mesh fixings are suffering from corrosion. | | |
| Cause | Corrosion | Certainty | High |

Corrosion to rear of West parapet rails

| Comments | Localised paint repairs to parapet | | |

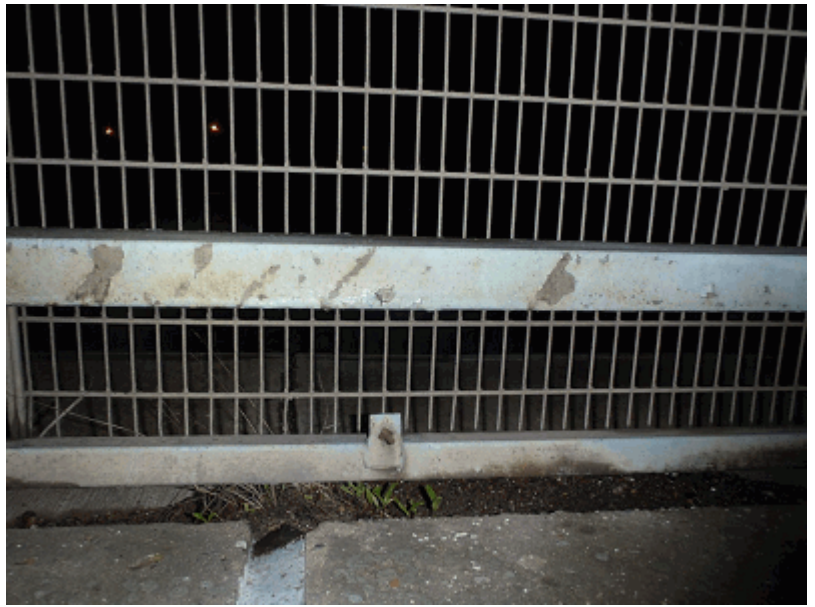
Typical deterioration of parapet protective paint system

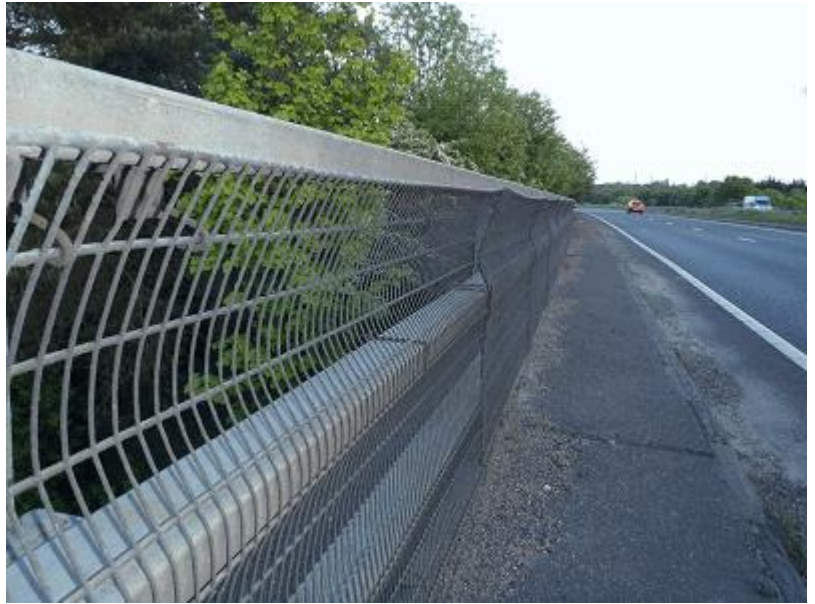
| Comments | The mesh infill to the east parapet has minor impact damage approximately 15m long. | |
| Cause | Accident Damage | Certainty High |

Damage to East parapet infill mesh

| Comments | Replace deformed mesh infill east parapet. | | |

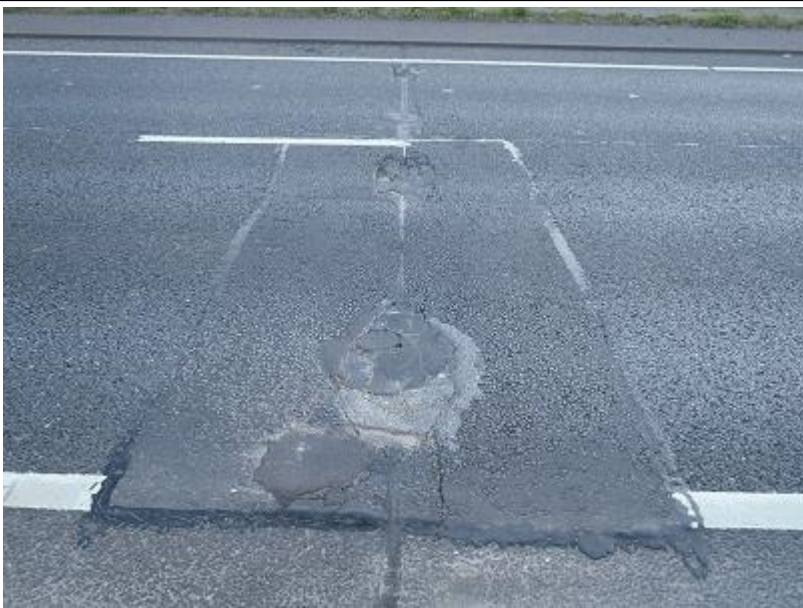
| Comments | Potholing and surfacing deterioration is present to the southbound carriageway at North pier | | |
| Cause | Age Expired | Certainty | High |
| Comment on Cause | Lack of binding agent to the aggregate leading to movement of material and breakup of the surfacing. | | |
| | Potholing at the North pier joint in the Southbound carriageway surfacing | | |

| Comments | Resurfacing of westbound lane 1 over the entire structure. Repairs/replacement of burried joint and waterproofing will also be required. | | |

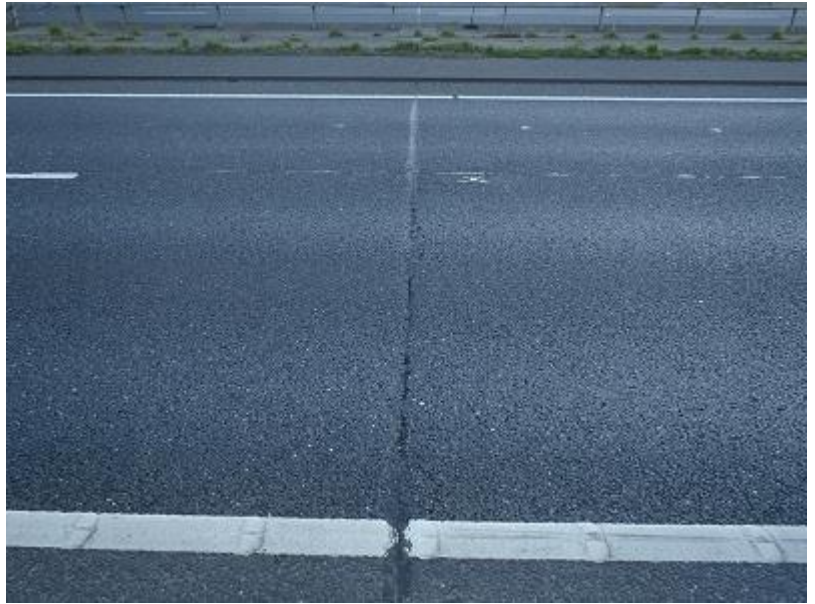
| Severity | D3 - Moderate: Defect is probably causing damage to element or structure, or is likely to do so in the near future | | |
| Cause | Maintenance Issue | Certainty | Medium |

Areas of no sealant in saw cut to surfacing above South pier, Eastbound

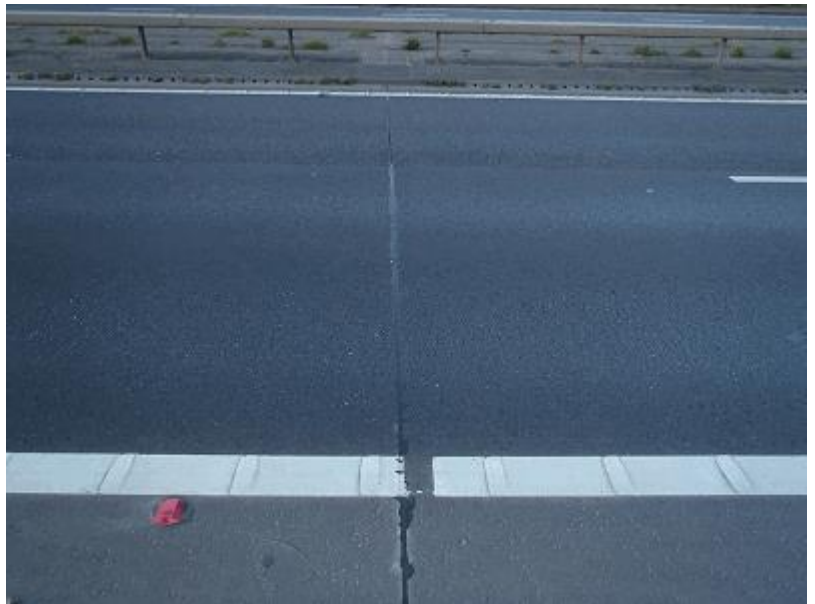
No sealant across saw cut to carriageway surface above North pier, Westbound

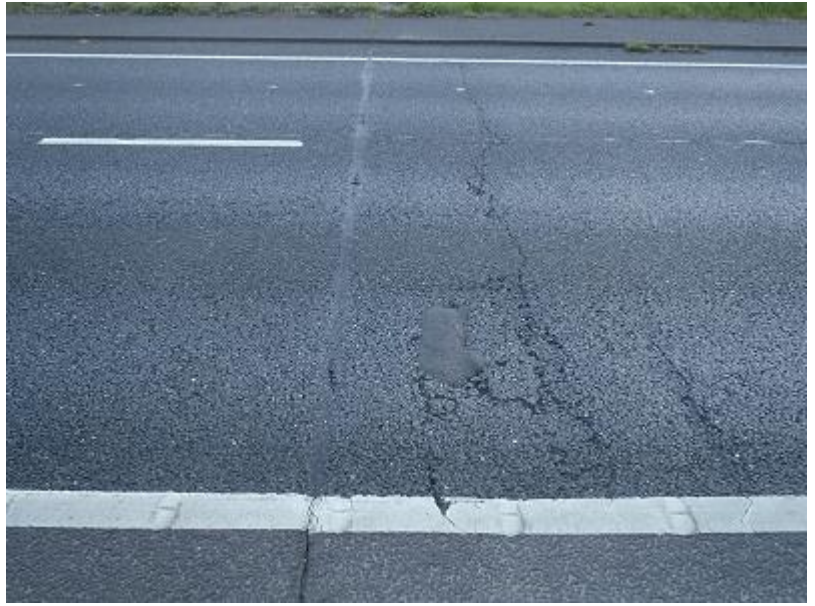
| Comments | There was cracking in the carriageway on the approach to the North joint (Eastbound). | |

Cracking to carriageway surface as a result of settlement

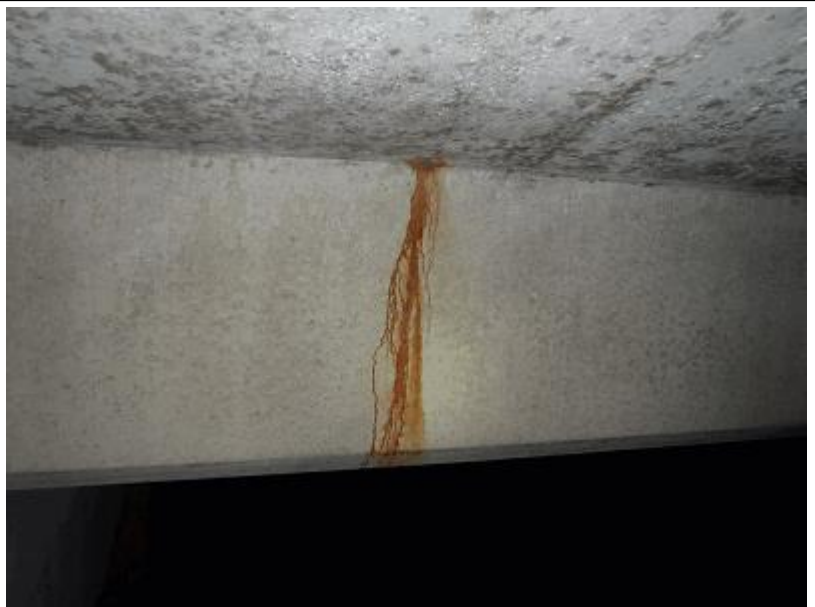
| Comments | In the west cantilever at the south end there is an area of corroding ferrous material with a spall, approx 60mm diameter. Similar defect in the same area approximately 1m south of the south pier. Also, a small area of exposed corroding steel on the north abutment east end. | |

Corroding ferrous debris to West edge beam in South side span

| Comments | Remove corroding objects and repair spalling on the west deck cantilerver soffit. | | |

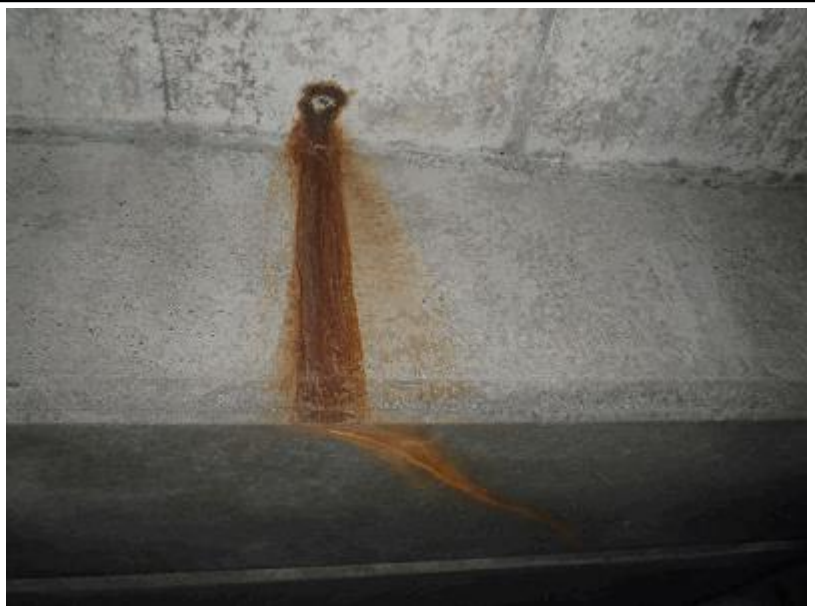
Corroding ferrous debris to West edge beam in South side span adjacent to South abutment
