Report on the investigation of
the death of a third officer struck by a freight vehicle
on the stern ramp of the ro-ro freight ferry

Seatruck Progress

Brocklebank Dock, Liverpool

15 May 2019

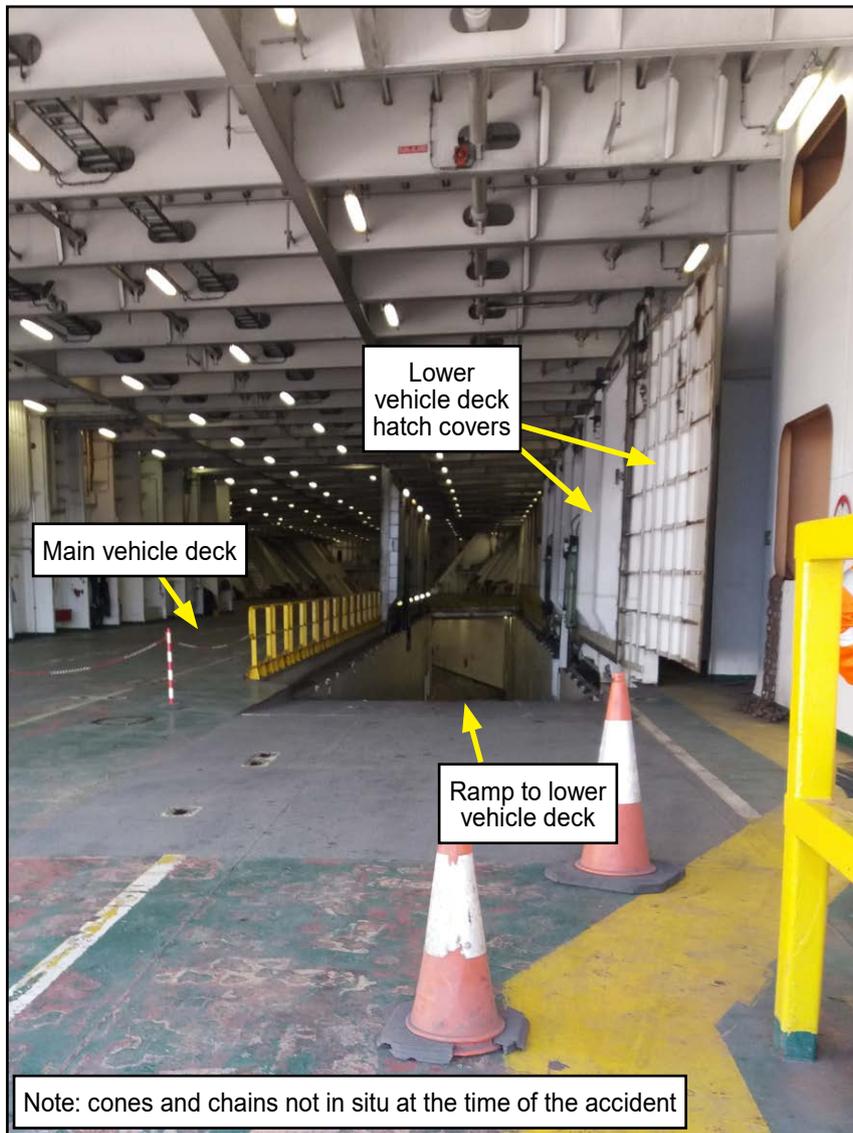
Figure 3: Ramp from main to lower vehicle deck post-accident (hatch covers open)

The 3/O returned to the CCR and left the outgoing master's car keys on the desk. He then chatted briefly with both chief officers and was asked by the relieving chief officer to oversee cargo operations while he went to his cabin and changed into working clothes. The 3/O also collected the key to the relieving master's car, which required moving on board from the quayside. By about 1900, the main vehicle deck was almost clear of cargo and the 3/O opened the hatch covers over the lower vehicle deck ramp on the main vehicle deck's starboard side (**Figure 3**).

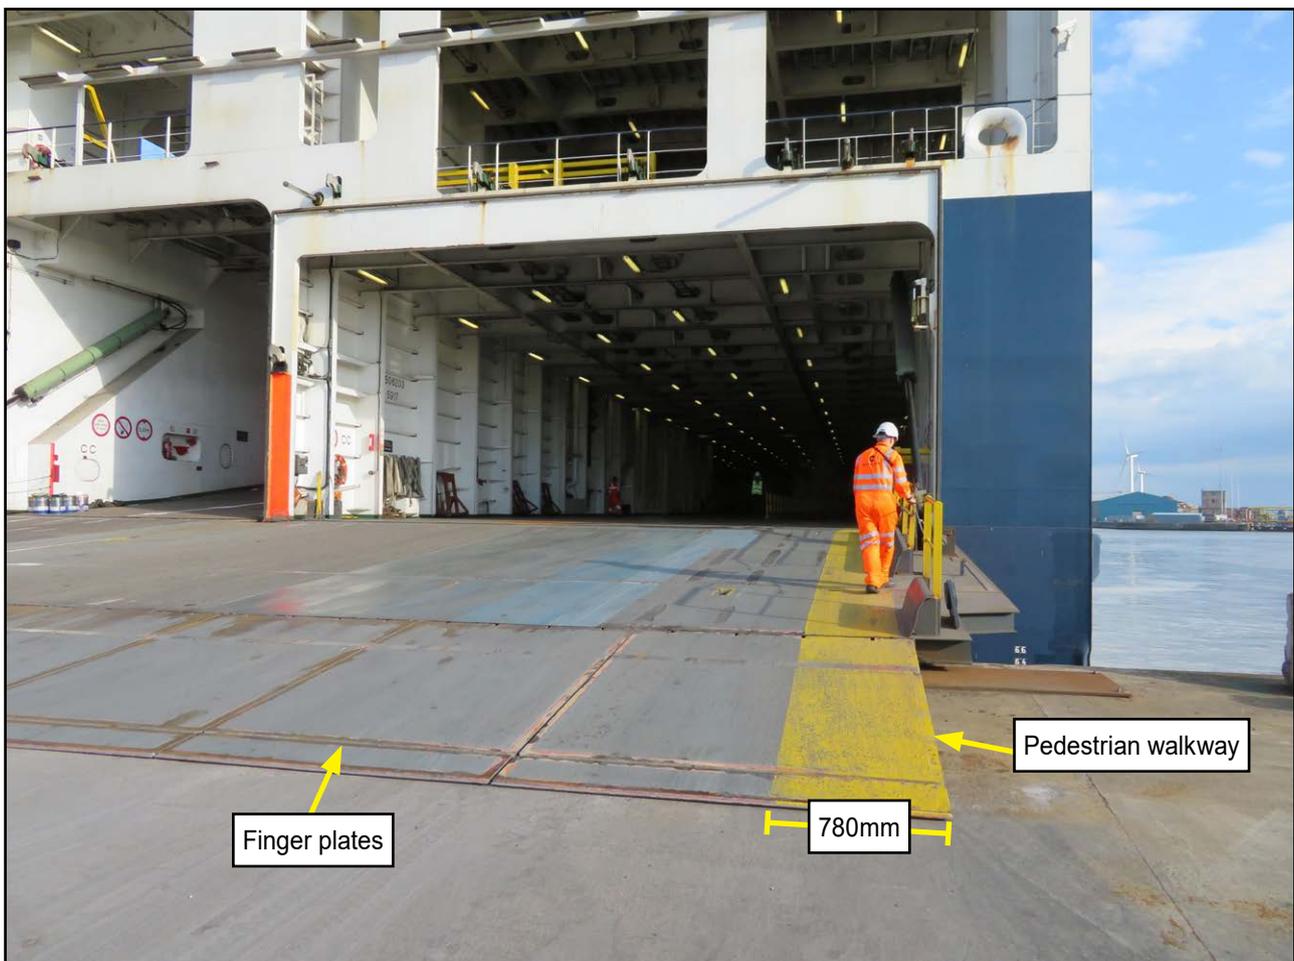
Figure 7: The stern ramp and painted pedestrian walkway

There were no locally produced onboard instructions concerning safe access to the ship. There were no signs, instructions or out of bounds areas for pedestrians marked near the ship's stern ramp, but a 780mm wide yellow line from the finger plates to the main vehicle deck was painted on the starboard edge (Figure 7). The line was an extension of an escape route marked on the main vehicle deck and indicated a walkway on the stern ramp. It was also intended to assist drivers in keeping vehicles clear of the stern ramp's starboard hydraulic ram. There was no corresponding line marked on the port side of the stern ramp. Markings on the starboard edge of the stern ramps on sister vessels managed by Seatruck varied between similar solid lines and painted footprints.

- Painted walkways on vehicle ramps and decks that are not protected are liable to be encroached upon by vehicles and are not safe unless other measures to control pedestrian access and vehicular traffic are also implemented. They are even less safe if they are not used.

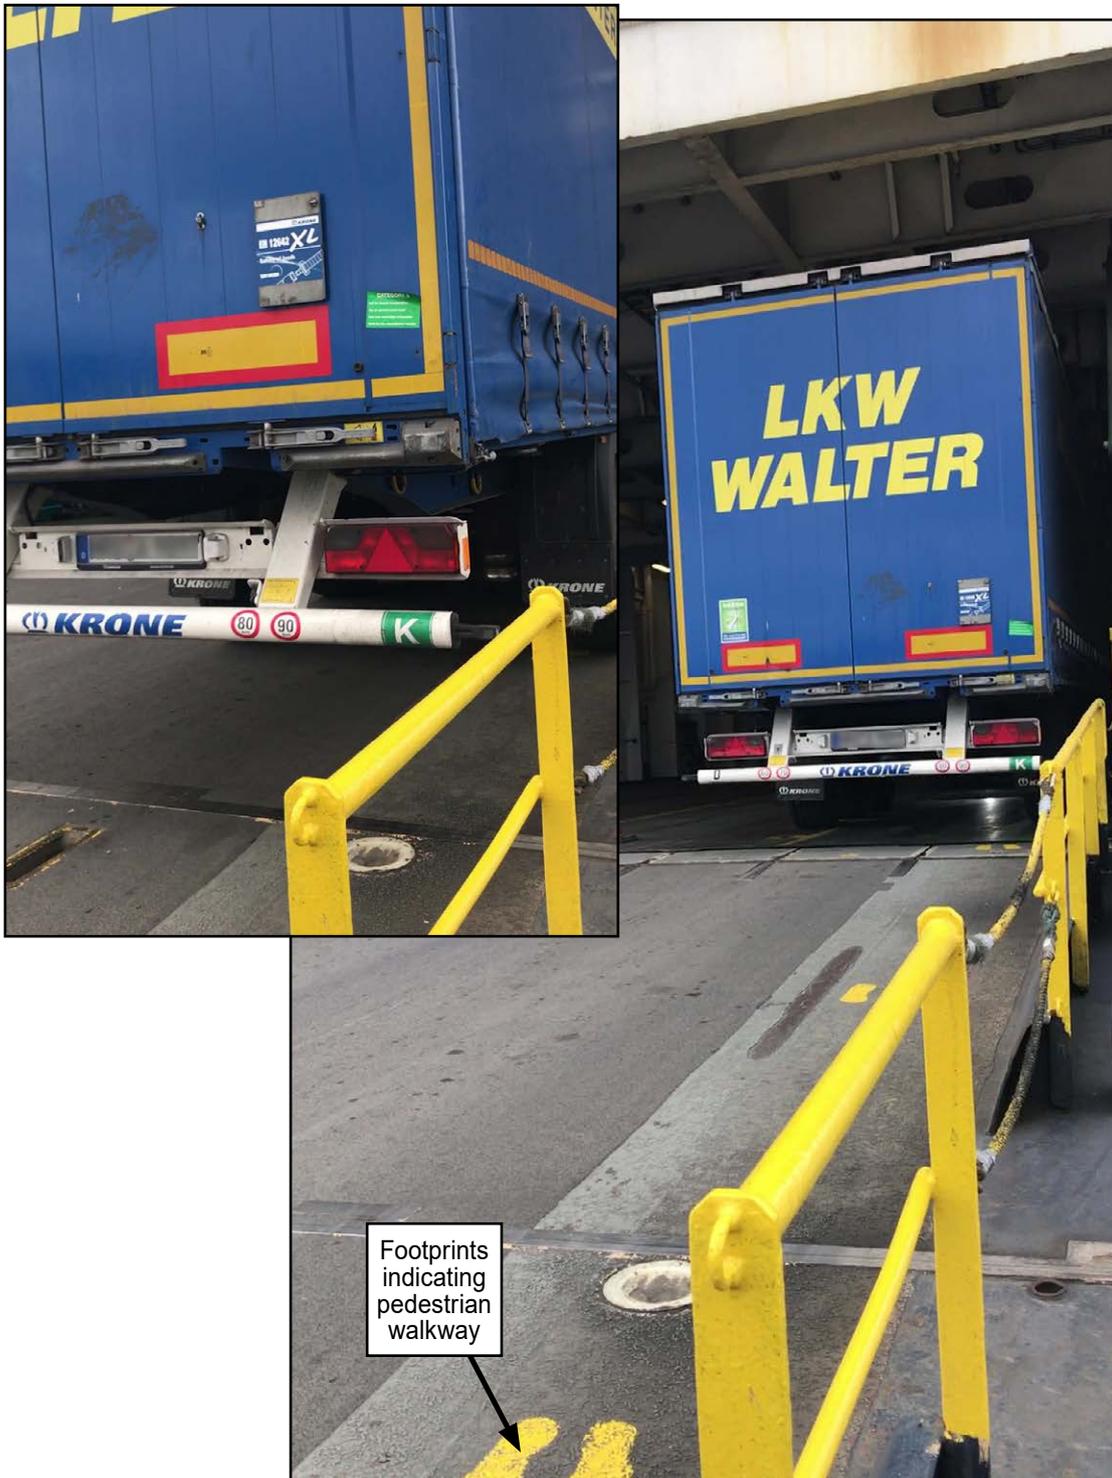
Figure 9: Semi-trailer being pushed down stern ramp during reconstruction (18 May 2019) on board *Seatruck Power*

When pushing the semi-trailer from the lower to the main vehicle deck (**Figures 4a and 4b**), the tractor driver had to keep the semi-trailer in a straight line between the sides of the lower deck ramp. A slight alteration to the right was made towards the top of the ramp to avoid hitting a protective barrier around the stern ramp's starboard hydraulic ram. It was also noted that when transiting down the stern ramp, the semi-trailer was kept parallel and close to the starboard side (**Figure 9**).

The noise from the tractor's engine as the semi-trailer approached was difficult to distinguish when standing at the bottom of the stern ramp. The tractor's audible reversing and pushing alarm could not be heard until the back end (free end) of the semi-trailer drew level with the observer's position. The tractor's orange flashing warning beacon was obscured by the semi-trailer and could not be seen.

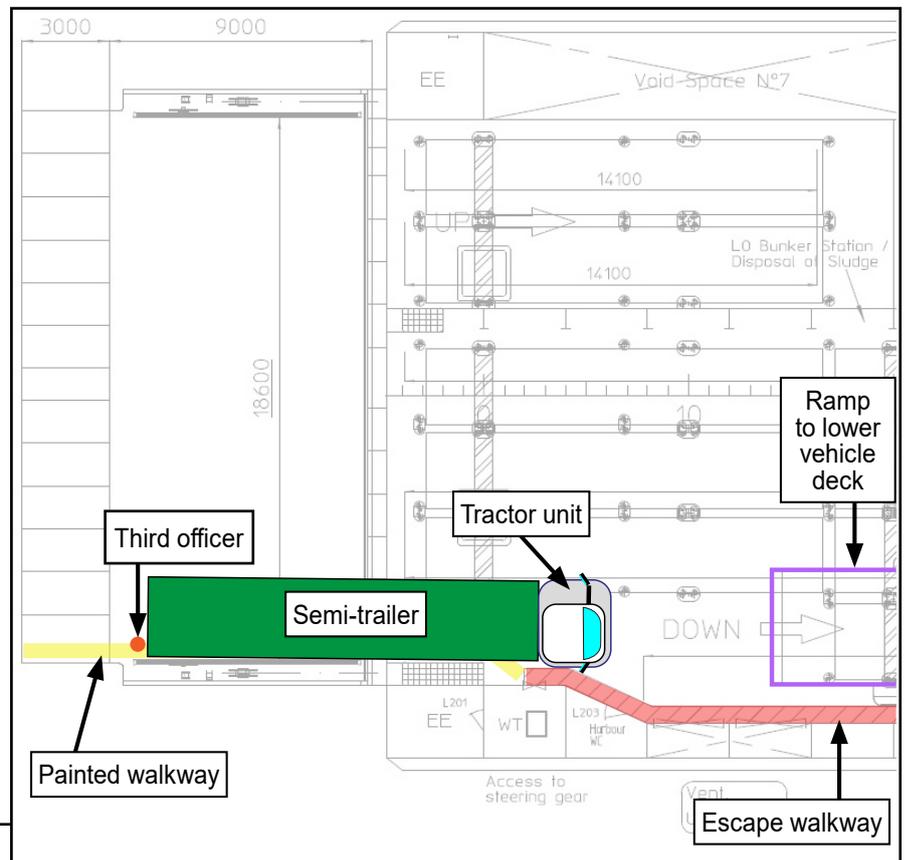
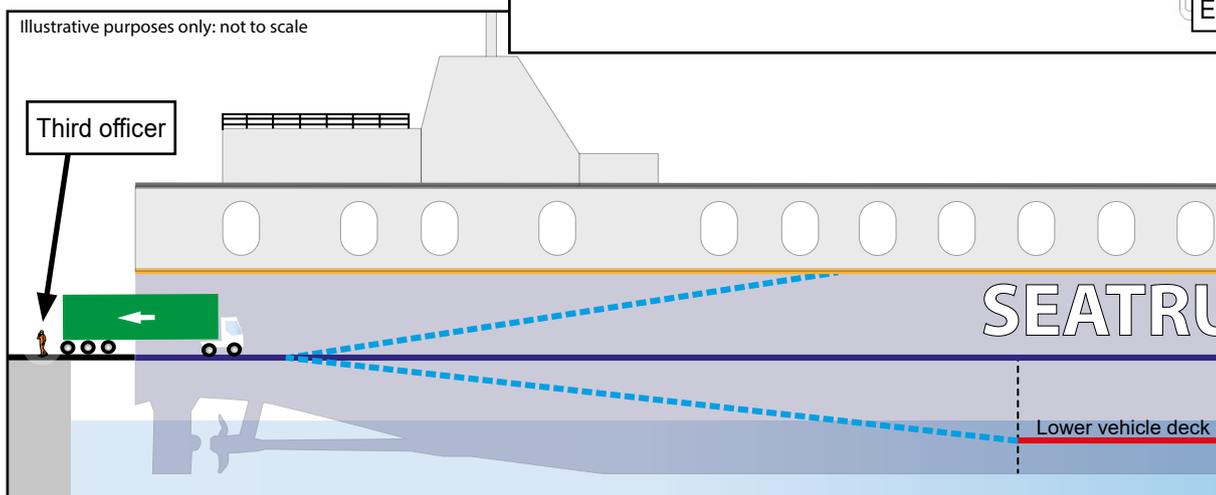
Figure 1: *Seatruck Progress* with the semi-trailer and the third officer on the stern ramp

The third officer was talking on his mobile telephone and was facing down the ramp, away from the direction of the semi-trailer's approach, when he was struck. He probably did not hear the trailer approaching amongst the noise from cargo operations on other decks, and he was standing away from a pedestrian walkway that was painted along the starboard edge of the ramp.
