## **Construction noise and vibration Monthly Report – March 2020**

### **London Borough of Camden**

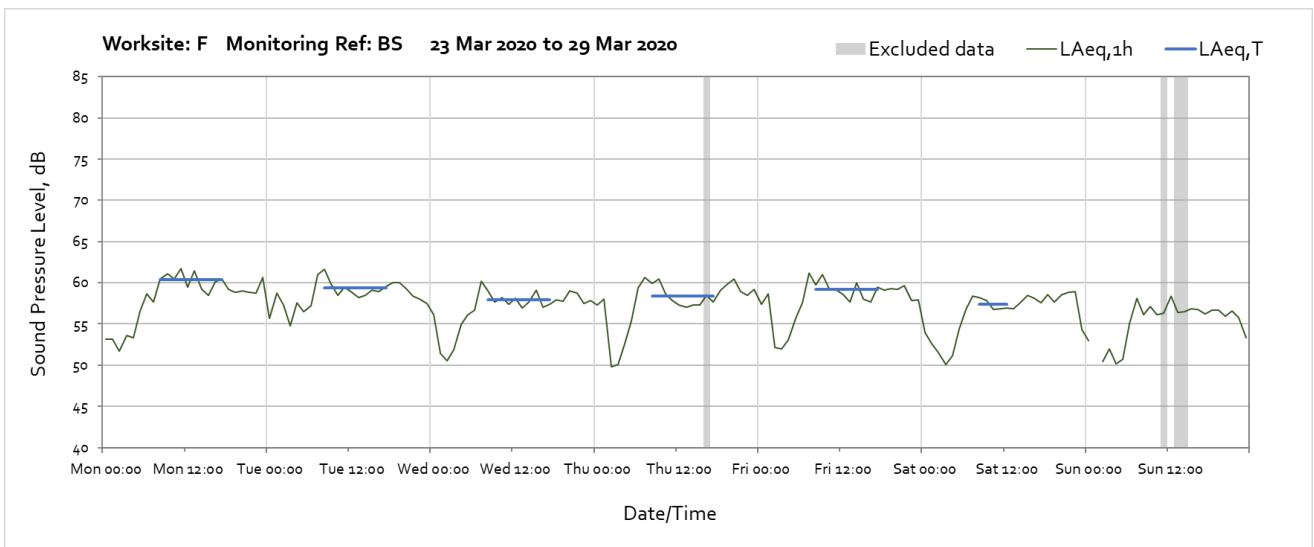
# Worksite: F – Monitoring Ref: BS

2.1.4 SOAEL exceedances identified at measurement ref. BS were caused by the demolition of a ramp at Euston Station during night-time hours. Complaints were received resulting in the works being stopped in order for the methodology and mitigation measures to be reviewed.
