Fall of a suspended load, resulting in injuries to two crewmen on board the general cargo vessel *ZEA Servant* in Campbeltown, Scotland on 2 March 2019

SUMMARY

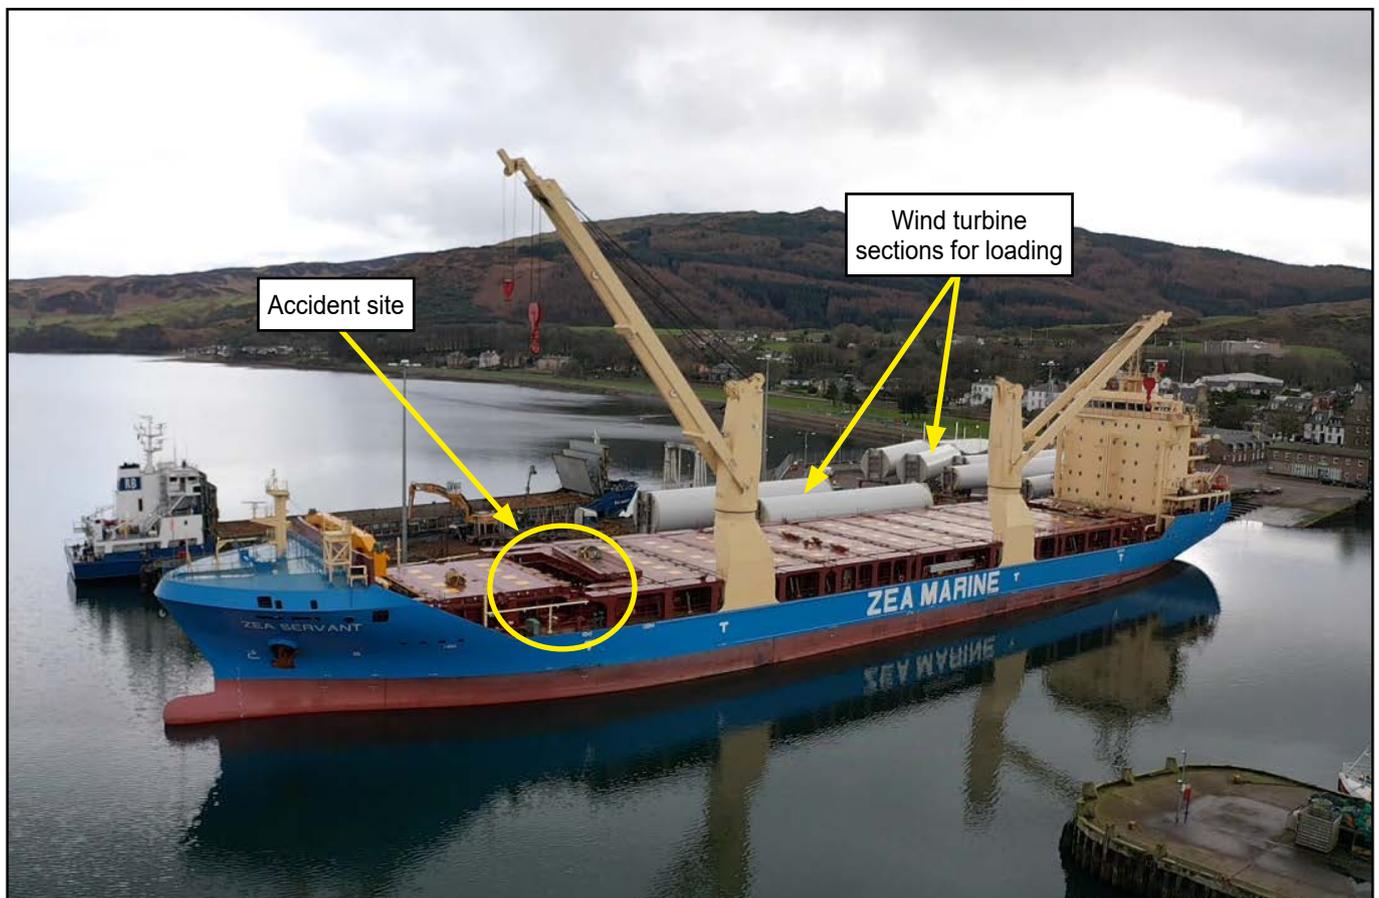
ZEA Servant arrived in Campbeltown, Scotland on 1 March 2019 to load a cargo of wind turbine tower sections (**Figure 1**). On 2 March 2019 the deck crew, supervised by the chief officer, began preparing the vessel for cargo loading. This work was halted in the afternoon due to adverse wind conditions, but was scheduled to recommence later in the evening when the weather was expected to improve. At 2100, the chief officer held a safety briefing and took up position as supervisor, accompanied by the bosun. By this time, the wind was light, and it was dark and dry; the vessel's deck working lights were on, illuminating the area where the crew were working.

Figure 1: *ZEA Servant* berthed in Campbeltown showing accident site and wind turbine sections for loading

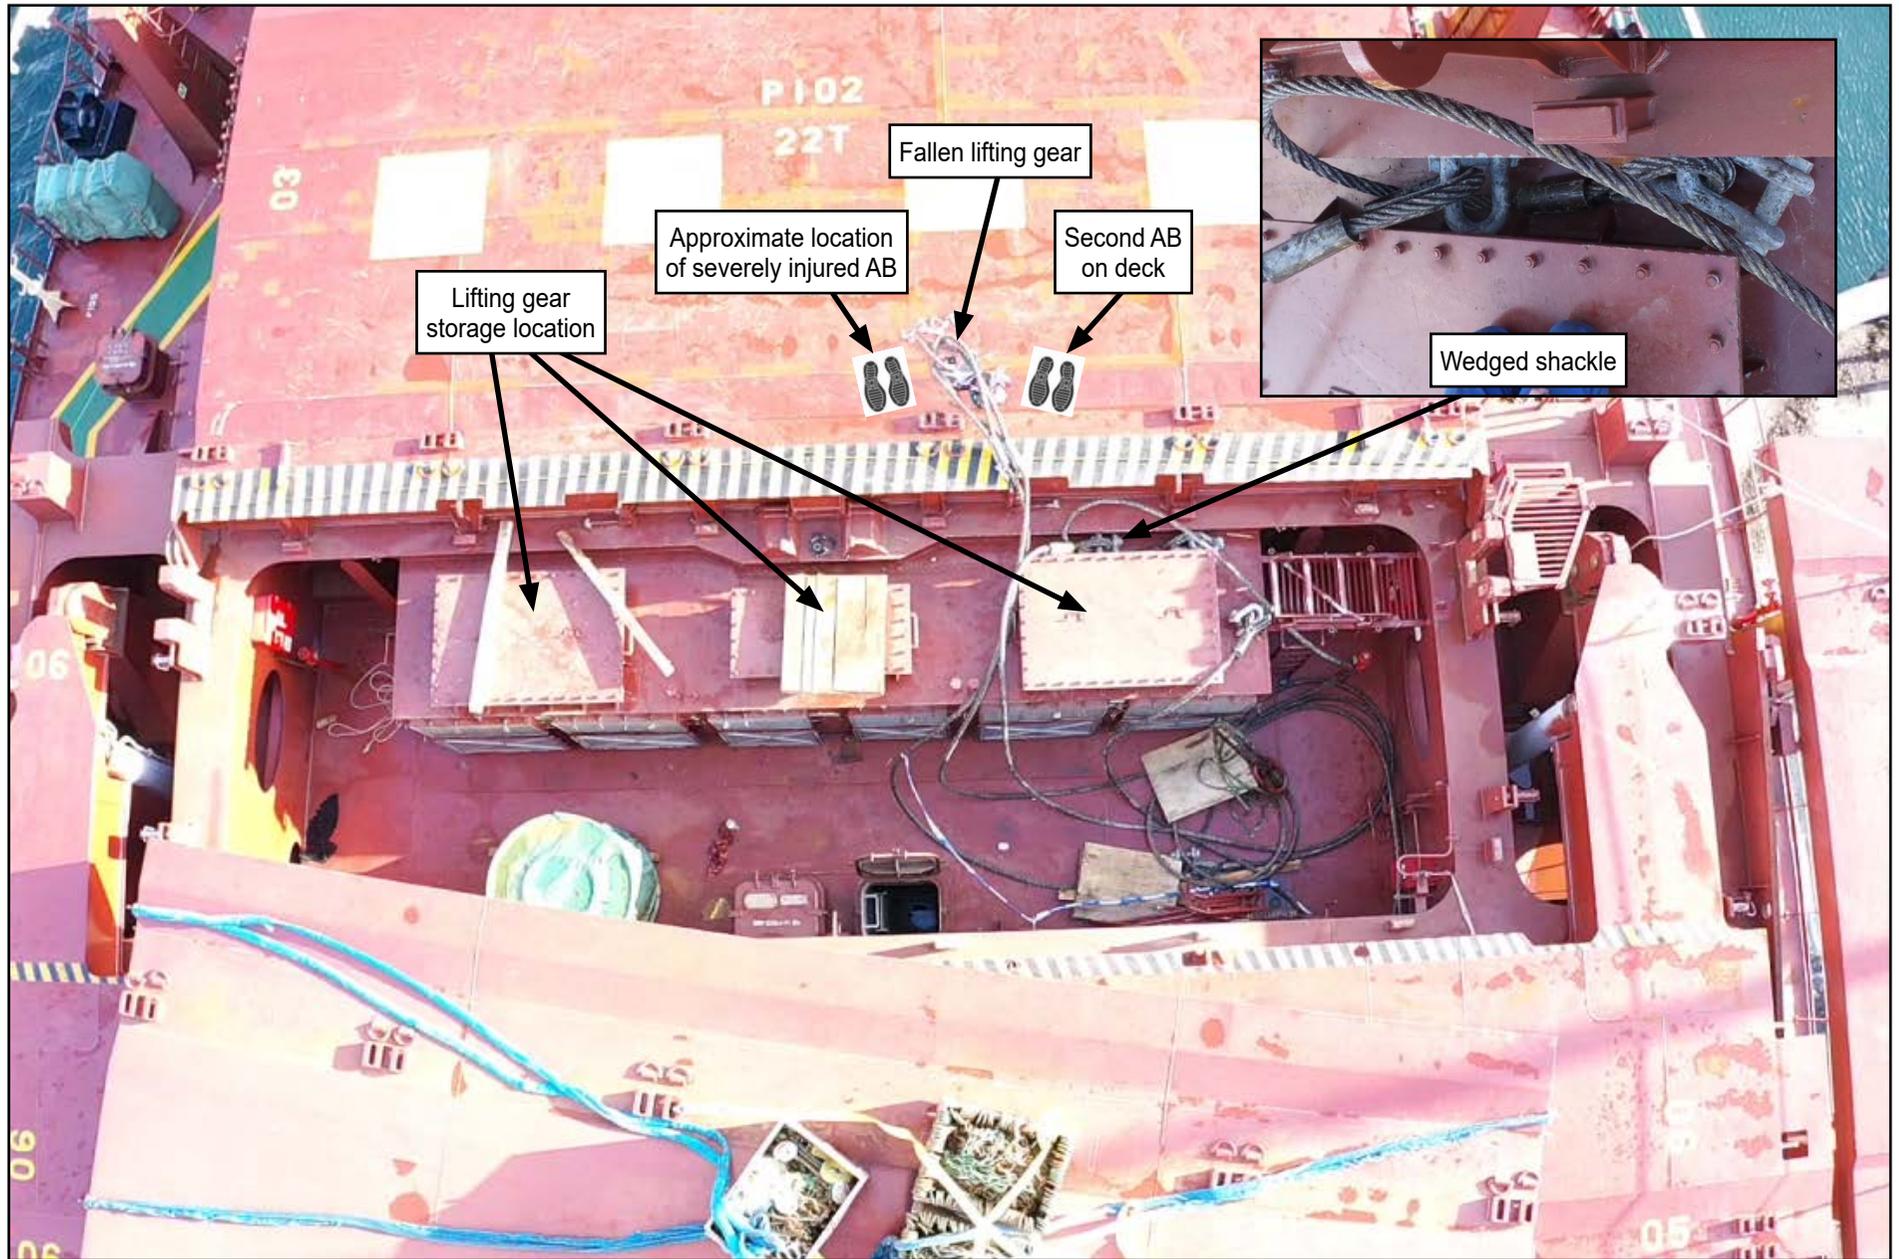
Following the safety briefing, one of *ZEA Servant's* able-bodied seamen (AB) used the vessel's forward crane to remove the cargo hold ventilation duct space hatch cover so that the cargo hold hatch cover lifting gear could be retrieved (**Figure 2**). Two other ABs then entered the ventilation duct space and attached the first of two cargo hold hatch cover lifting gear sets to the crane's hook using a fibre sling (**Figure 3**). Both ABs then climbed out of the space and stood close to the hatch edge ready to guide the load and free any snags as it was lifted.

Shortly after the lifting operation recommenced, a shackle at the lower end of the load became snagged on a ventilation trunk coaming (**Figure 2**). The chief officer immediately instructed the crane driver to stop, but at the same time the fibre sling parted and the lifting gear fell to the deck, striking both ABs.

Figure 2: Plan view of the ventilation duct space and accident site (inset: close up of wedged shackle)

ZEA Servant had not been built with a dedicated storage area for the heavy cargo hold hatch cover lifting gear. As a result, the crew had devised a local arrangement to store the lifting gear on top of wooden pallets in the cargo hold ventilation duct space (**Figure 2**). This might have appeared appropriate as a suitable storage space because it was accessible; however, it was an area where there was a significant number of potential snagging hazards, especially for lifting slings with shackles at their ends.

- Identified an alternative and more suitable location to stow the cargo hold hatch cover lifting gear and developed a lifting plan for its removal and re-stowing.
- Notified its fleet of the importance of crew safety awareness, including the need for self-protection measures and safe positioning during lifting operations.
- Notified its fleet of the importance of the safety brief and the responsibilities of those supervising lifting operations.
- Undertaken a review of the vessel's safety management system.
- Provided additional safety training to *ZEA Servant's* crew on the procedure to open hatches and the inspection of lifting equipment.
- Issued a fleet circular requiring checks to lifting equipment, including SWL of each component, certification and the condition of fibre slings.
- Required shore managers to inspect operational safety of crew.

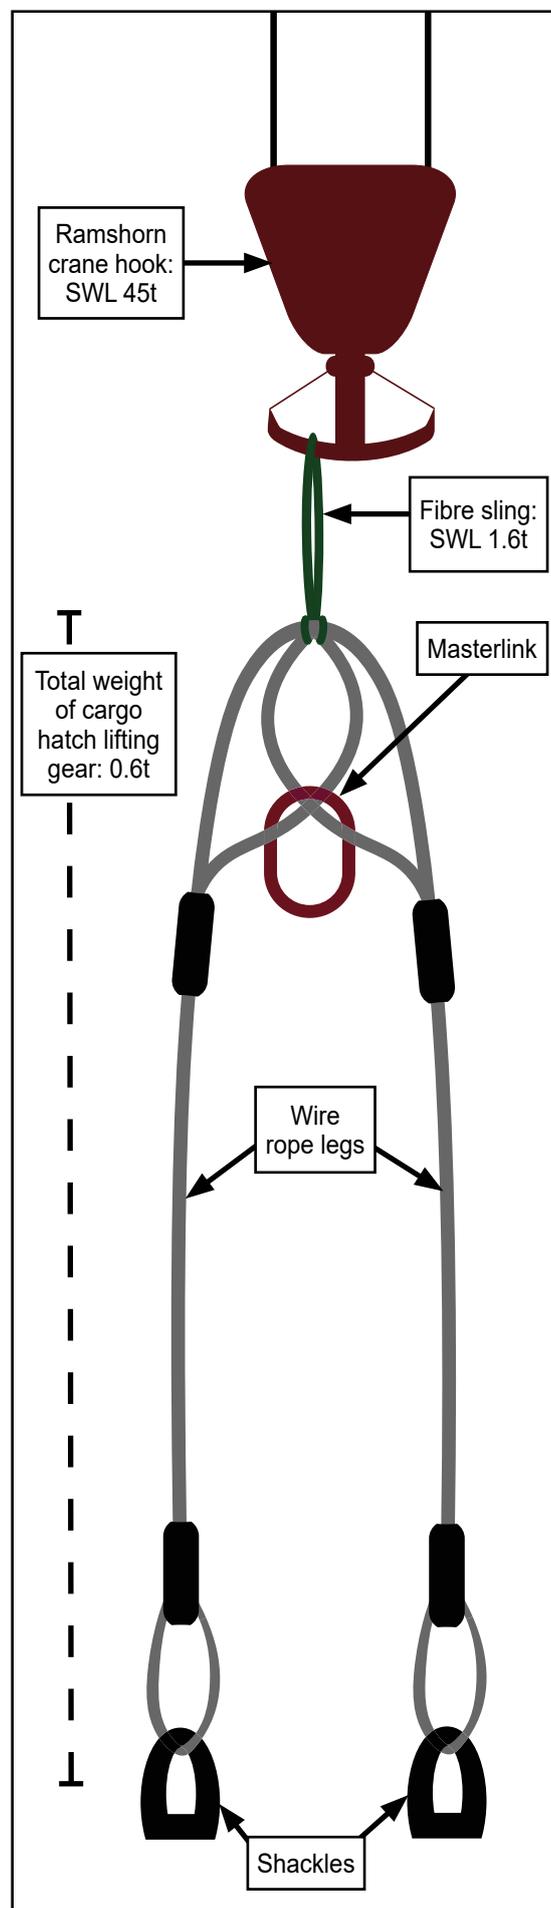
ZEA Servant's forward crane had a safe working load (SWL) of 250 tonnes (t), and its ramshorn hook had a SWL of 45t. The crane was in date for survey and had no known defects. The cargo hold hatch cover lifting gear was made up of two slinging sets; each set weighed 0.6t and consisted of two 17m long, 52-millimetre (mm) diameter, wire rope legs joined together with a master link (Figure 3). Each wire leg had a shackle attached to an eye at the lower end.

Figure 3: Cargo hold hatch cover lifting gear - attachment to crane hook with fibre sling

The crew used fibre slings to connect the hatch cover lifting gear to the crane's ramshorn hook because of the weight of the gear and the restricted amount of space around the ventilation coamings. The crew had used the same method to remove the lifting gear from the ventilation duct space on at least five previous occasions and had experienced similar snagging events. When these had occurred, the deck crew had manually freed the gear after the crane had stopped hauling.

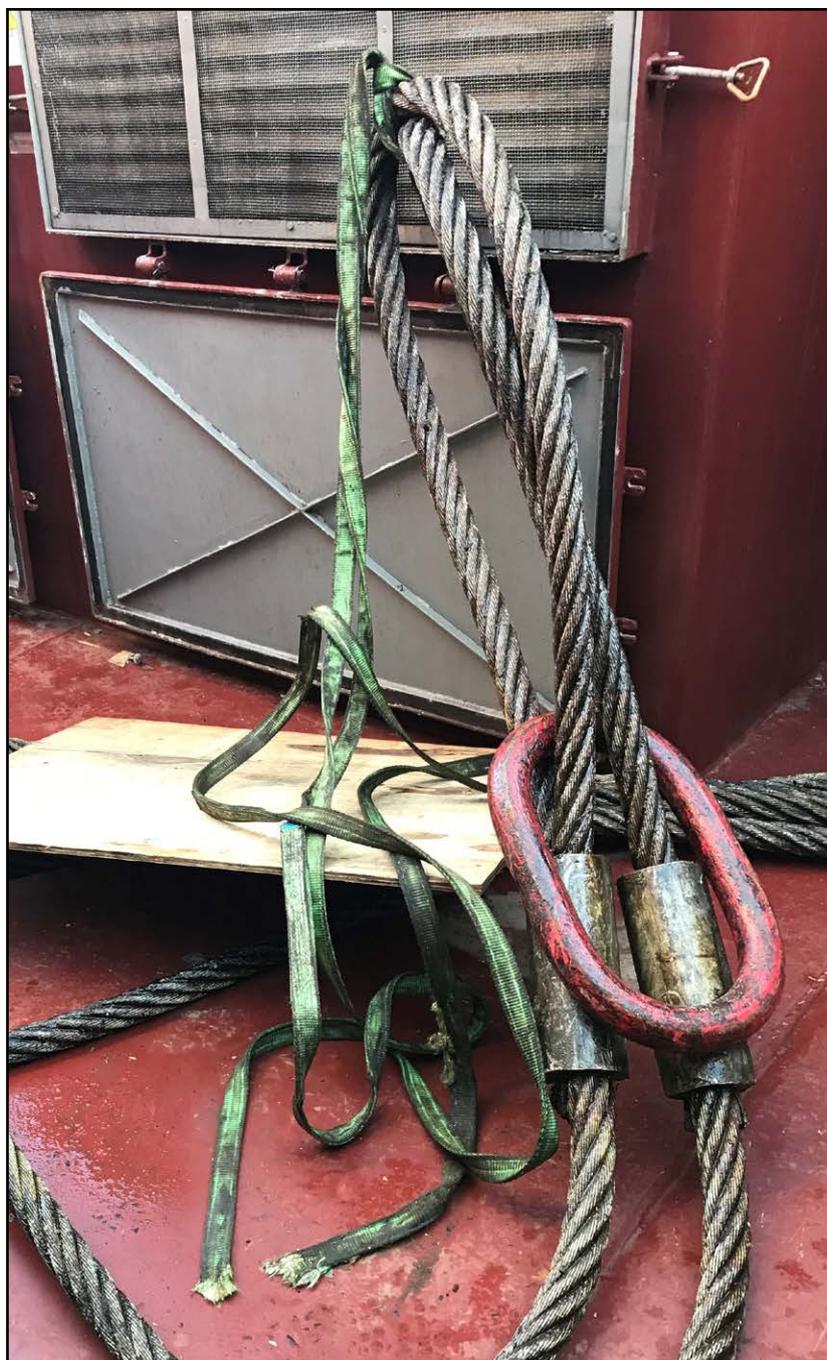
The fibre sling that parted (**Figure 4**) had been rigged using a choke hitch; it was one of several similar slings on board and had an SWL of 2t with a factor of safety of 6:1. This equated to a minimum breaking load (MBL) of 12t in a straight pull. These values reduced to 1.6t SWL and 9.6t MBL in a choke hitch configuration.

After the accident the parted sling (**Figure 4**) and five other similar slings from *ZEA Servant* were examined at an expert testing centre. The report of these tests stated that all six slings would have failed a visual inspection as they were soiled and had illegible identification markings. The parted sling was also noted to have some localised damage. During destructive testing, one of the other fibre slings failed at a load of 6.4t when rigged in the choke hitch configuration. The test laboratory report estimated that the actual breaking load of the parted sling at the time of the accident would have been 6.25t.

Figure 4: Broken fibre sling (after the accident)

The load fell because the synthetic fibre sling used to lift it parted under tension. It was reasonable to use such a fibre sling as its SWL was more than twice the weight of the load being lifted when rigged using a choke hitch. However, the fibre sling in use was in a poor condition, with local damage, soiling (**Figure 4**) and illegible identification markings. It therefore should have been discarded. Destructive load tests and laboratory analysis showed that its residual strength was almost half its design MBL.

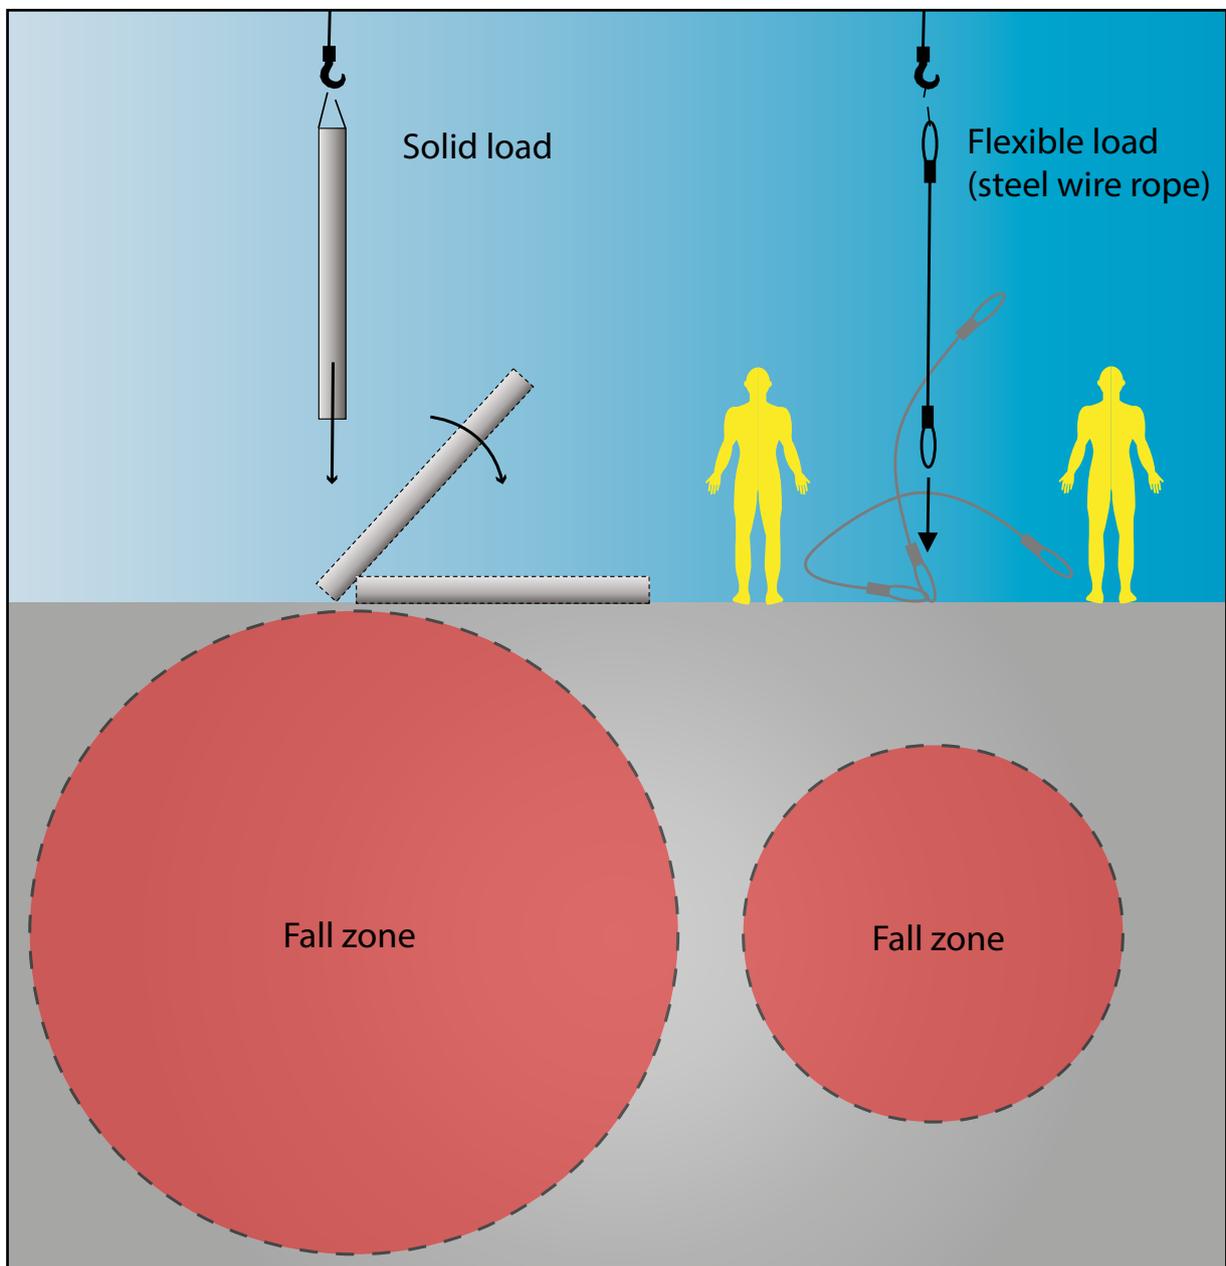
All lifting operations should be properly risk assessed and planned, and safe systems of work put in place. Lifting plans and safe systems of work should address the foreseeable risks involved in the work and identify all the appropriate resources necessary for safe completion of the task. Factors to consider when developing a lifting plan include: appropriate equipment, suitably qualified personnel, rigging arrangements, lift route, other proximate hazards, visibility, weather and an assessment of the fall zone (**Figure 5**).

The fall zone is not limited to the immediate area directly beneath the load; instead it is the reasonably foreseeable area that partially or completely suspended loads could fall into in the event of an accident. Solid loads can bounce, roll, topple over or fragment in any direction on impact with the ground. Flexible loads, such as steel wire ropes, will collapse into an area dependent on their stiffness of the wire ropes (**Figure 6**). Having assessed the hazards and resources, the plan should then set out clearly the actions involved at each step of the operation and identify the responsibilities of those involved.

Figure 5: Illustration of the fall zone around a suspended load

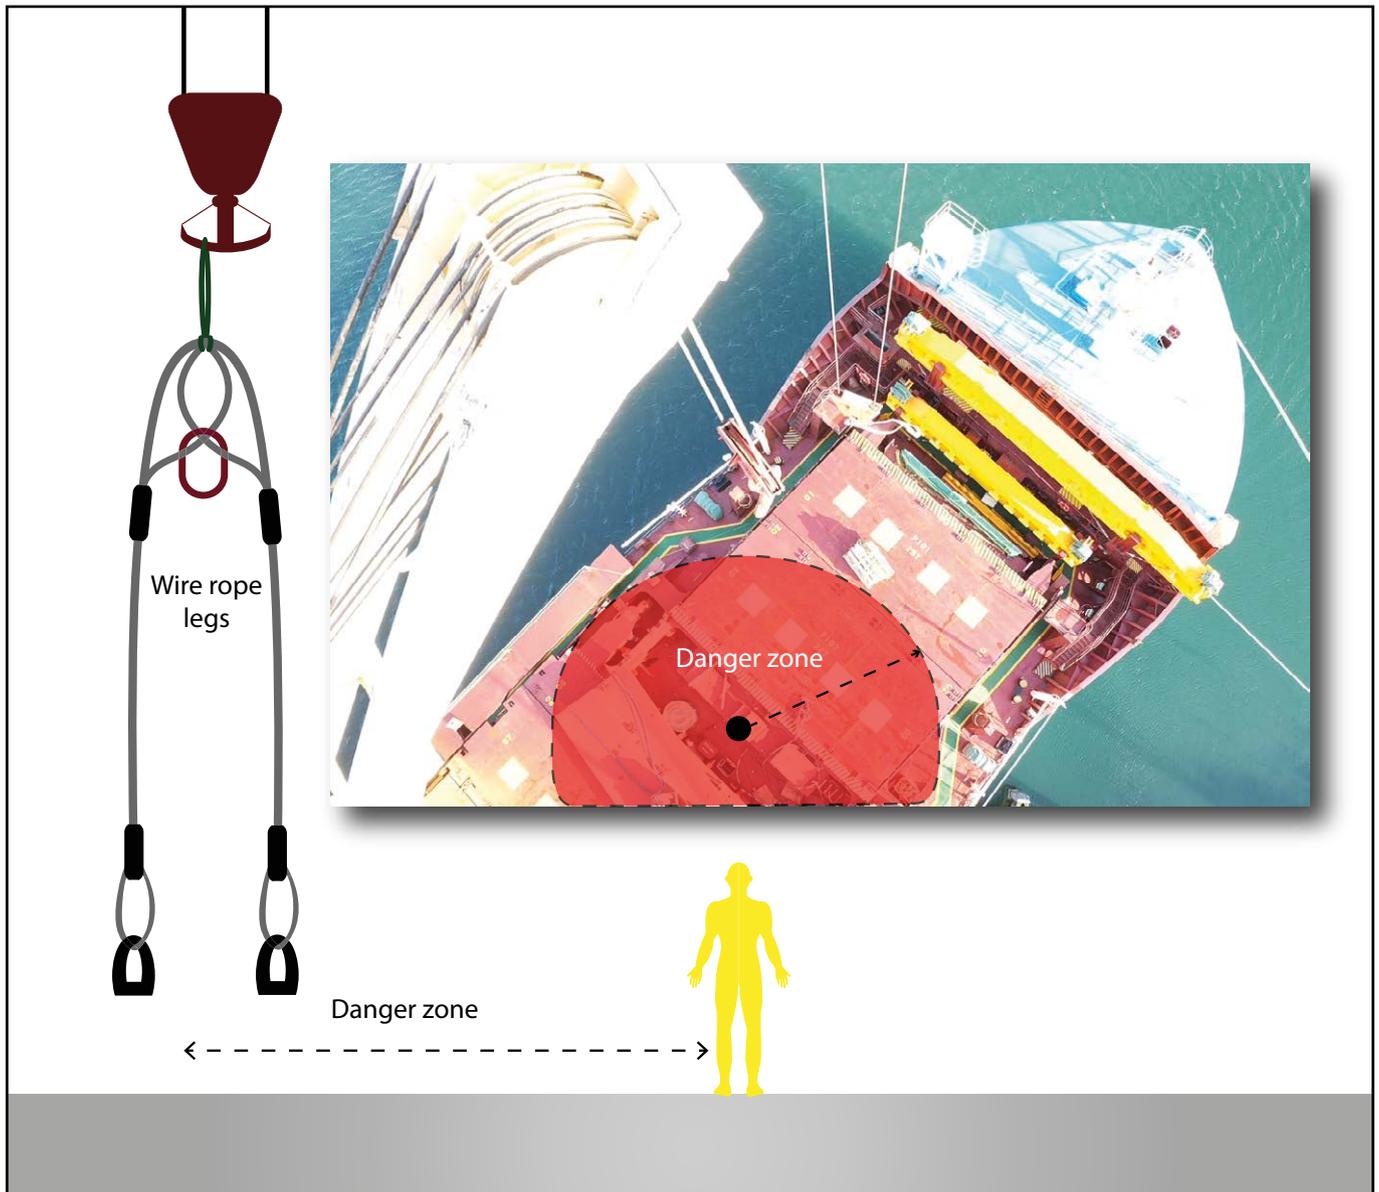
ZEA *Servant*'s safety management system did not contain a risk assessment or a procedure for the stowage and handling of the cargo hold hatch cover lifting gear, nor any guidance for the conduct of a lifting plan and the identification of fall zones. Had a fall zone assessment been undertaken, it would have been evident that it was unsafe for the crew to position themselves so close to the suspended load.

Figure 6: Illustration of the estimate of the danger zone that the lift would have created on board *ZEA Servant*
