OPERATIONAL SAFETY REVIEW TEAM MISSION

TORNESS

NUCLEAR POWER STATION
United Kingdom

NSNI/OSART/199F/2018

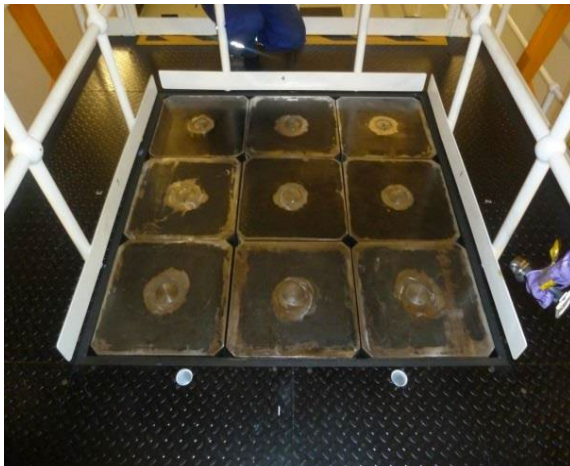
Fuel Floor Simulator – Floor Intact

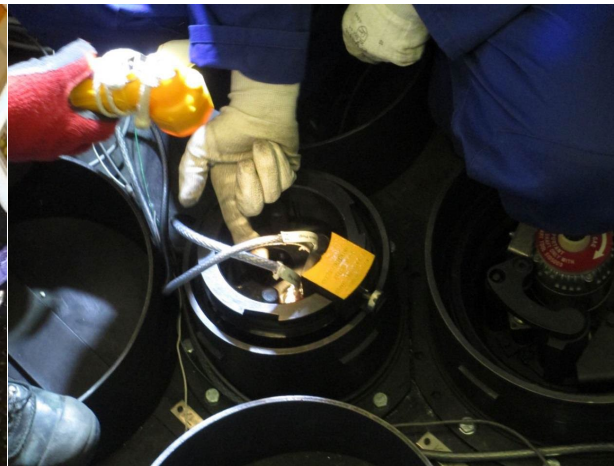
Trainees checking control rod cables – simulated contamination control area

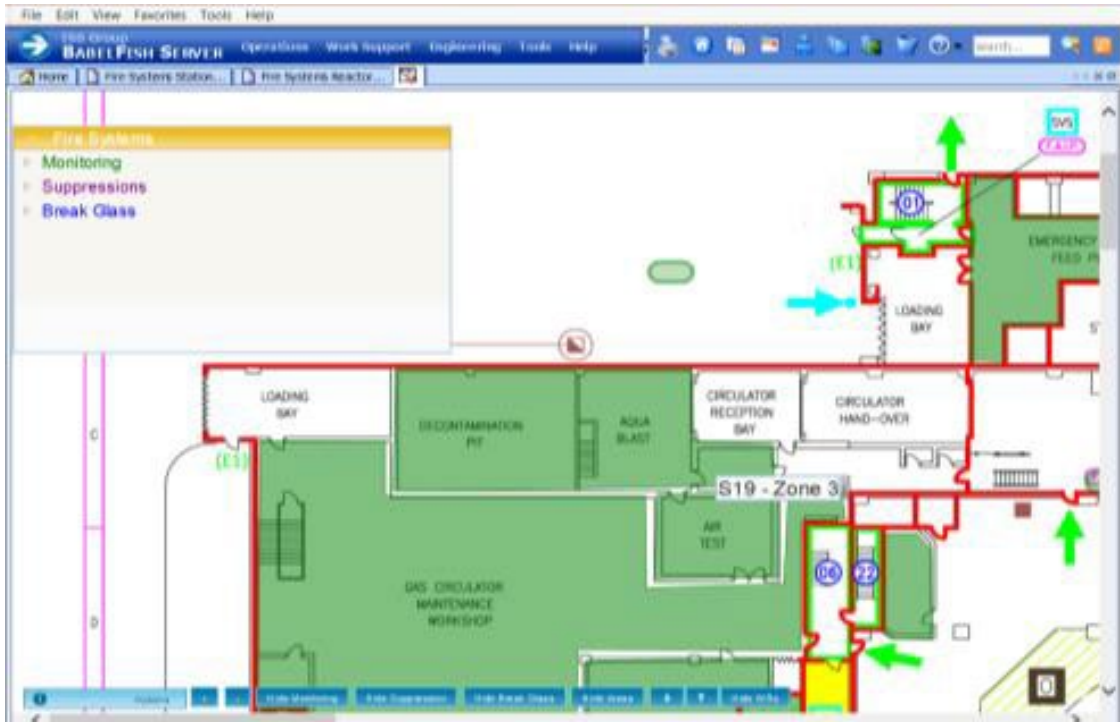
Figure 2: Detailed view of the Fire Station Systems Status in Maintenance Workshop Area

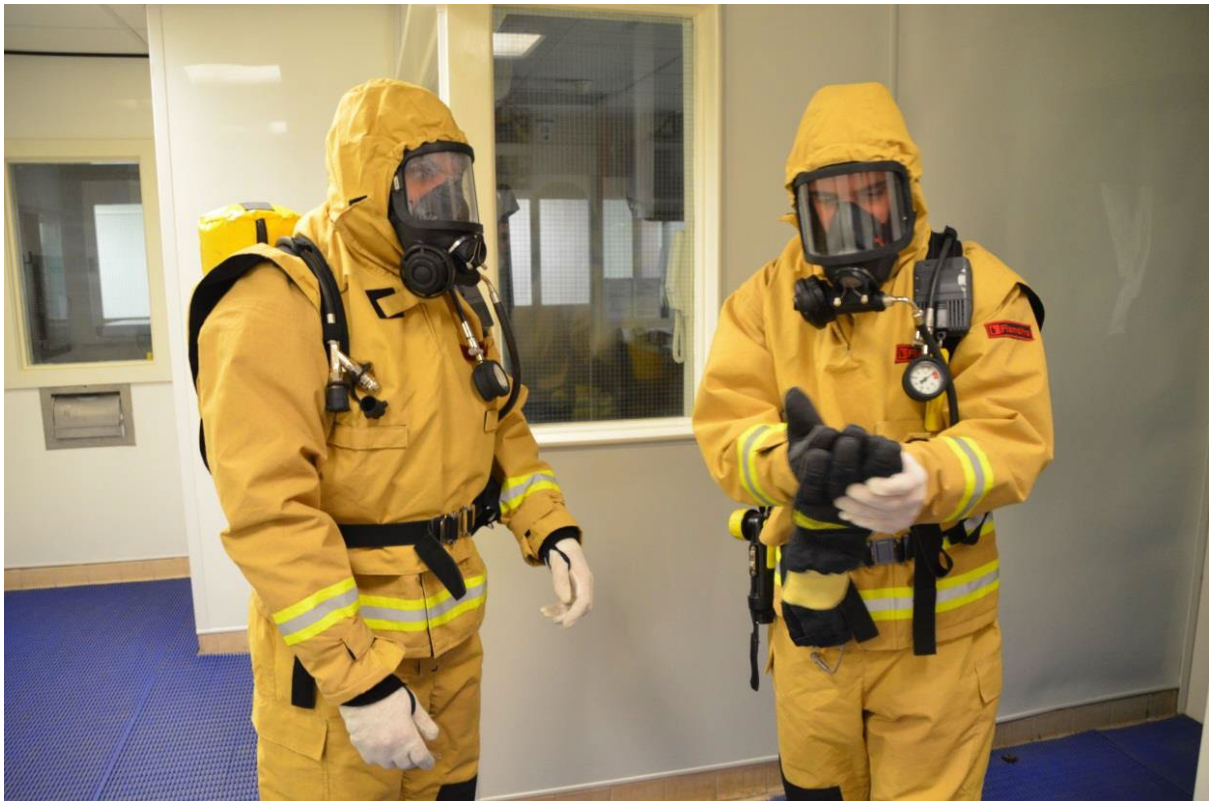
9.2(a) Good Practice: Beta Hood – Protection of emergency responders from skin contact with radioactive water.

During an emergency event, responders could be exposed to contaminated water runoff. In a normal fire kit of flash hood and tunic, this water can run down into the clothing and contaminate the skin of the responders. Any beta contamination within the water will then irradiate the skin and cause harm to the responder. To address this the station now provides Beta Hoods that improve on the normal flash hood and provide enhanced protection to the responders. They add a covering to the shoulders of the responders that is incorporated into the hooded protection for the face. The benefit is that any possibly contaminated water runs down and off the responders, rather than inside the protective clothing.
