Report on the investigation of the near miss
between the ro-ro ferry
Stena Superfast VII
and a submerged
Royal Navy submarine
in the North Channel
on 6 November 2018

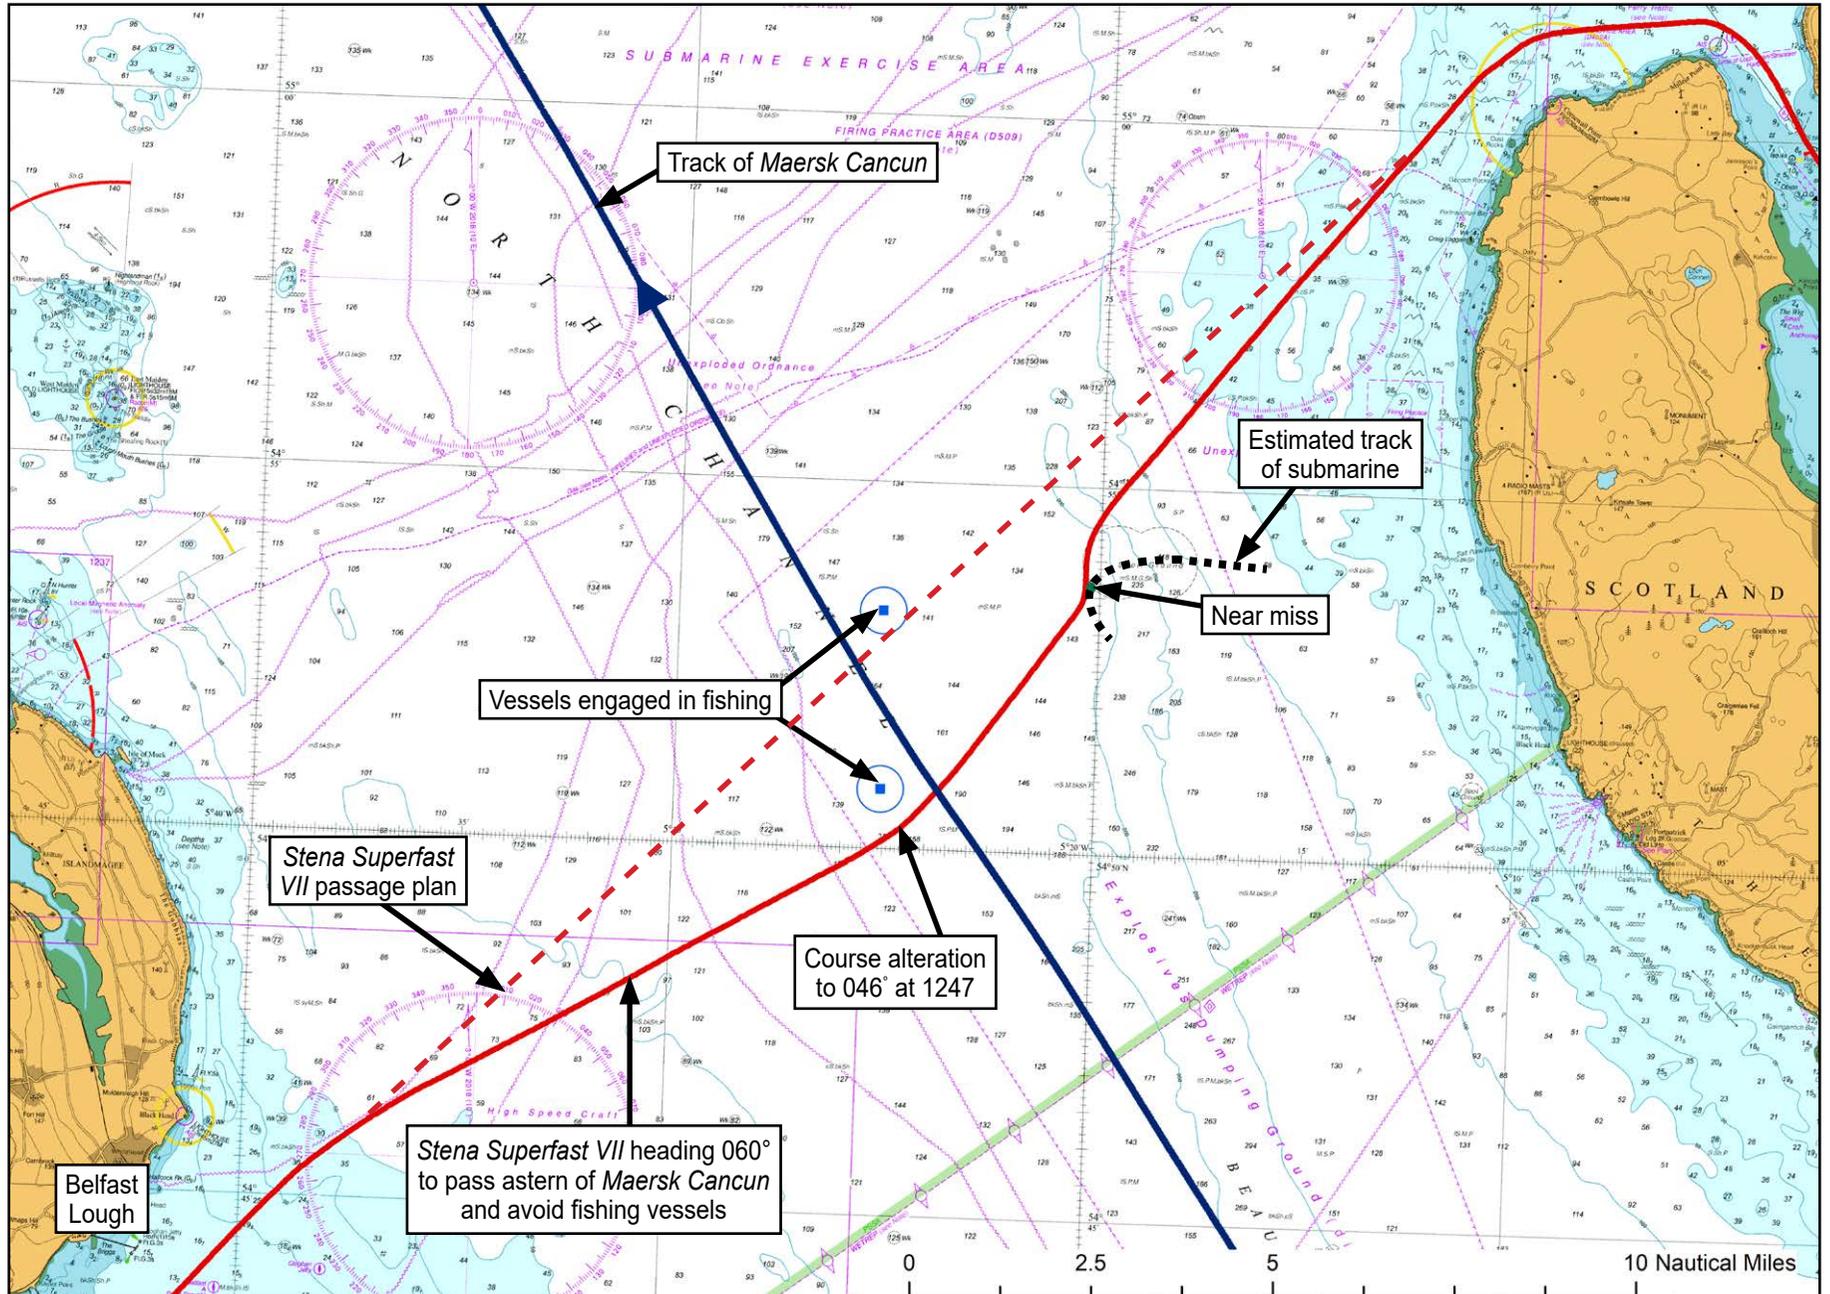
At 1243, the submarine's periscope watchkeeper (a trainee) reported sighting a new surface contact, the range of which was estimated to be between 9000 yards¹ (yds) and 10000yds. The new contact was reported to the submarine's OOW and was visually identified as a ferry; the compass bearing correlated with a passive sonar contact. The visual information on the new contact was entered into the submarine command system (SMCS). The submarine was on a westerly heading at a speed of about 6kts (**Figure 2**).

At 1254:50, *Stena Superfast VII*'s AB lookout saw a submarine's periscope on the port bow at close range. The lookout immediately alerted the OOW, who also saw the periscope and observed, from its wake, that it was crossing the ferry's bow from port to starboard. Given this geometry and assessing that there was an imminent risk of collision, the OOW told the lookout to adopt hand-steering and, at 1255:20, 10° of port rudder was applied. Further port rudder angle was applied during the turn to increase the CPA from the periscope. The OOW also alerted the master, who came to the bridge immediately. At 1256:03, with the submarine's periscope passing close to starboard, *Stena Superfast VII* was steadied on a heading of 005° (**Figure 2**).

Figure 2: Overview of both vessels' tracks and the incident location

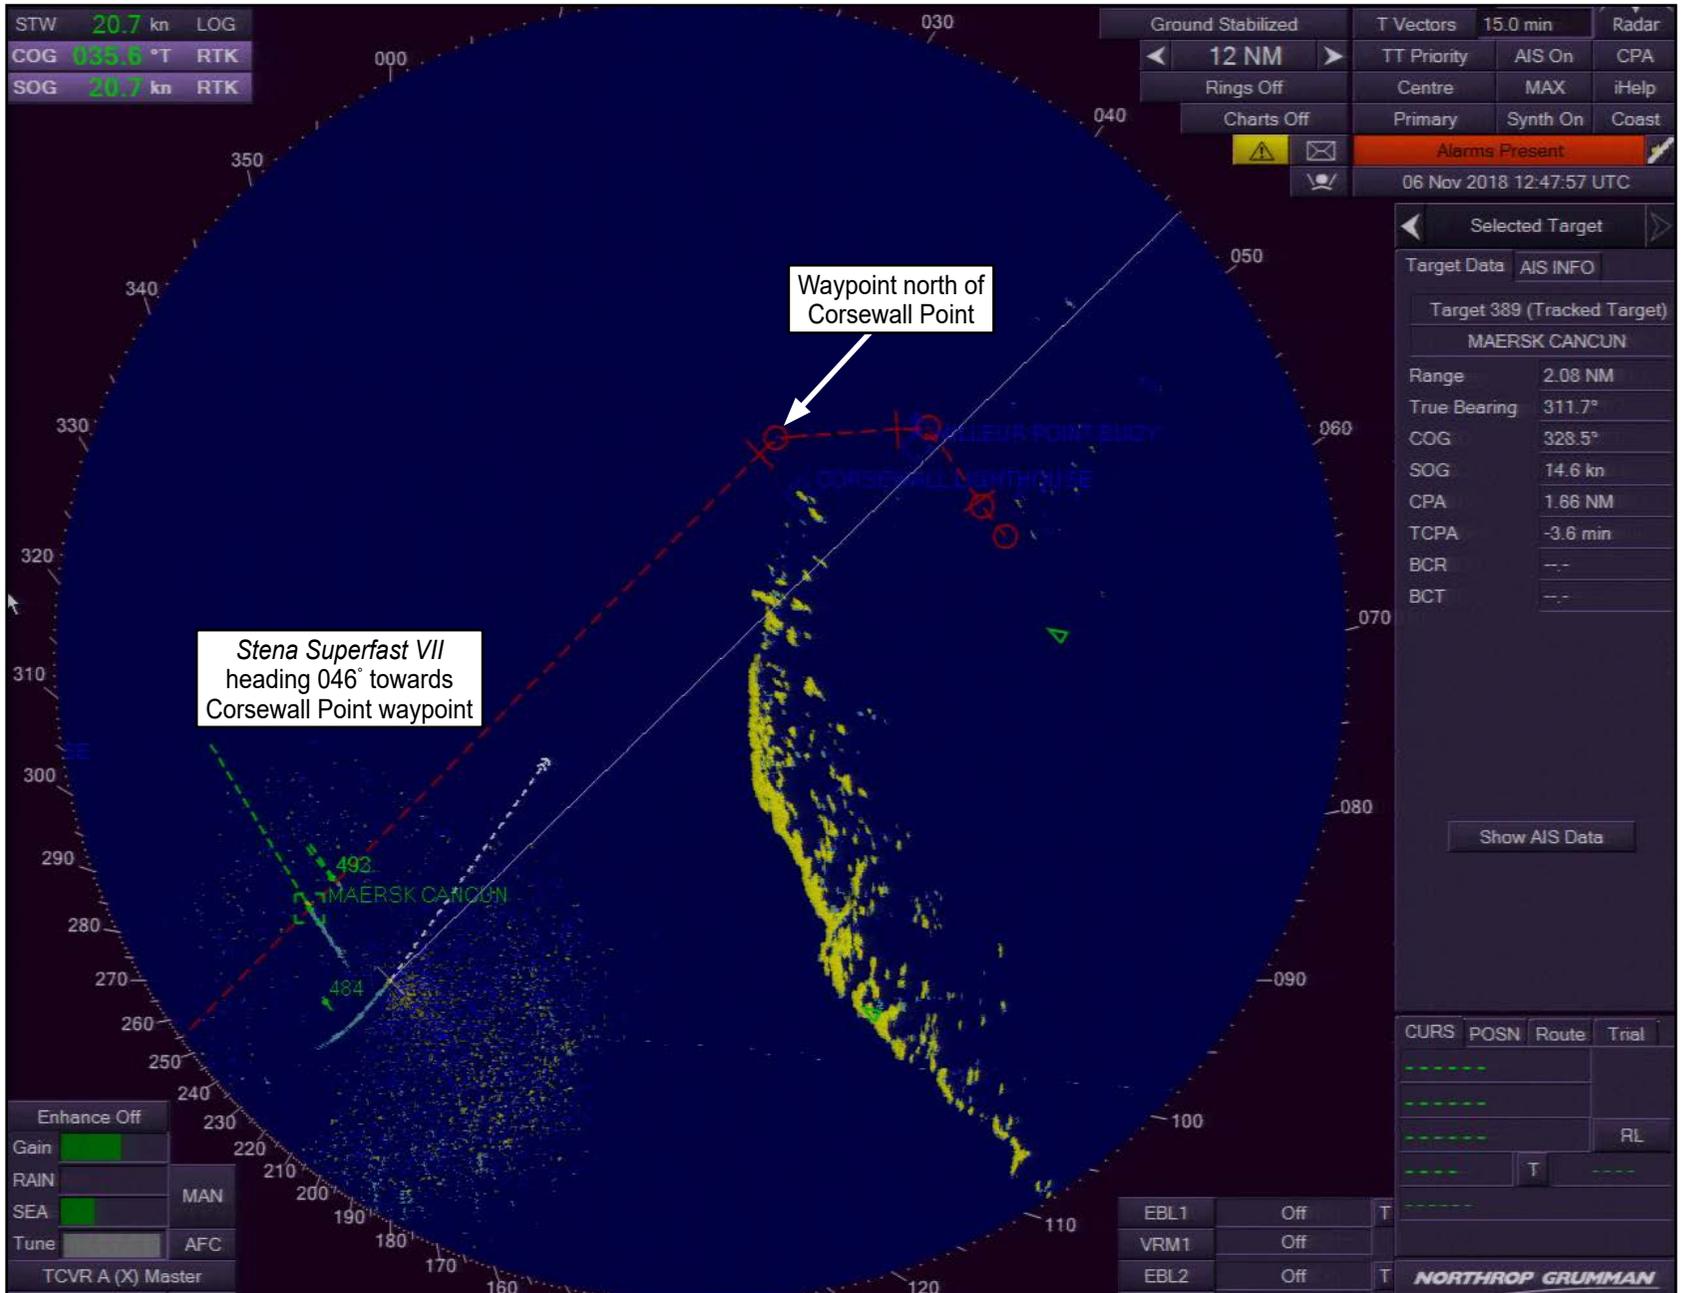
At 1247, and having passed safely astern of the northbound *Maersk Cancun*, *Stena Superfast VII*'s OOW altered course to port to 046°; the ferry was 2 nautical miles (nm) to starboard of its planned track, steering towards its next waypoint north of Corsewall Point (**Figures 2 and 3**).

Figure 3: *Stena Superfast VII*'s radar picture at 1247 showing its relative position to the planned track, other vessels painting on radar and the ferry's heading towards its next waypoint

In the build-up to the incident, the submarine's command team correctly assessed that *Stena Superfast VII* was to starboard of its planned track (**Figure 3**). However, this track was a line between Belfast Lough and Corsewall Point, whereas the ferry route was in reality a corridor. **Figure 10** shows historical AIS data for the 7 days following the incident and its location. This illustrates that, although the OOW might have considered that the submarine was clear of the ferry lanes, it was actually operating within the hazardous zone.

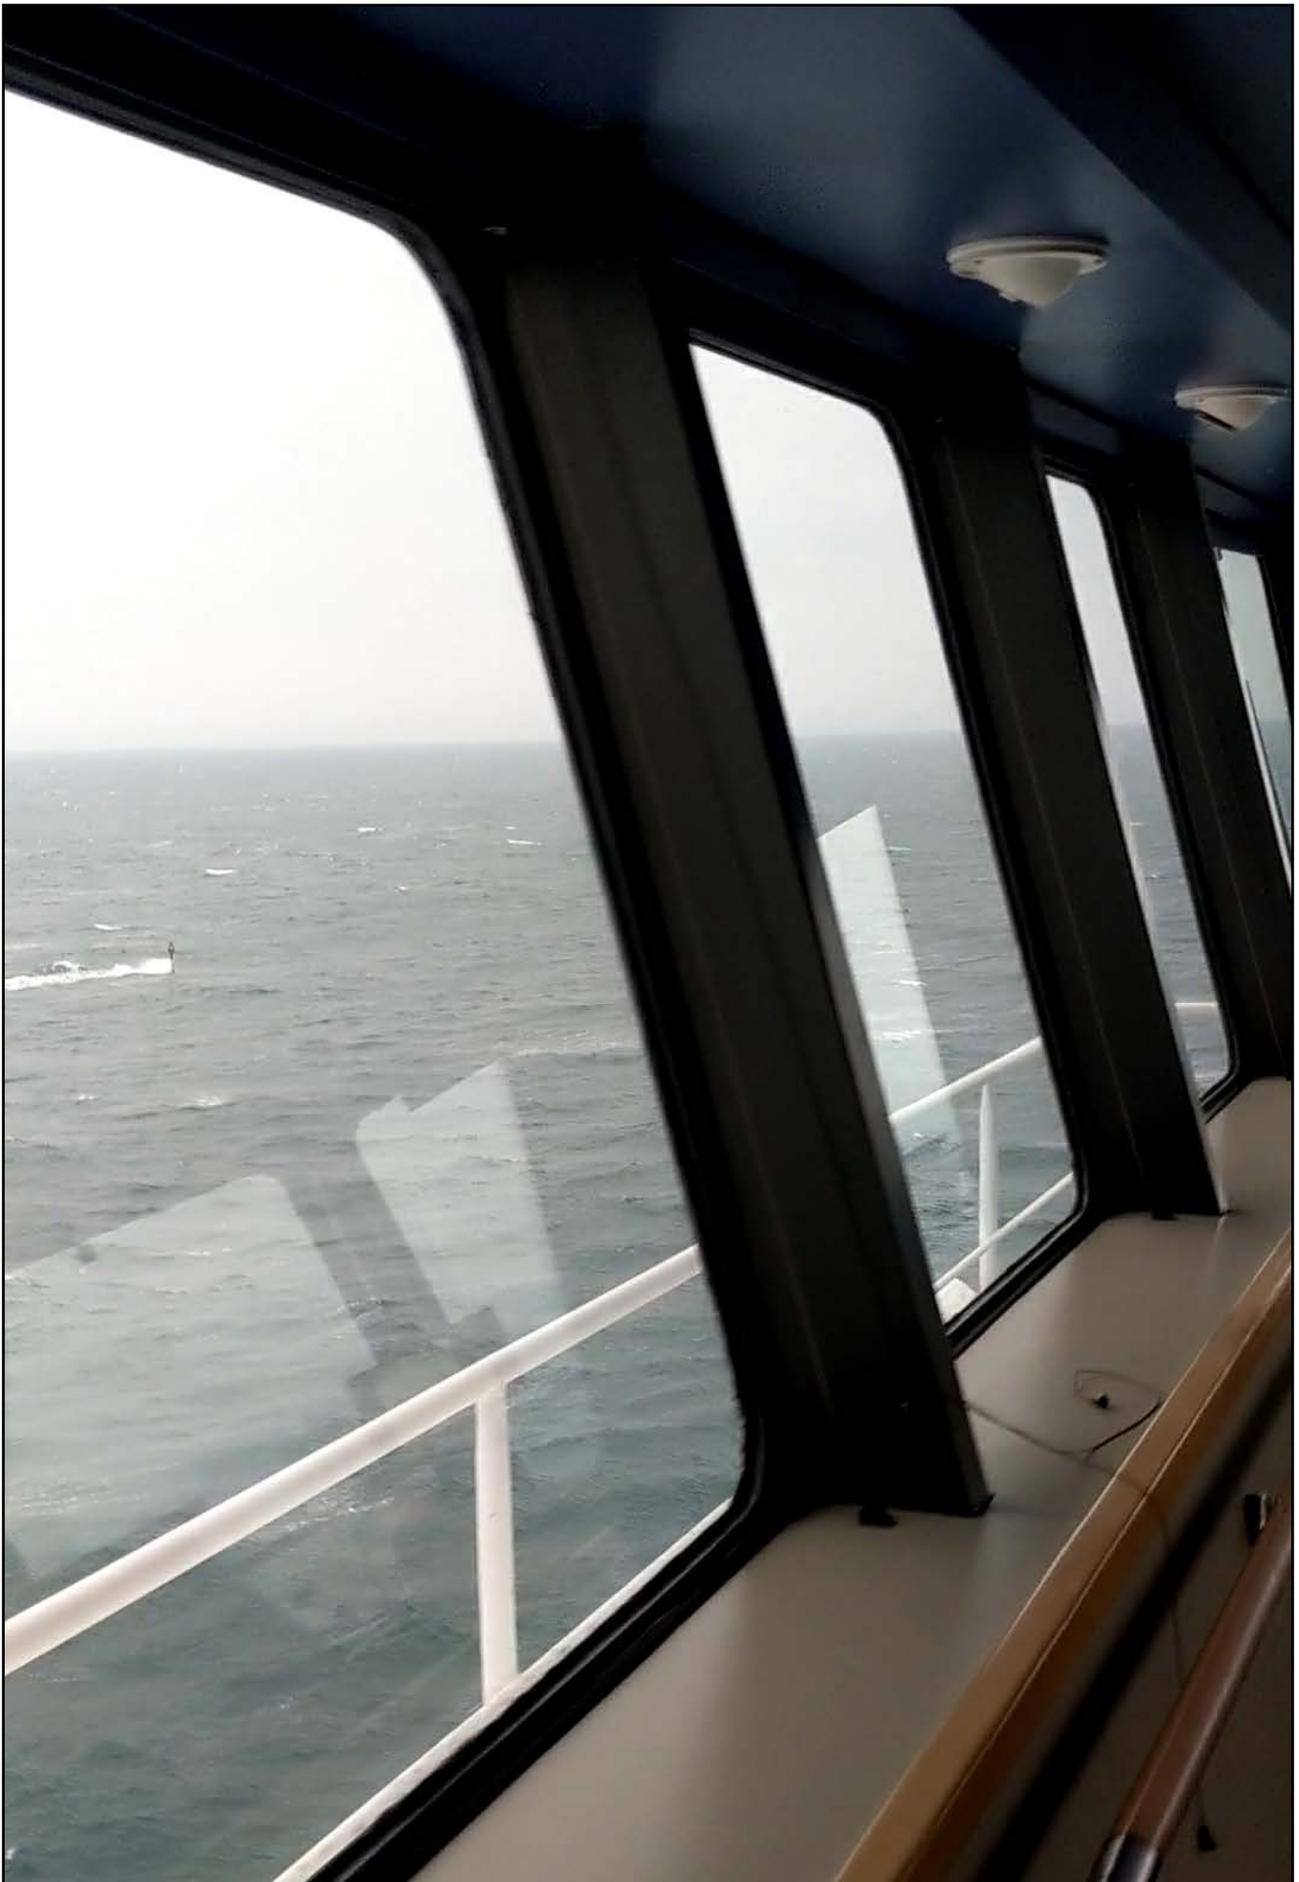
Stena Superfast VII's OOW maintained visual contact with the submarine as it passed close down the ferry's starboard side (**Figure 4**). The ferry's master also made a visual observation of the submarine's periscope close to starboard.

Figure 4: The submarine's periscope as seen from the bridge of *Stena Superfast VII* (looking to starboard)

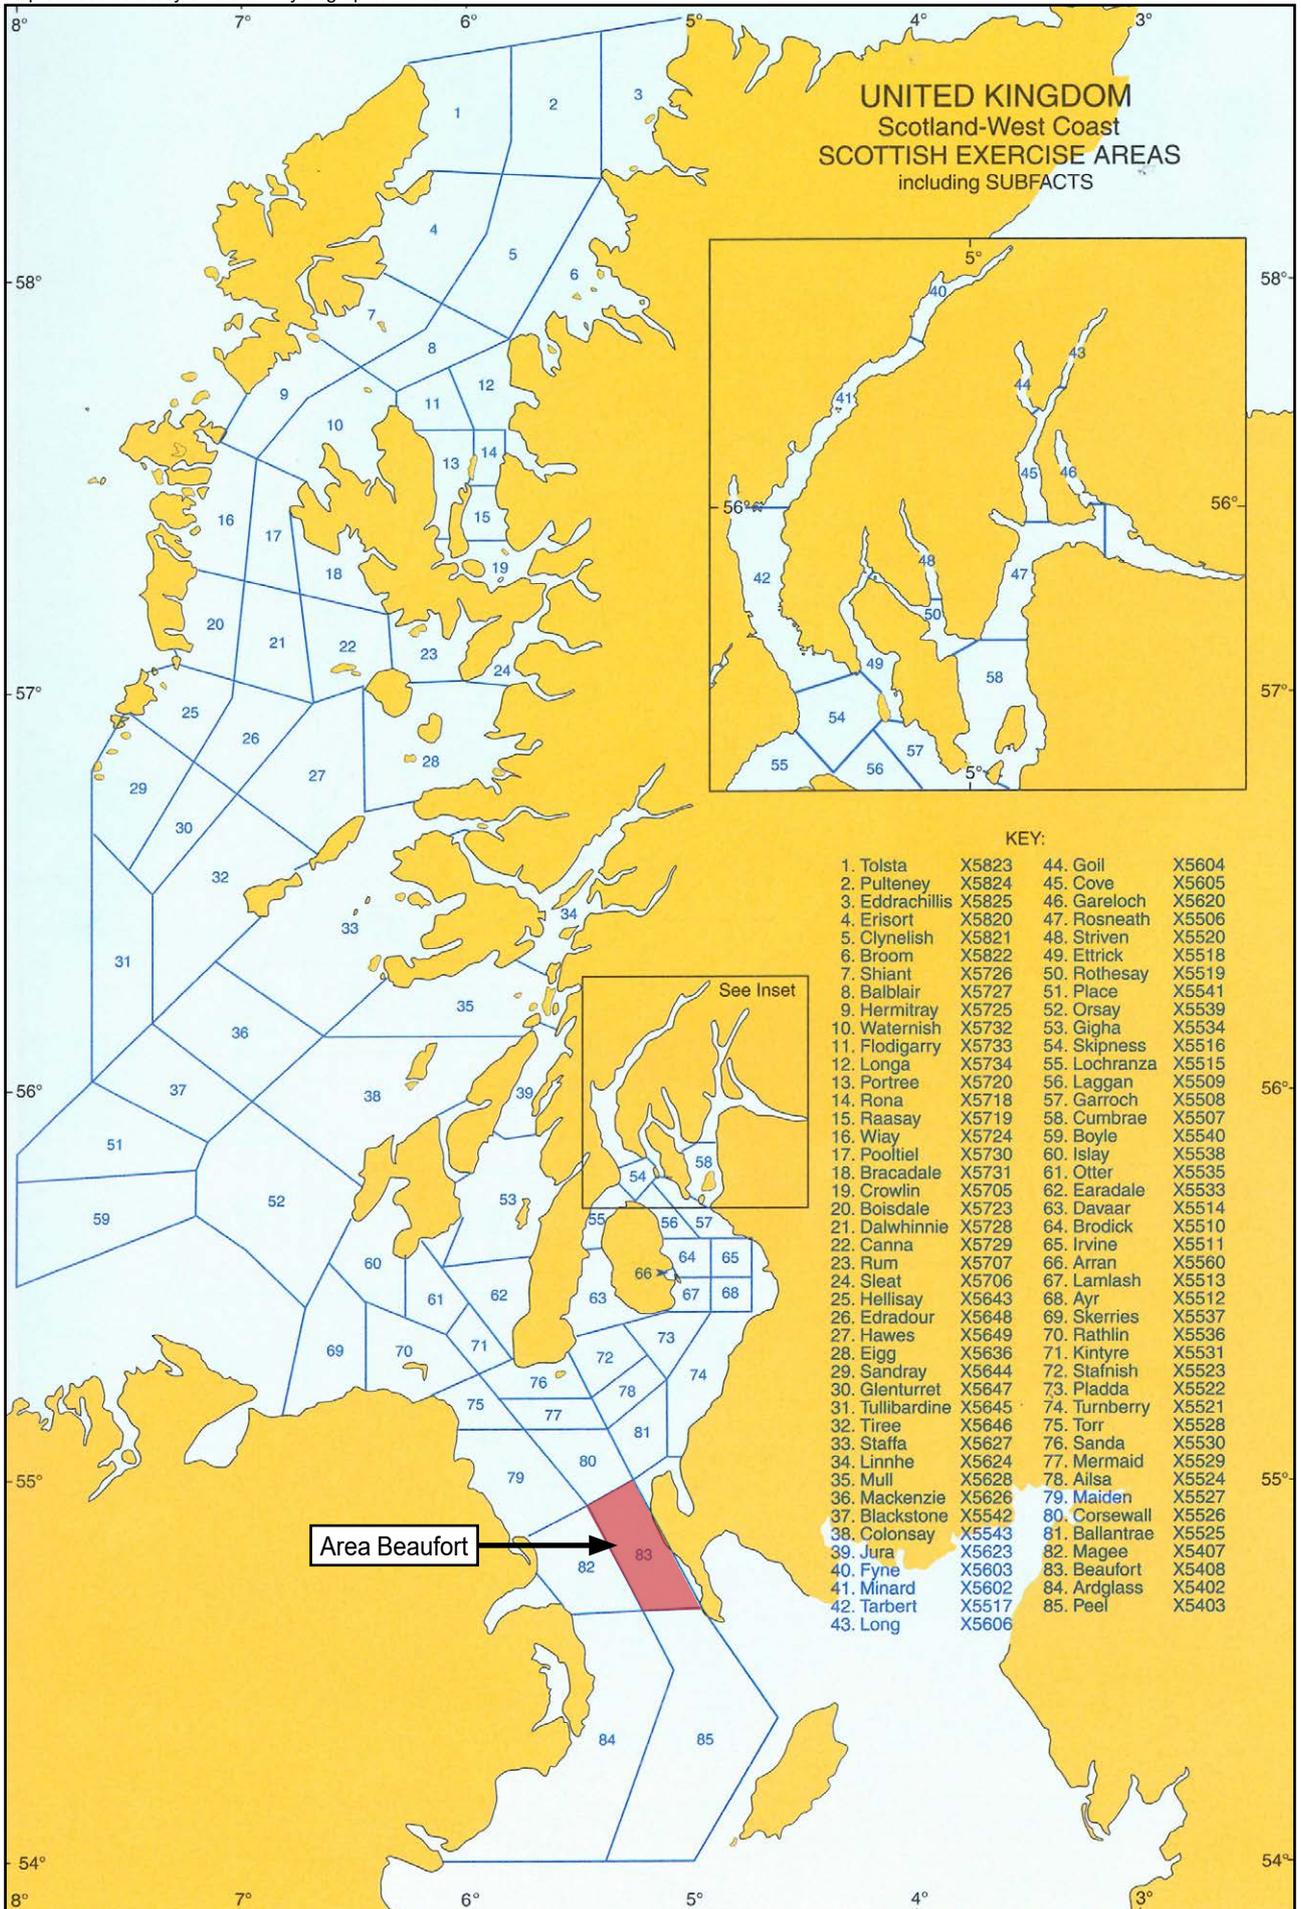
Figure 7: SUBFACTS chart highlighting area Beaufort that was allocated to the submarine at the time of the incident

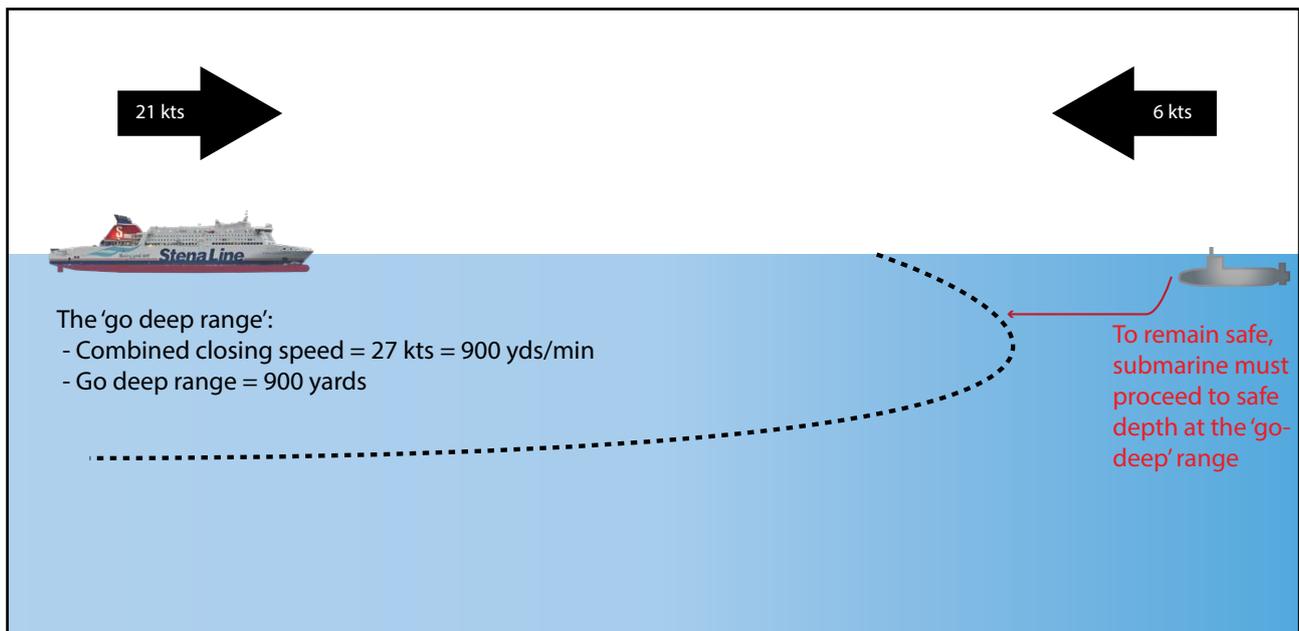
Submarine watchkeepers make rapid mental arithmetic calculations to assess the relative movement of surface contacts when only estimated range information is available⁶. For this incident, the worst-case combined closing speed between *Stena Superfast VII* and the submarine was 27kts. This meant that the go-deep range for *Stena Superfast VII* was 900yds (**Figure 8**).

Figure 8: Illustration of the go-deep range of *Stena Superfast VII* proceeding at 21kts and the submarine at 6kts

With a worst-case scenario of a combined closing speed of 27kts, the range at which the submarine needed to go-deep to safely avoid the ferry was 900yds, and it was unsafe to remain at periscope depth with the ferry inside this range.

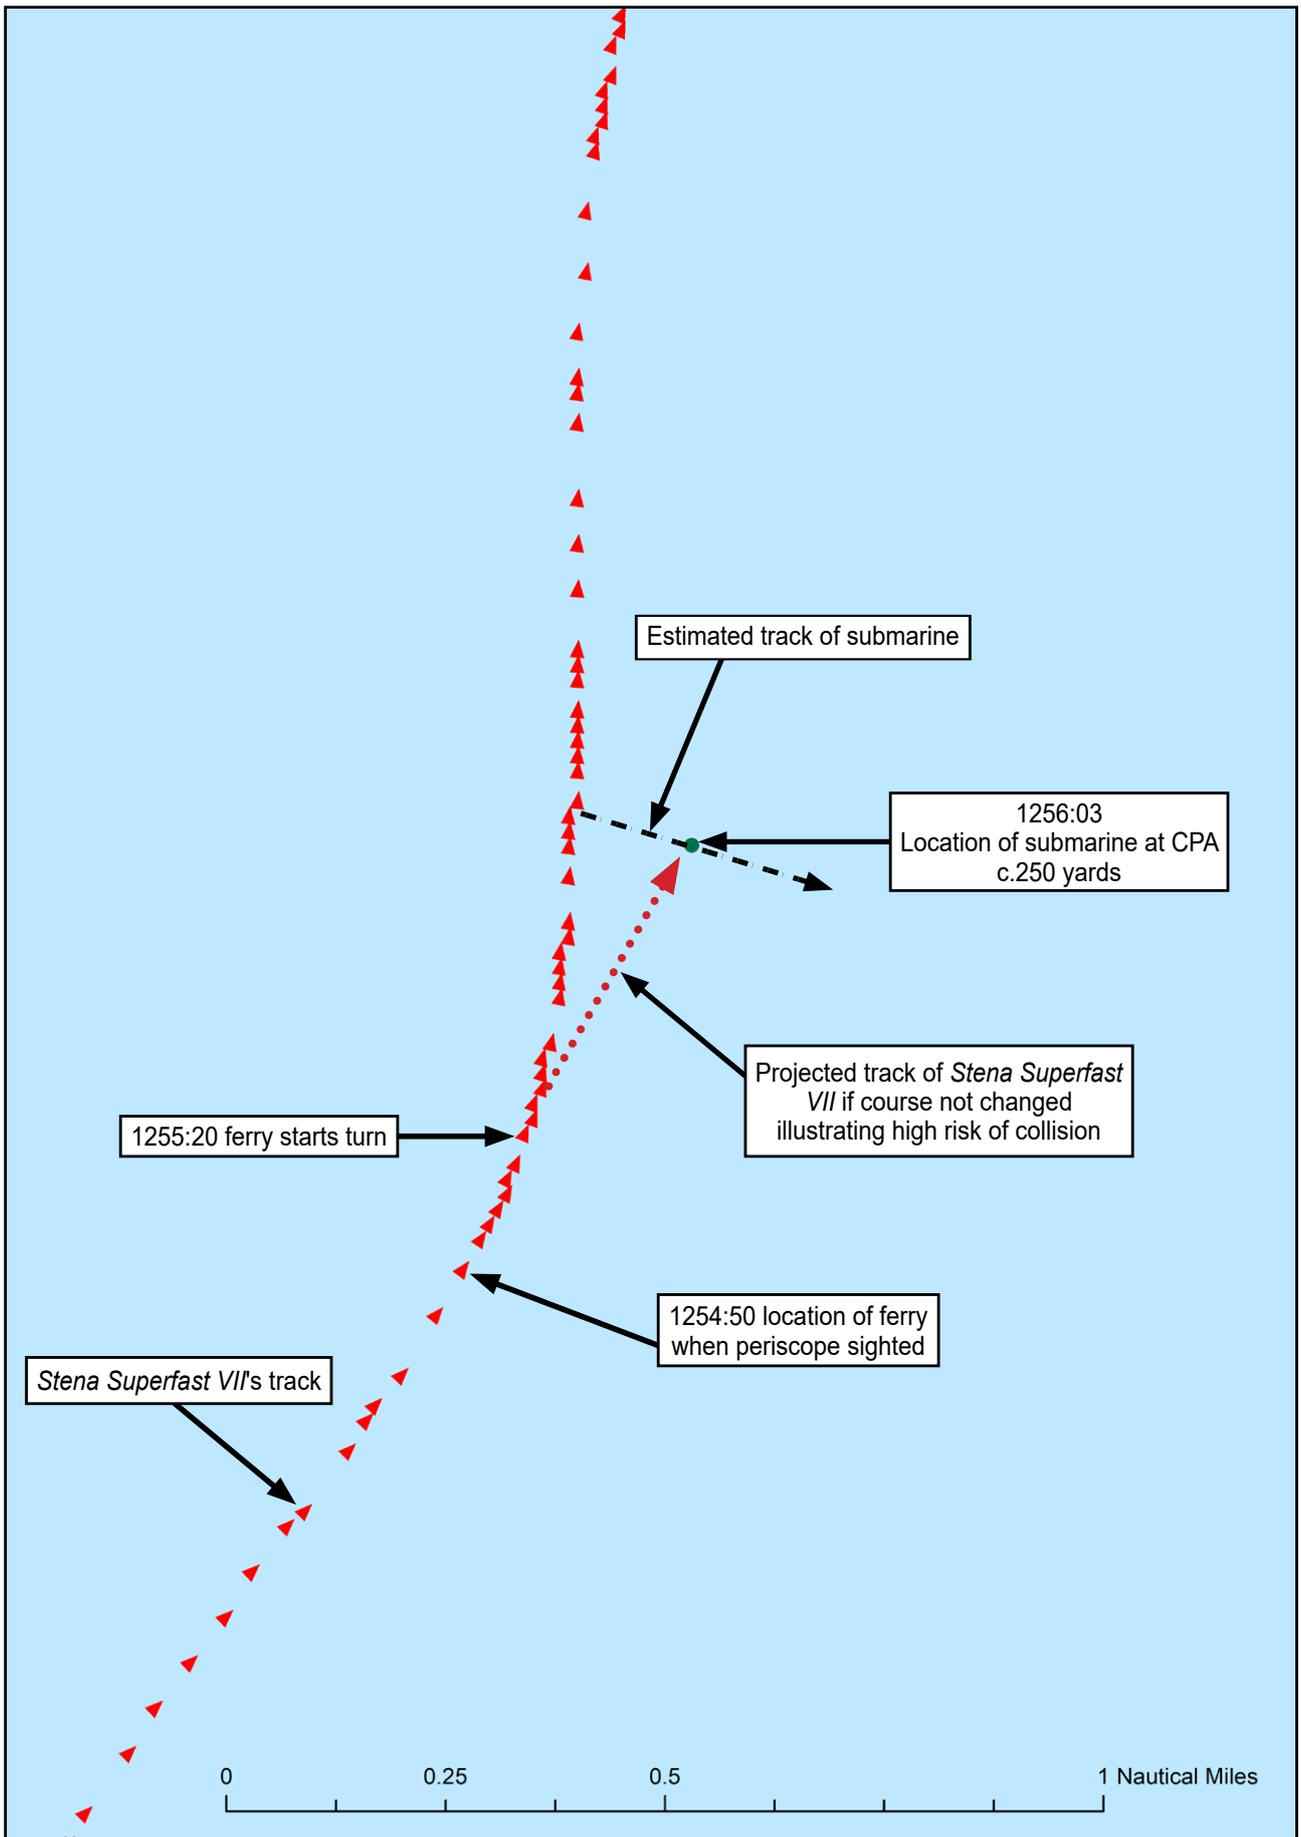
Figure 9: Detail of *Stena Superfast VII*'s track and the estimated CPA position of the submarine highlighting the risk of collision had the ferry not altered course

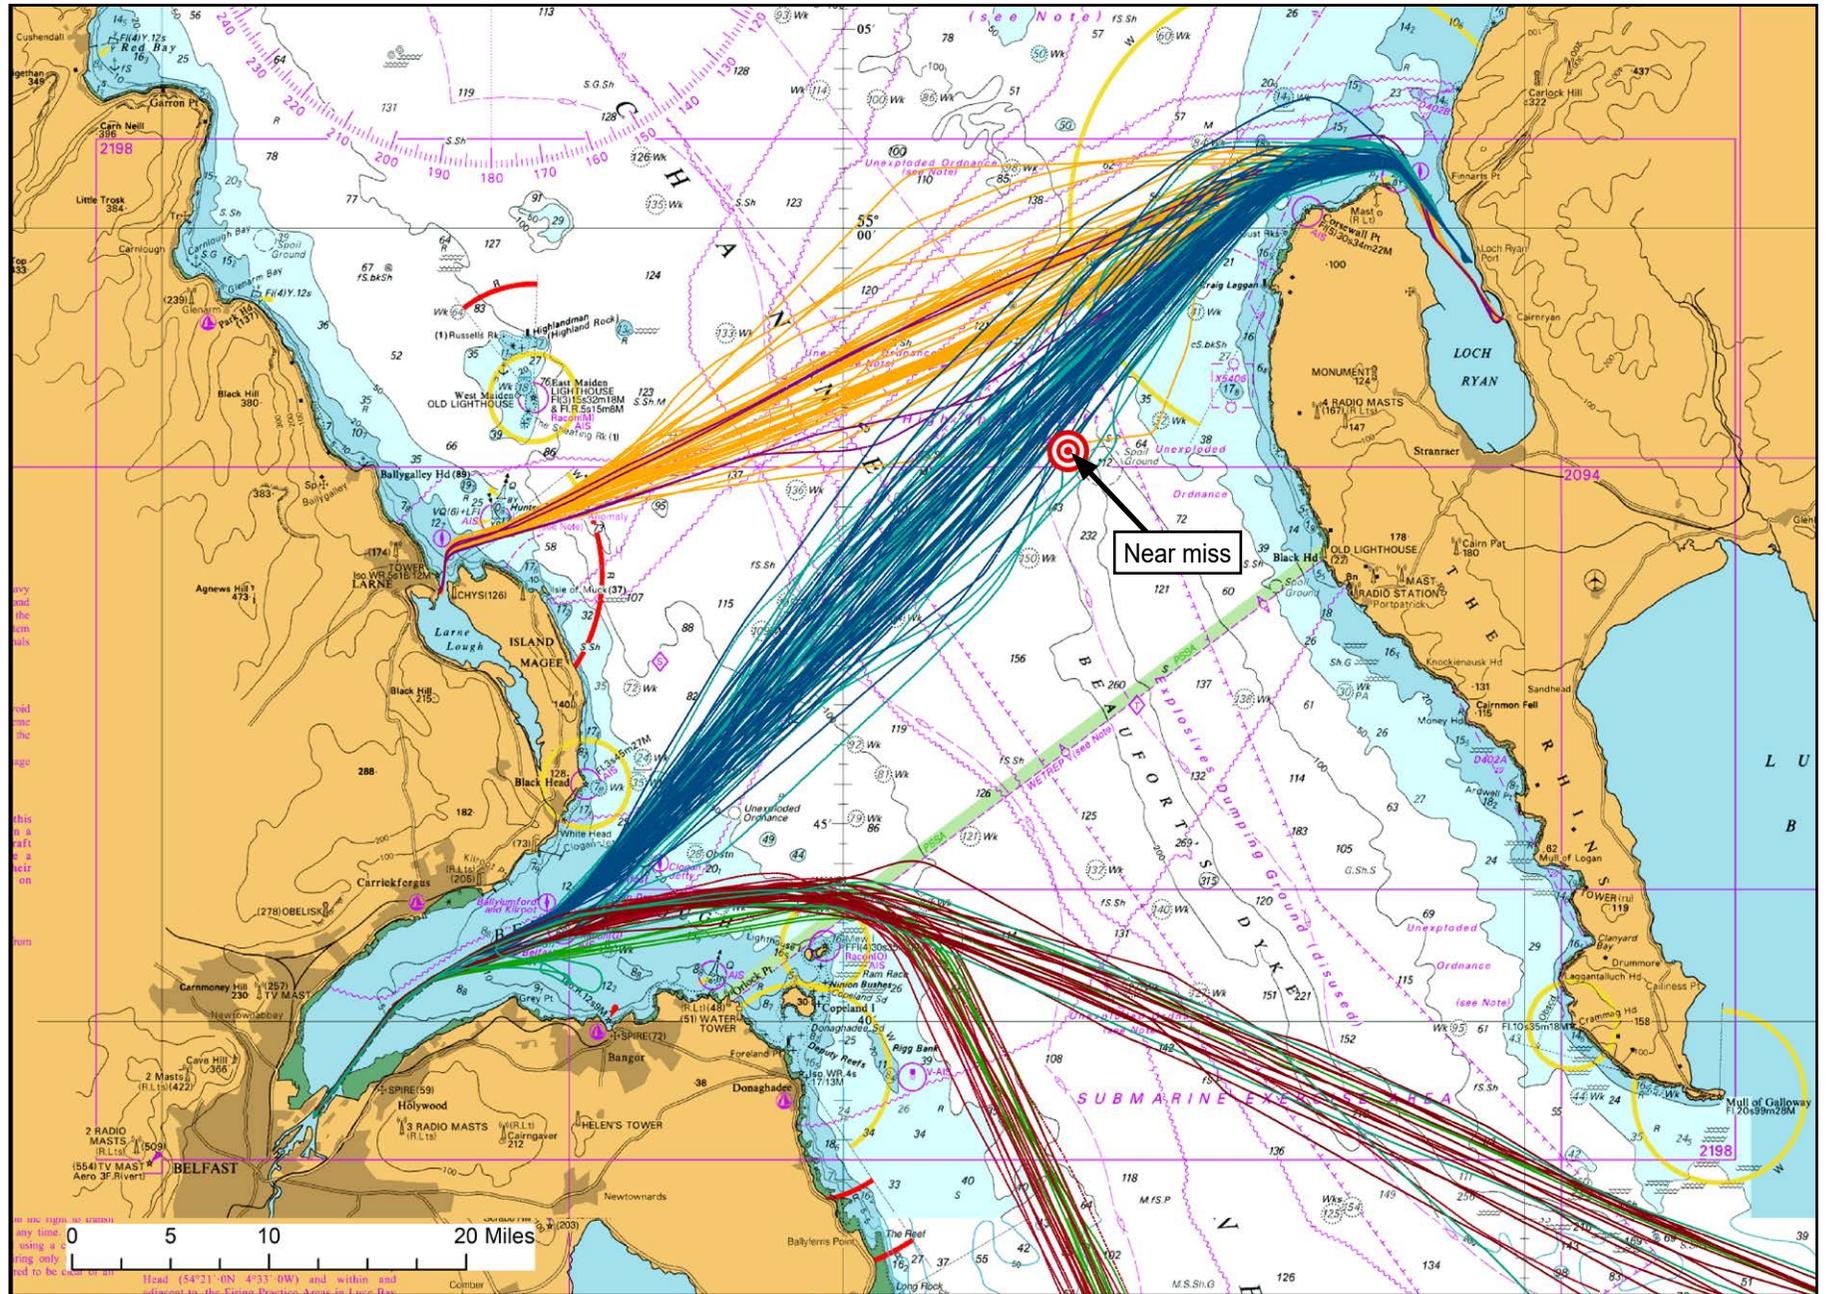
Figure 10: Seven days of AIS data for the North Channel showing ferry corridors and the incident location
