ACCIDENT

| Aircraft Type and Registration: | Rockwell Commander 114, G-BFXS |
| Date & Time (UTC): | 20 May 2020 at 1015 hrs |
| Location: | Little Snoring Airfield, Norfolk |

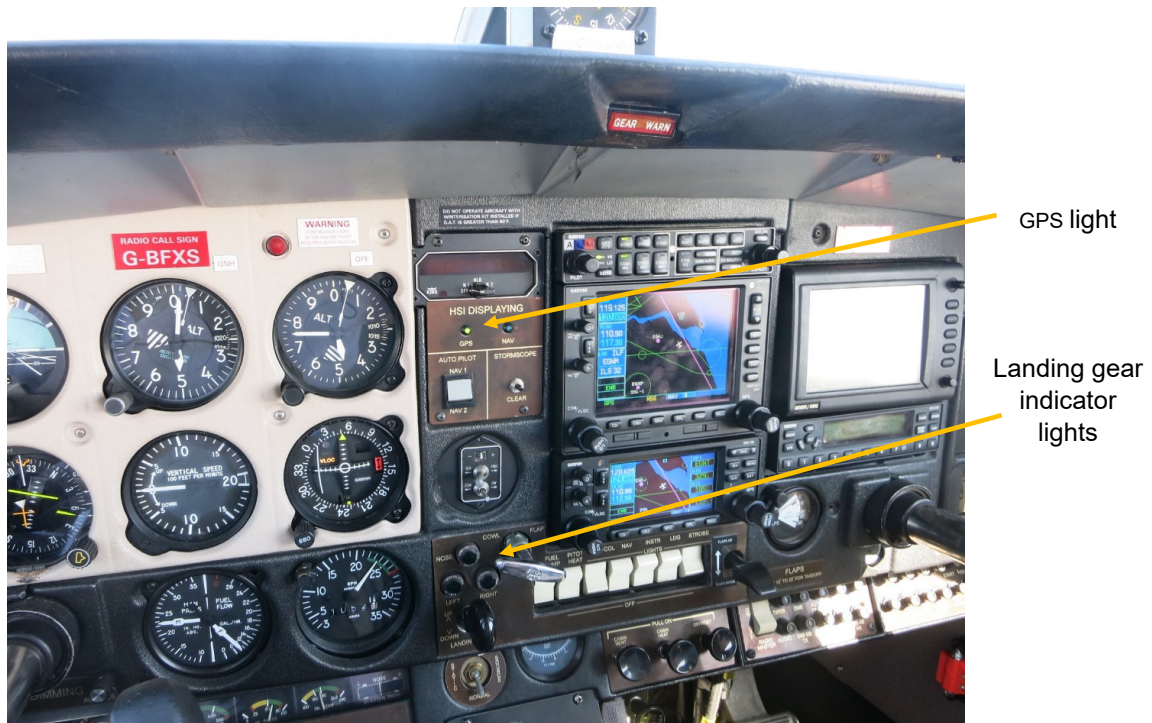
Figure 1

The pilot had not flown for several months and he thinks that the lack of recency combined with the distraction of extending the circuit caused him to forget to extend the landing gear. He believes that on final approach he glanced inside and saw the GPS green light² and mistook it for the landing gear green lights.

G-BFXS instrument panel showing the landing gear indicator lights and GPS light
