Defence  
Infrastructure  
Organisation

# Safety Alert                      Parts A, B & C

## Subject: Powered Industrial Doors – Motor Security

### Number SA 2020/53

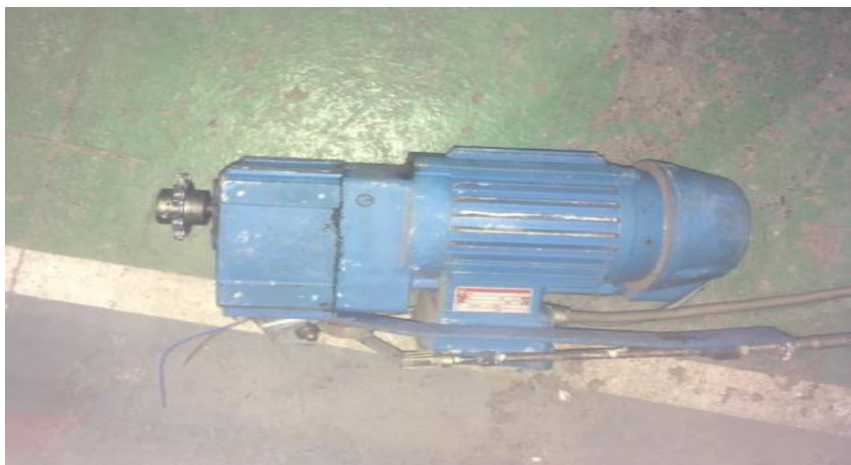
8. A member of staff sustained cuts and bruising to his right arm whilst attempting to open the electrically operated doors in a MOD Establishment. The injury was caused by the electrical drive motor falling from the top right-hand side of the folding door panel. An investigation as concluded that the electrical motor drive was inadequately secured. This door system was originally manufactured and supplied by European Profiles and was installed in 1992 by Rhino doors; it is not known how many of this door systems, or similar systems with suspended motor/drive gear have been fitted across the estate, nor when the inadequate fixings were installed.

Photo 1 Showing the Motor

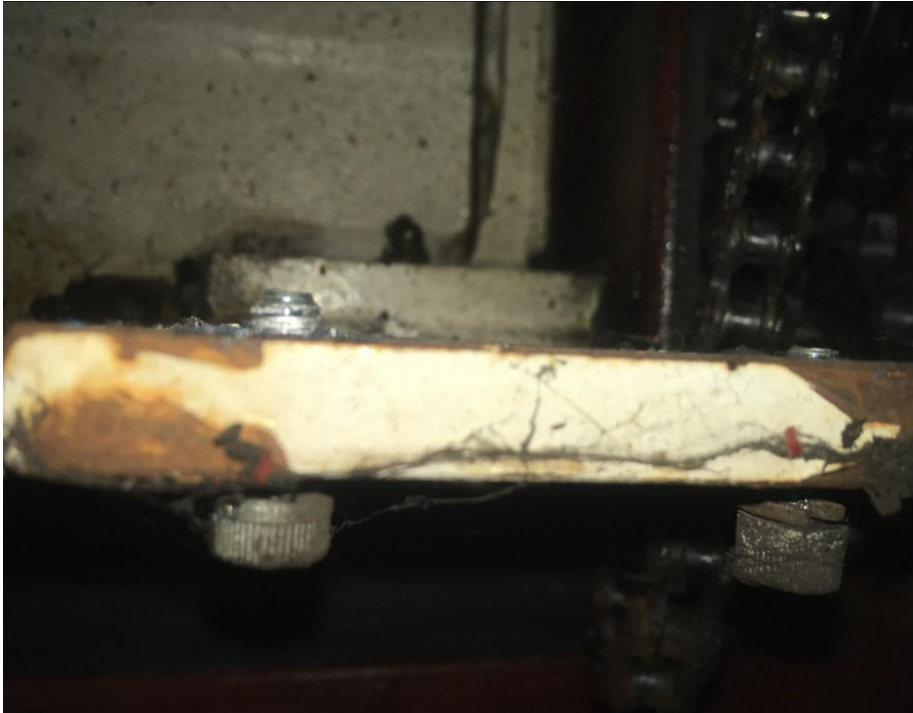
- Investigation of the incident identified that the motor fixing bolts at just 15mm were of insufficient length, and consequently very little thread was engaged (3.5 mm), providing insufficient mechanical attachment to the door base plate. Additionally, no safety tether was fitted to the motor/drive gear to retain it in the event of a mechanical failure.

Photo 2 Showing depth of thread available to engage with door base plate

22. Where it is identified that Industrial Door Systems are fitted with suspended motors/drive gear the threaded fasteners providing the mechanical attachment are to be examined for suitability (including length) and where appropriate a solution similar to that adopted by Rhino doors is to be employed, i.e. fixing the motor to the door by 4 x 40mm M6 socket set cup screws that are fully threaded into the motor fixing points, these are then secured to the door by means of a flat washer, a spring washer and an M6 nut. As an additional measure, thread lock is also applied.

23. Where the above cannot be adopted due to blind holes or similar, thread lock is to be applied to the most suitable length threaded fasteners, fitted where practicable with a flat washer and spring washer. Where there is any doubt regarding the suitability or security of the motor/drive gear attachment to the door frame a tether should be fitted to prevent the motor/drive gear falling in the event of a failure of the mechanical attachment.

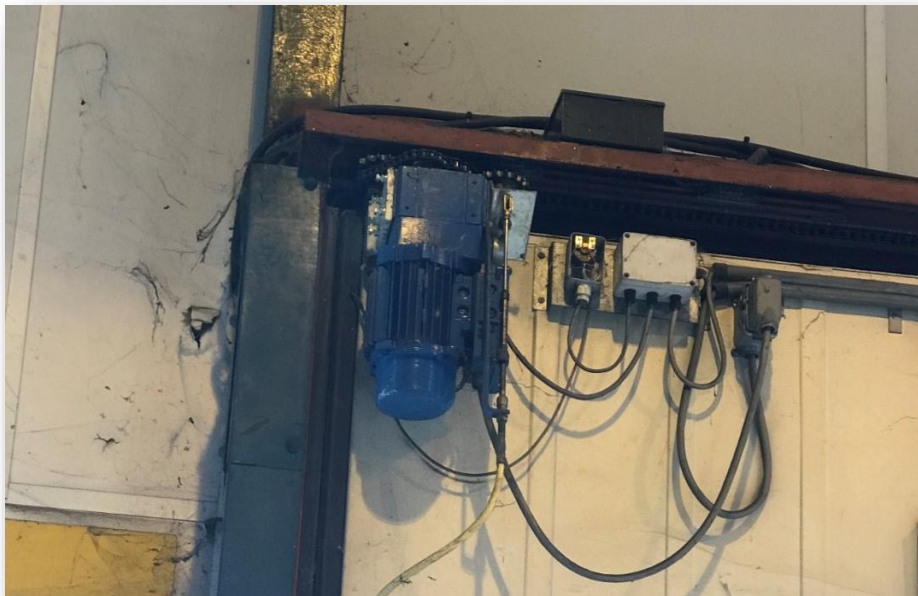
Photo 3 Showing Motor Suspended under Door Frame
