Defence  
Infrastructure  
Organisation

# Safety Alert

**Subject: Aeronautical Ground Lighting: Loose or Missing Fixings for AGL Light Fittings**

**Number: SA 2020/50**

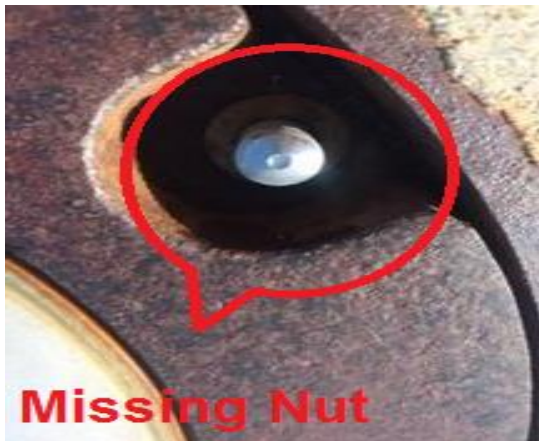
5. Prior to the departure of a military aircraft at a MOD aerodrome, the Air Operation Assurance Team conducted their usual FOD check from the stand out to the taxiway. During this check the Team noticed some taxiway centreline light fittings had loose nuts (See the photographs at Annex A).

Photograph – 01: Missing Nut

- a. A visual inspection of all AGL fittings to ensure all fixings are present with a sample of light fittings from each AGL service to be checked to confirm the fixings are tightened to the required torque setting in accordance with manufacturer's instructions. It is recommended the sample comprises of at least 10% or 5 light fittings per service with this being increased if loose fixings are found. Where practicable, missing fixings are to be immediately replaced and tightened to the required torque setting. Where this is not practicable arrangements are to be made to repair the seating arrangement and Air Traffic informed of the potential FOD risk.

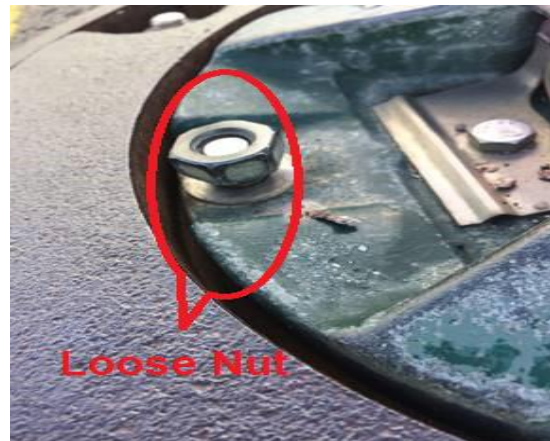
Photograph – 02 : A Loose Nut

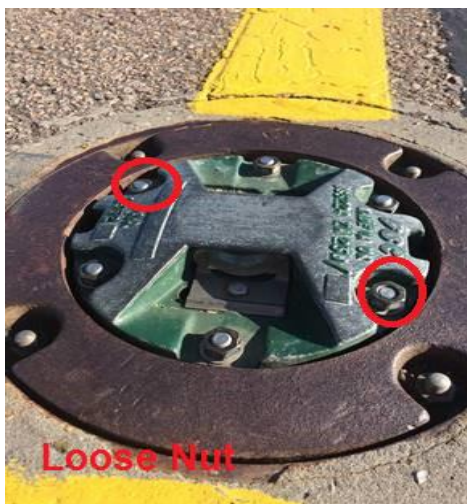
Photograph – 03 : Loose Nuts
