Person struck by tram at Gravel Hill tram stop, Croydon, 10 March 2020

Summary of the accident

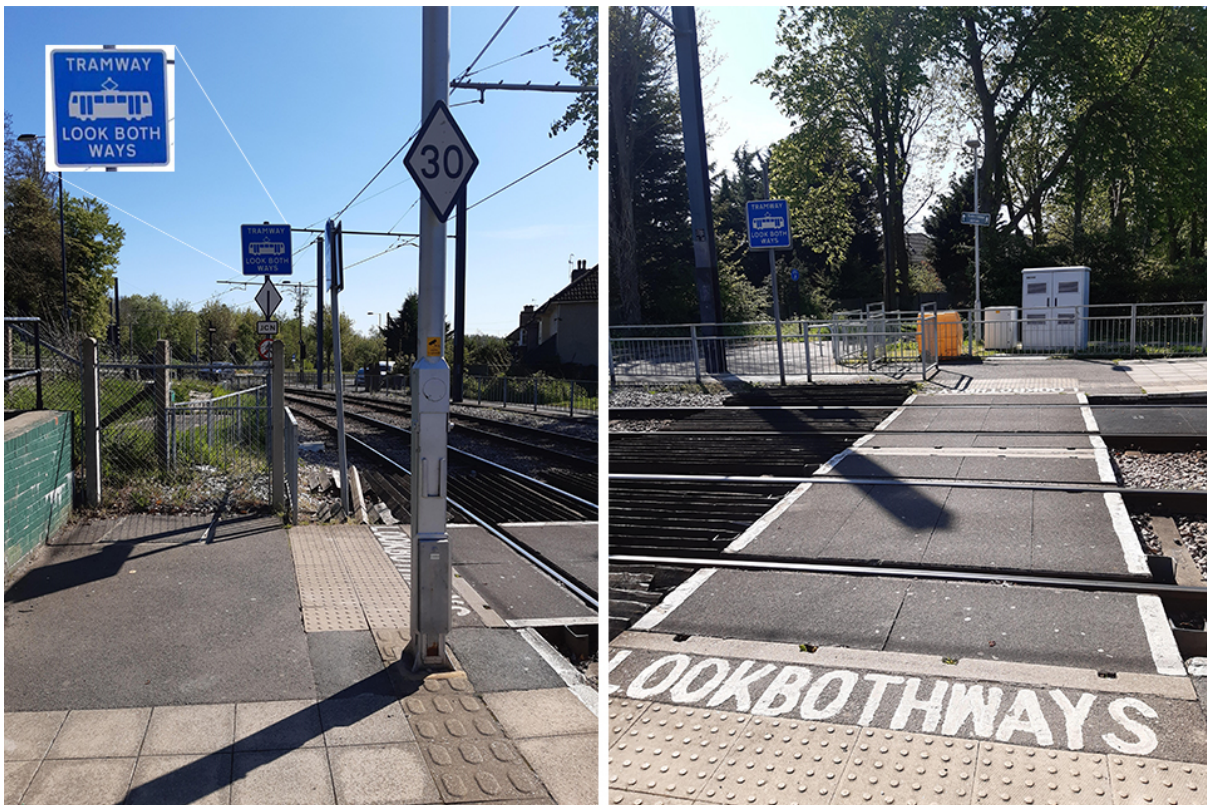
Signage in area where injured person entered foot crossing

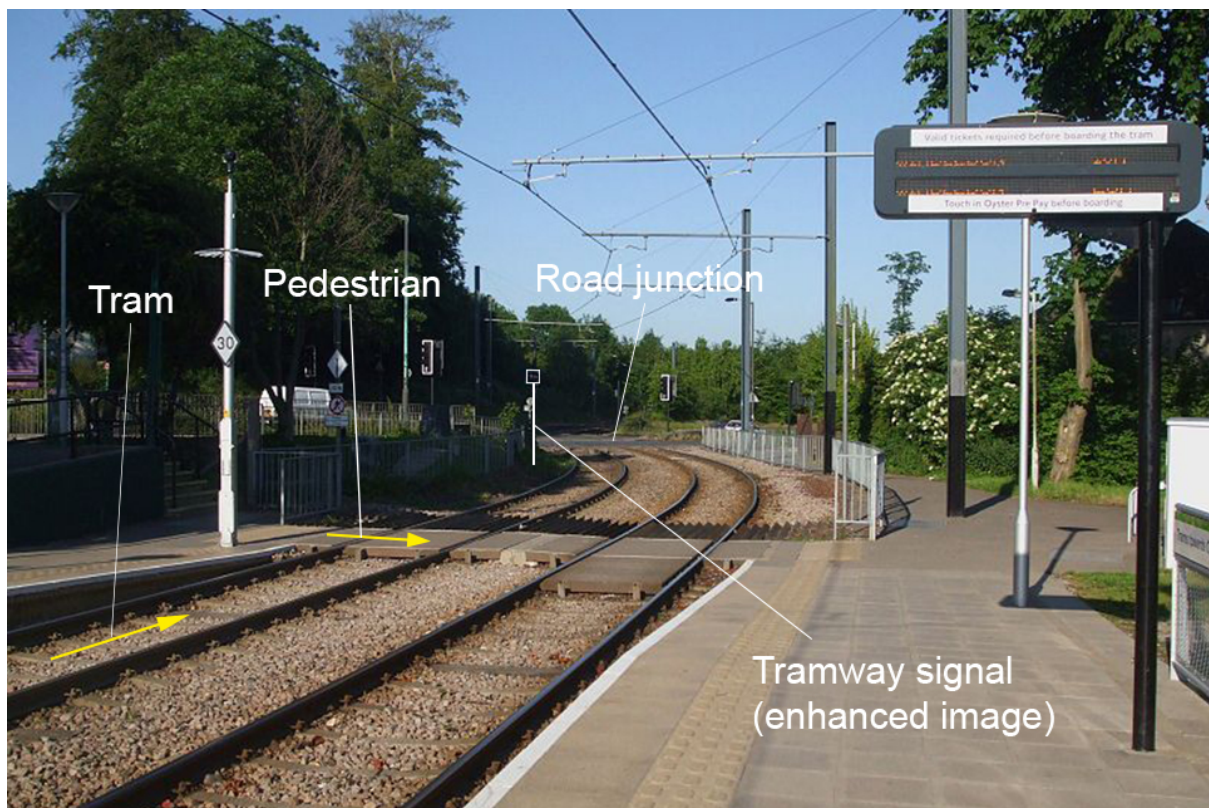
Beyond the tram stop, the tramway crosses a road at a junction controlled by road traffic signals and tramway signals. Trams departing from the tram stop and travelling towards New Addington go over the foot crossing, then pass the road junction tramway signal before crossing the road. For tram movements in this direction, the signal sequence to stop road vehicles and permit trams to cross the road is usually initiated by tram drivers operating a cab-mounted, ready-to-start button as the tram is about to leave the tram stop.

Foot crossing and road junction (photograph by Sunil060902, distributed under a CC-BY-SA 3.0 licence.)

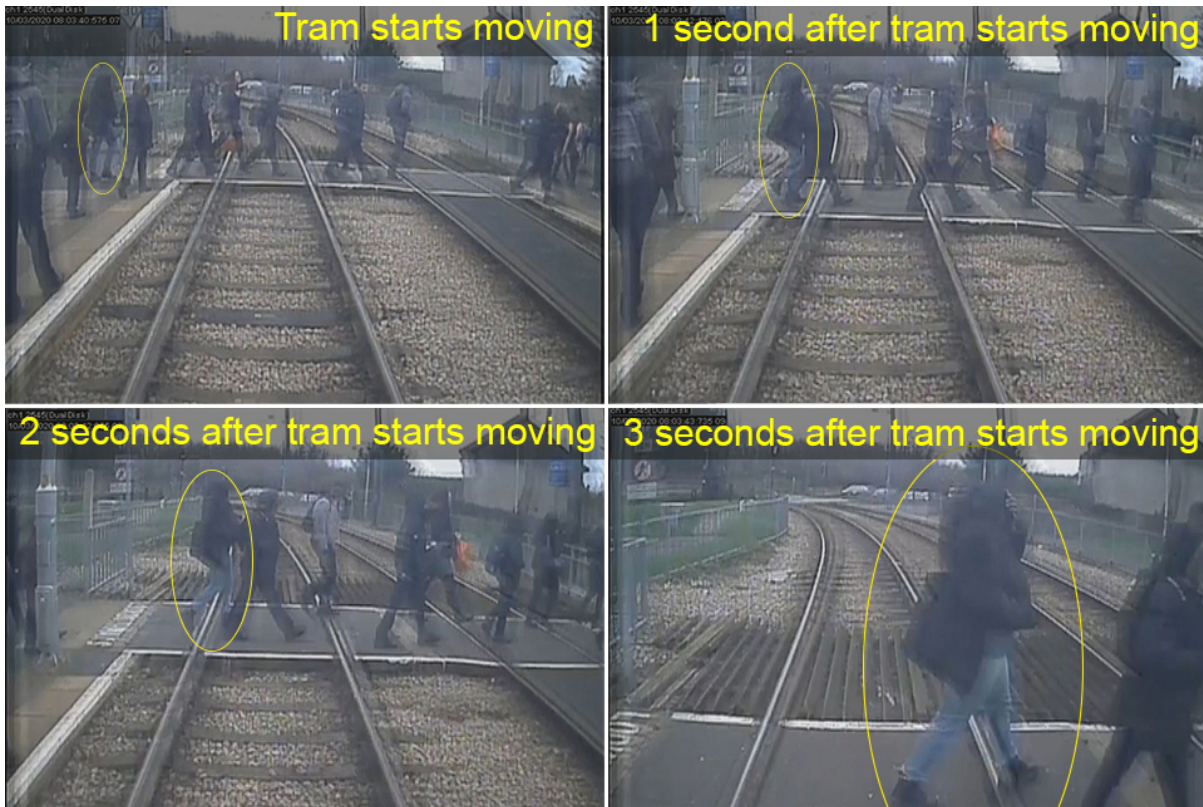
Two people, including the person struck by the tram, started to cross about one second after the tram began to move. The next person to arrive at the crossing waited for the tram to pass, as did a substantial number of people who arrived subsequently.

Positions of injured person as tram leaves tram stop (CCTV images courtesy of Tram Operations Limited)

Approximately four seconds after the tram started moving, it had reached a speed of about 17 km/h (11 mph) when it reached the foot crossing, where it struck the person a glancing blow.
