ACCIDENT

Aircraft Type and Registration:	DH-82A Tiger Moth, N54556	
No & Type of Engines:	1 De Havilland Gipsy Major 1H piston engine	
Year of Manufacture:	N/K (Serial no: T-6392RO)	
Date & Time (UTC):	21 July 2019 at 1304 hrs	
Location:	Private airstrip near Hythe, Kent	
Type of Flight:	Private	
Persons on Board:	Crew - 1	Passengers - 1
Injuries:	Crew - 1 (Fatal)	Passengers - 1 (Serious)
Nature of Damage:	Aircraft destroyed	
Commander's Licence:	Private Pilot's Licence	
Commander's Age:	51 years	
Commander's Flying Experience:	523 hours (of which 77 were on type) Last 90 days - 10 hours Last 28 days - 3 hours	
Information Source:	AAIB Field Investigation

Synopsis

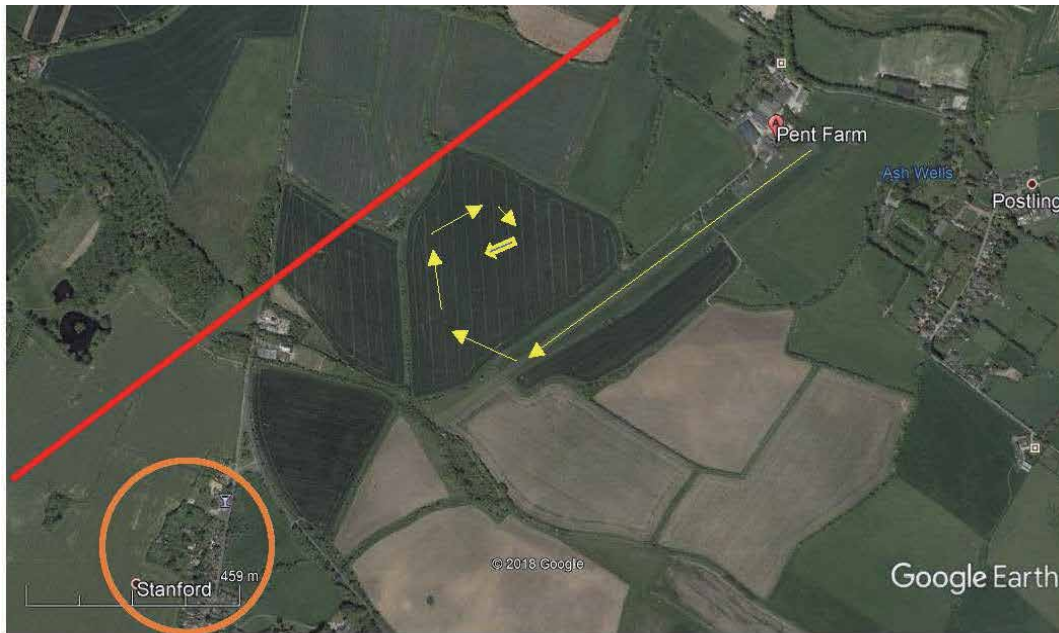
Figure 2

Pent Farm is a private airstrip 2.5 nm north-north-west of Hythe, Kent, with an elevation of 240 ft amsl. It has a single grass runway orientated 070°/250°, 1,000 m long and 25 m wide. There are high tension powerlines and 70 ft high pylons approximately 450 m to the north of and running parallel to the runway. There is high ground rising to 550 ft to the northeast and powerlines 25 ft high close to the Runway 25 threshold. Circuits are flown to the north, to the right from Runway 25, at 1,000 ft amsl. The village of Stanford on the extended centreline of Runway 25 is treated as an avoidance area. There is also a property to the north of Stanford to the west of the Runway 07 threshold which, although not part of the avoidance area, has horses and it would be normal to avoid overflying it, especially at a low height. The airfield and immediate surrounding area are shown at Figure 2.

Pent Farm airfield showing the avoidance area of Stanford, estimated aircraft track and accident site in yellow, with pylon wires in red
