## ACCIDENT

<b>Aircraft Type and Registration:</b>	Cirrus SR22T, 2-RORO
<b>No &amp; Type of Engines:</b>	1 Continental Motors TSI0-550-K piston engine
<b>Year of Manufacture:</b>	2014 (Serial no: 701)
<b>Date &amp; Time (UTC):</b>	12 May 2019 at 0950 hrs
<b>Location:</b>	A40, near Abergavenny, Wales
<b>Type of Flight:</b>	Private
<b>Persons on Board:</b>	Crew - 1                      Passengers - 2
<b>Injuries:</b>	Crew - 1 (Minor)          Passengers - 2 (Minor)
<b>Nature of Damage:</b>	Aircraft destroyed
<b>Commander's Licence:</b>	Commercial Pilot's Licence
<b>Commander's Age:</b>	52 years
<b>Commander's Flying Experience:</b>	1,600 hours (of which 700 were on type) Last 90 days - 70 hours Last 28 days - 30 hours
<b>Information Source:</b>	AAIB field investigation

## Synopsis

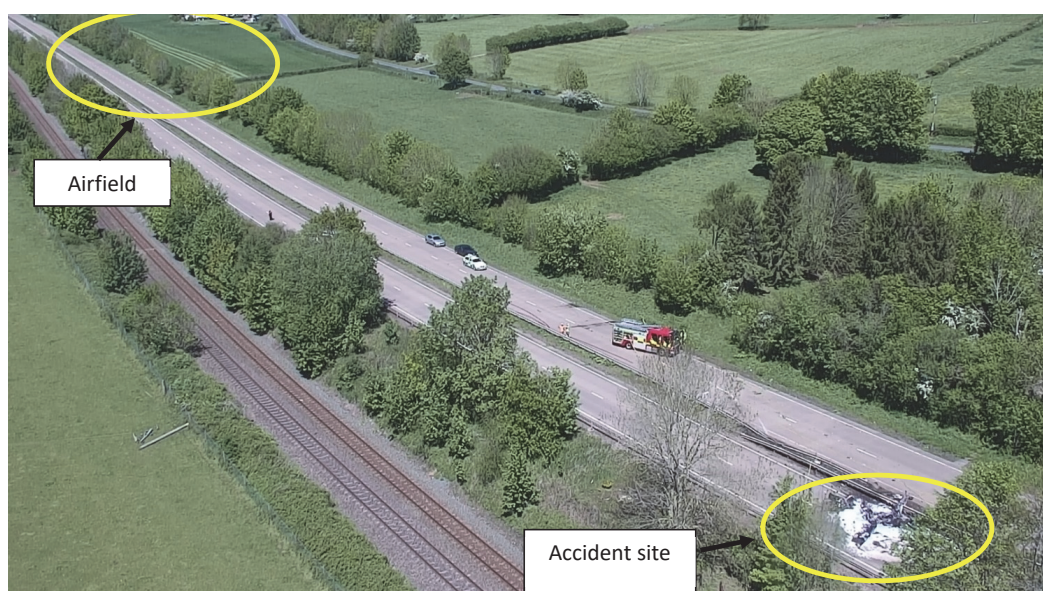
**Figure 1**

Accident site with Abergavenny Airfield in the background

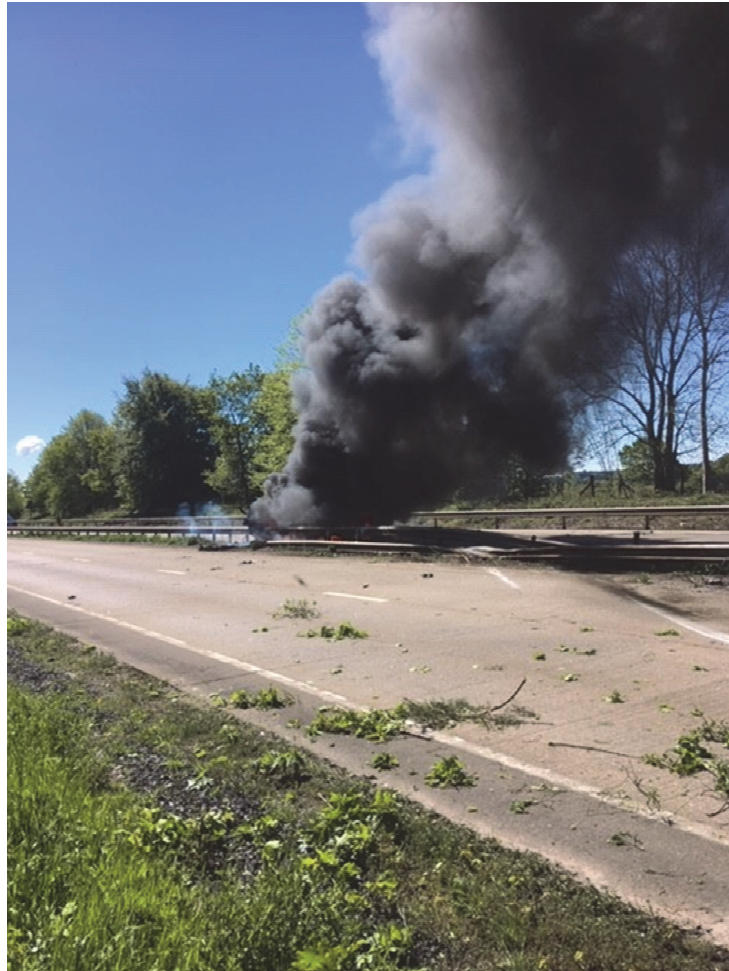
**Figure 2**

Aircraft fire after the occupants' escape

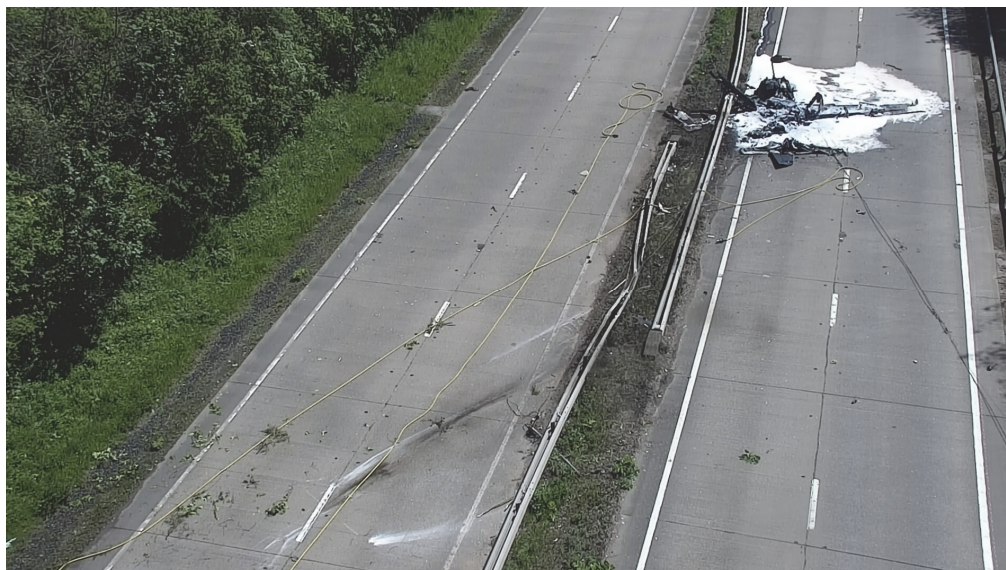
**Figure 3**

The aircraft came to rest against the central reservation barriers of the northbound carriageway of the A40 approximately one mile south of Abergavenny, Monmouthshire. There were clear witness marks on the carriageway indicating that the aircraft slid from the initial impact point to its final resting place. Figure 3 shows the accident site and the marks on the road.

Accident site showing the ground marks

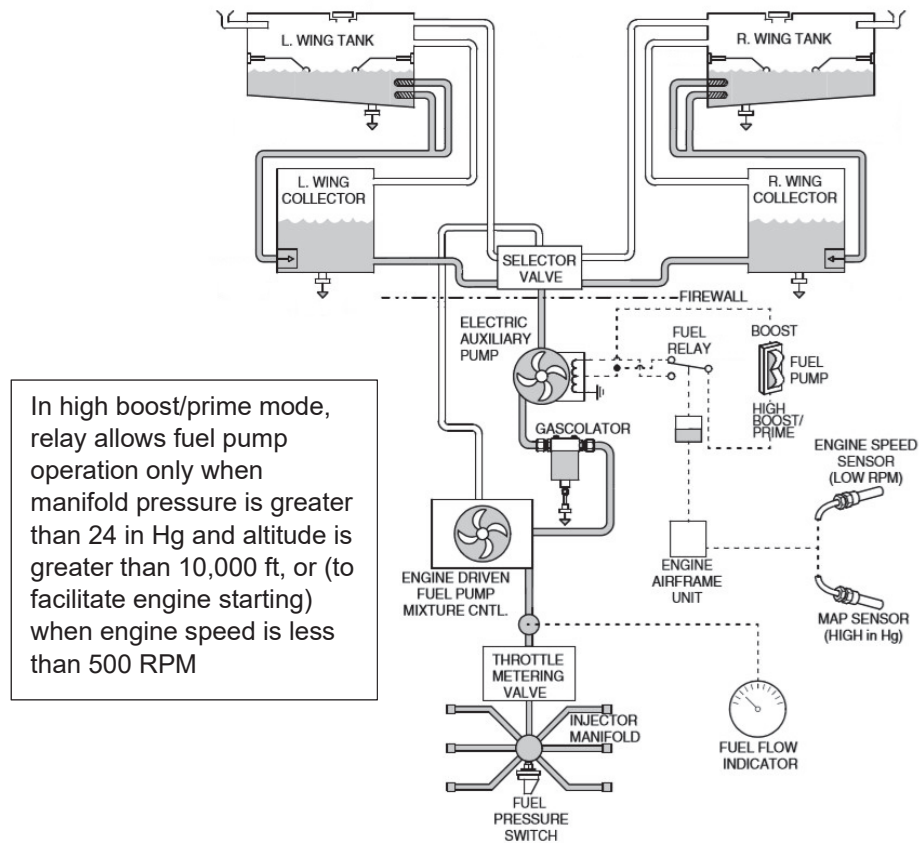
**Figure 4**

Cirrus SR22T fuel system incorporating software update v0764.36

The lockout relay limits the electric fuel pump to the lower pressure BOOST even if the switch is selected to HIGH BOOST/PRIME. During takeoff, although the manifold pressure would have been in excess of 24 in Hg, the aircraft was below 10,000 ft altitude and therefore the lockout relay should have limited the fuel flow. The altitude restriction was introduced by a software update after several incidents with this aircraft type where the electrical fuel boost system was suspected of causing over-fuelling<sup>2</sup> to the engine resulting in black soot deposits and reported engine “surging”.

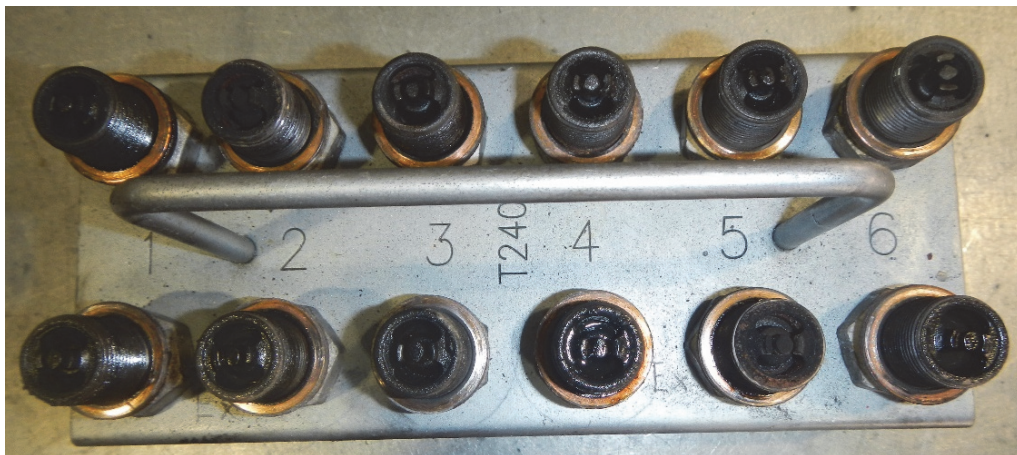
**Figure 5**

The engine was examined externally prior to strip down. Although it sustained thermal damage from the post-accident fire, this was concentrated at its bottom and rear. There were no external pre-accident anomalies visible with any of the components. The spark plugs were removed and examined. All were coated in a dark black soot with oil also coating all but the No 2 top and No 5 bottom sparkplugs (Figure 5). The No 1 top, No 4 bottom and the No 6 bottom sparkplugs had fractured centre insulators. All the sparkplugs displayed what the engine manufacturer described as a '*severe worn-out wear condition*', as the central electrodes on all sparkplugs had eroded to an elliptical or diamond shape. The sparkplugs were tested and the ones with the cracked insulators failed to produce a spark.

Spark plugs removed during engine strip

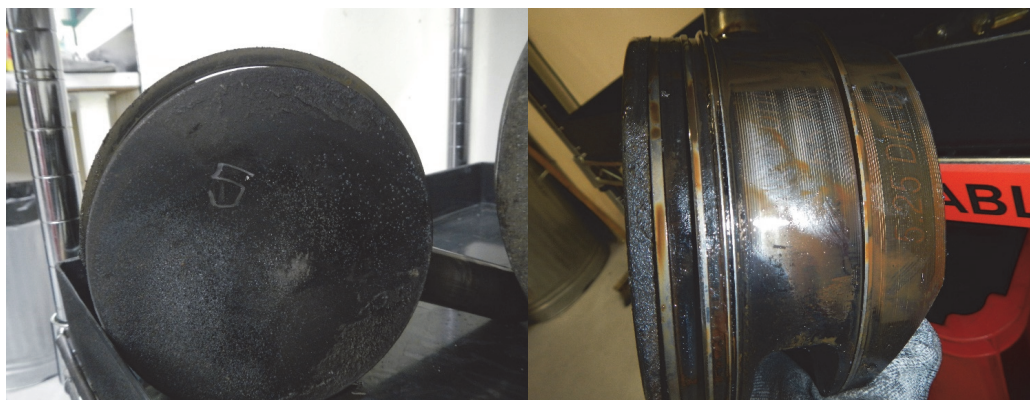
**Figure 6**

All six cylinders remained attached to the crankcase and produced compression when the crankshaft was manually rotated, and all rockers/valves moved normally. None of the cylinders' internal components showed any significant combustion deposits. On removal it was seen that all cylinder heads and intake valves were covered in black soot. Cylinder No 5 also displayed evidence of lean-mixture piston head and cylinder head erosion as shown in Figure 6.

Cylinder No 5 showing the dark soot deposit and the lean-mixture piston face and cylinder head erosion

The pilot’s description, together with the soot on the cylinders and intake valves, suggested the engine was running with a rich fuel mixture (over-fuelling). However, the engine itself revealed a longer-term issue with magneto timing, lean running (under-fuelling) and spark plug damage. These longer-term faults could all be linked with the magneto timing issues causing both the spark plug damage and the cylinder damage but could not explain the engine malfunction on the day of the accident. The longer-term faults may have eventually caused a loss of power on the engine, but they were not the cause of the failure on the accident flight.
