**SERIOUS INCIDENT**

<b>Aircraft Type and Registration:</b>	Boeing 737-4Q8, G-JMCR	
<b>No &amp; Type of Engines:</b>	2 CFM CFM56-3C1 turbofan engines	
<b>Year of Manufacture:</b>	1992 (Serial no: 25372)	
<b>Date &amp; Time (UTC):</b>	4 June 2019 at 1846 hrs	
<b>Location:</b>	Brussels National Airport, Belgium	
<b>Type of Flight:</b>	Commercial Air Transport (Cargo)	
<b>Persons on Board:</b>	Crew - 2	Passengers - None
<b>Injuries:</b>	Crew - None	Passengers - N/A
<b>Nature of Damage:</b>	None	
<b>Commander's Licence:</b>	Airline Transport Pilot's Licence	
<b>Commander's Age:</b>	34 Years	
<b>Commander's Flying Experience:</b>	2,525 hours (of which 2,325 were on type) Last 90 days - 83 hours Last 28 days - 7 hours	
<b>Information Source:</b>	AAIB Field Investigation

**Synopsis**

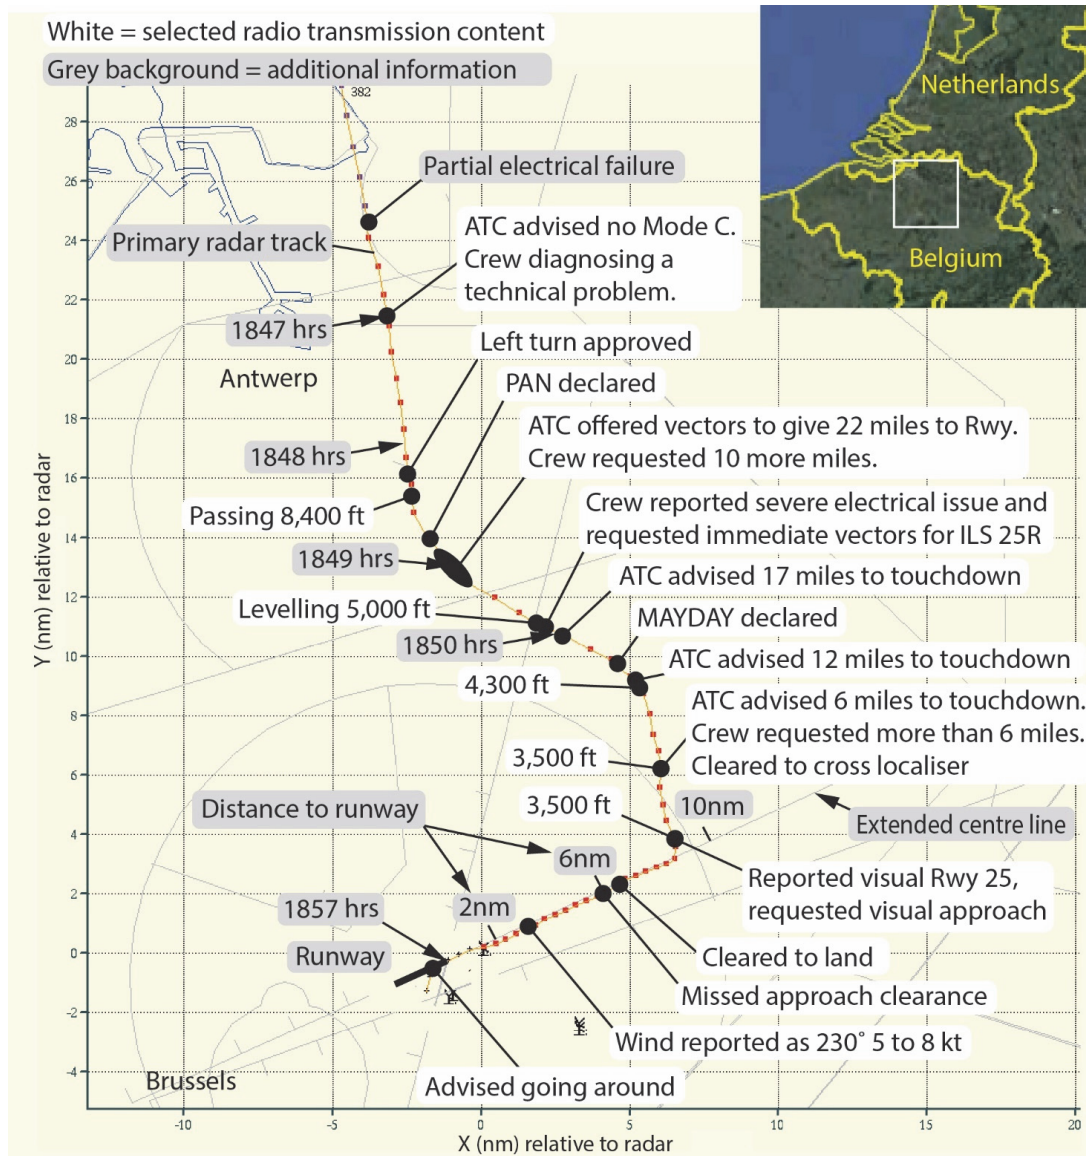
Figure 1

The position of the aircraft when the electrical failure occurred and where a number of the radio calls between the crew and ATC took place are plotted at Figure 1. It was approximately five minutes between ATC informing the crew that they had “no read out from Mode C” to the aircraft intercepting the localiser. During this period the pilots made or responded to numerous radio calls, while being vectored and assessing the effect of the electrical failure on the aircraft systems.

Primary radar track and timing of some radio calls

The misreporting of the distance as 6 nm, one minute after being informed it was 12 nm, would have upset the pilots' mental picture and their decision to level off and ask for extra distance would have given them time to assess the situation and review their plan. The correct distance (DME) would have been displayed on the PF's EHSI and on both pilots Radio Distance Magnetic Indicator; however, neither pilot questioned this discrepancy with ATC. Thirty seconds later the PF reported that he was visual with the runway and was cleared for a visual approach. The extra distance, and time, previously requested was not used and as a result of arresting the descent the aircraft was approximately 700 ft above the glideslope.
