**ACCIDENT**

<b>Aircraft Type and Registration:</b>	DJI M600 Pro (UAS, registration N/A)	
<b>No &amp; Type of Engines:</b>	6 electric motors	
<b>Year of Manufacture:</b>	2019 (Serial no: 2016DP6137)	
<b>Date &amp; Time (UTC):</b>	13 December 2019 at 1521 hrs	
<b>Location:</b>	Wallsend, Tyne and Wear	
<b>Type of Flight:</b>	Aerial Work	
<b>Persons on Board:</b>	Crew - None	Passengers - None
<b>Injuries:</b>	Crew - N/A	Passengers - N/A
<b>Nature of Damage:</b>	Propellers, arms, landing gear, gimbal and camera lens damaged	
<b>Commander's Licence:</b>	Not applicable	
<b>Commander's Age:</b>	31 years	
<b>Commander's Flying Experience:</b>	44 hours (of which 6 were on type) Last 90 days - 8 hours Last 28 days - 4 hours	
<b>Information Source:</b>	AAIB Field investigation

**Synopsis**

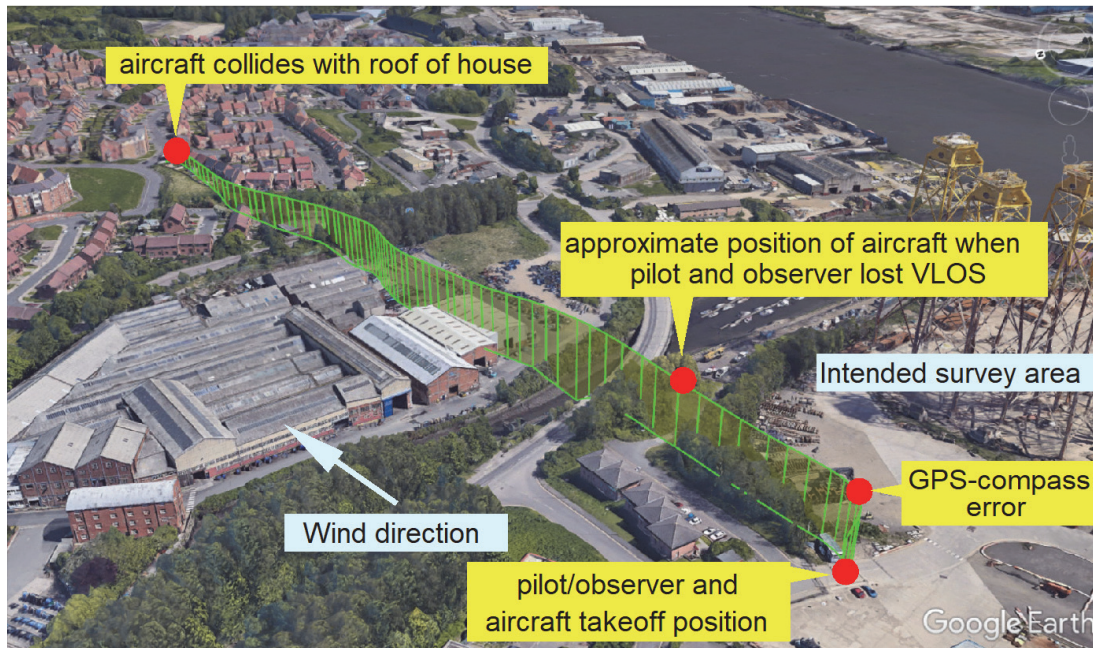
**Figure 1**

The takeoff was normal but, as the aircraft approached 100 ft amsl (a height of about 65 ft agl), the pilot noticed that a **GPS-COMPASS ERROR** was displayed on the controller. The aircraft stopped climbing and proceeded to fly in an east-north-easterly direction at a ground speed of about 13 kt, whilst maintaining an altitude of about 100 ft amsl (Figure 1). The pilot and observer reported that they were initially taken by surprise. The pilot then selected the return-to-home (RTH)<sup>4</sup> function on the controller several times, but the aircraft did not respond. Within about ten seconds, the pilot and observer lost visual line of sight (VLOS) with the aircraft when it travelled beyond a line of trees located at the boundary of the construction site. No manual flight control inputs were made using the controller.

The aircraft proceeded to fly overhead a large industrial area before approaching a housing estate located 300 m from where it had taken off. The aircraft had continued to maintain its altitude; however, its relative height above the ground reduced as it approached the housing estate due to the rising terrain. The recorded logs from the aircraft showed that, at 1521:07 hrs, the aircraft collided with the roof of a house before falling into the rear garden of the property (Figures 2 and 3). There were no persons in the garden at the time. The aircraft's propellers, arms, landing gear, gimbal and camera lens were damaged. The flight time from when the GPS-compass error had occurred and the aircraft colliding with the house was 75 seconds. The controller had remained in radio contact throughout the flight.

Recorded GPS flightpath of aircraft

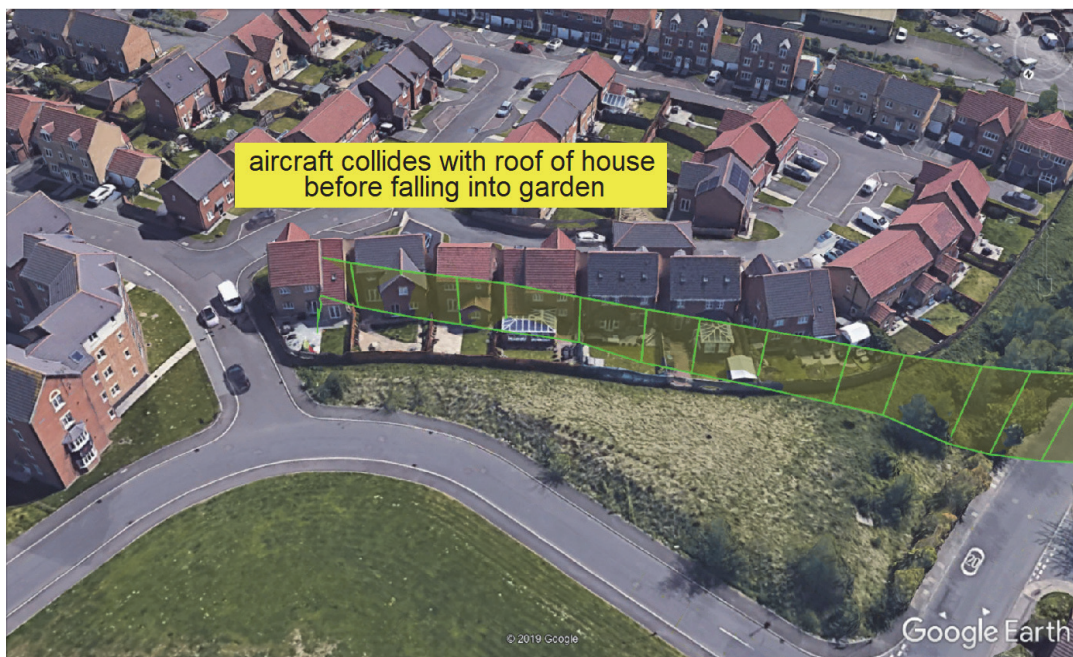
**Figure 2**

Accident location
