## ACCIDENT

<b>Aircraft Type and Registration:</b>	Standard Cirrus 75, G-DDGX	
<b>No &amp; Type of Engines:</b>	No engines	
<b>Year of Manufacture:</b>	1975 (Serial no: 619)	
<b>Date &amp; Time (UTC):</b>	27 July 2019 at 1130 hrs	
<b>Location:</b>	Gwernesney Airfield, Monmouthshire	
<b>Type of Flight:</b>	Private	
<b>Persons on Board:</b>	Crew - 1	Passengers - None
<b>Injuries:</b>	Crew - 1 (Fatal)	Passengers - N/A
<b>Nature of Damage:</b>	Aircraft destroyed	
<b>Commander's Licence:</b>	British Gliding Association (BGA) Certificate with B Badge Endorsement	
<b>Commander's Age:</b>	54 years	
<b>Commander's Flying Experience:</b>	Total hours not determined 182 flights totalling 41 hours since August 2015 (of which 2 hours and 20 minutes were on type) Last 90 days - 3 hours and 42 minutes Last 28 days - 1 hour and 38 minutes	
<b>Information Source:</b>	AAIB Field Investigation

## Synopsis

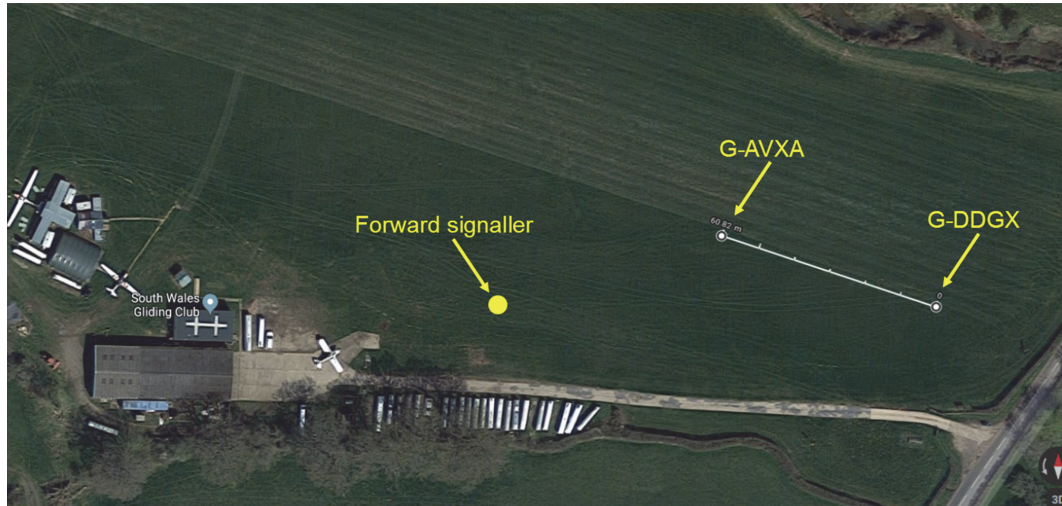
Approximate disposition of G-AVXA, G-DDGX and forward signaller before takeoff

G-DDGX's tailplane was not securely attached and separated from the glider shortly after the aerotow ground roll began. A stop signal was made as soon as the rigging failure was detected by the wing runner. The signal was relayed by the forward signaller, but the tug pilot did not see it. Given his training, ops manual direction and the known takeoff risks, it is considered likely that the glider pilot had one hand on the cable release lever during the takeoff roll. That the tow cable remained attached until after the glider was airborne, strongly suggests that the accident pilot did not hear or see either stop signal. It was not determined whether the tow rope back-released from the glider or if the accident pilot operated the cable release mechanism.

It is recommended that the British Gliding Association specifies in its Operational Regulations the minimum requirements for an '*adequate system of communication*' for glider launching.

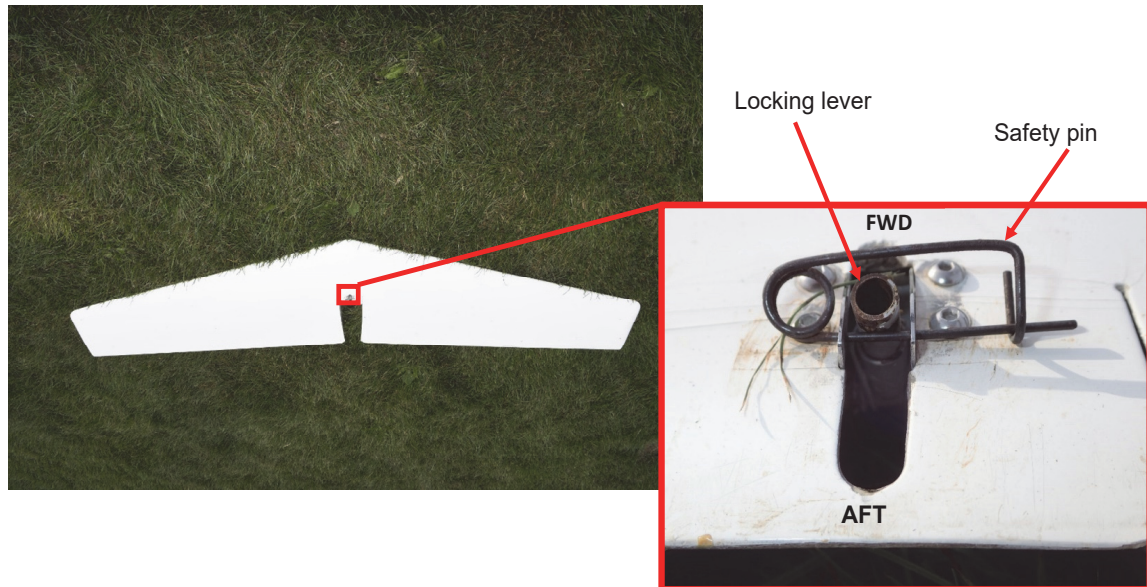
The tailplane had come to rest close to the launch point, approximately 237 m from the main wreckage. It was immediately apparent that, although the tailplane safety pin was installed, the tailplane locking lever was forward of, rather than the normal position aft of, the safety pin (Figure 3).

**Figure 3**  
G-DDGX tailplane (as found condition)  
with inset showing locking lever forward of safety pin

The tailplane was undamaged. The locking lever was protruding through the slot in the upper surface of the tailplane and was resting against, and forward of, the safety pin. Upon removal of the safety pin, the locking lever sprang back to its neutral position. The top of the locking lever in the area where it was in contact with the safety pin showed evidence of missing paint and surface corrosion, the extent of which was greater on the rear face of the lever (Figure 9). In normal operation the lever moves freely within the slot and does not come into contact with any other structure.

Regardless of how the locking lever came to be forward of the safety pin, in this condition the lever would rest against the safety pin under spring force, such that the locking hooks would be engaged on the axle of the rear mechanism but not fully locked. Nonetheless, in this condition, it was demonstrated that the locking hooks appeared to provide a reasonable degree of attachment and the tailplane could not be dislodged. Although an undesirable condition, with a correctly engaged front fitting, this condition alone may not have accounted for the separation of the tailplane.

It is recommended that the European Union Aviation Safety Agency require a means to detect incorrect alignment of the tailplane locking lever on gliders with locking features similar to the Standard Cirrus 75.

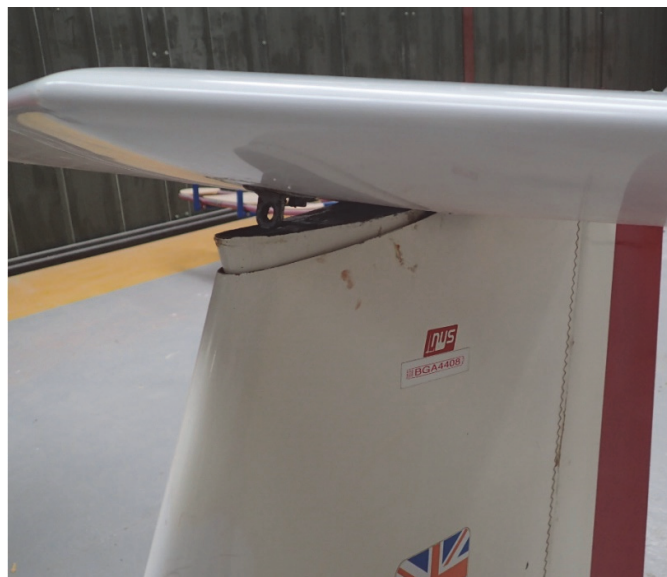
If the tailplane was offered up to the fin in a trailing-edge down orientation, it was possible to achieve full engagement of the locking hooks on the axle and move the lever aft to the fully locked position, while the tapered bolt was not engaged in the lug of the front fitting. If the locking lever was already resting forward of the safety pin when this was done, it was possible to achieve a condition where the rear mechanism was engaged but not locked (as previously described) and the front fitting was entirely disengaged. In both cases a large gap was present between the leading edge of the tailplane and the moveable fairing, where it was visually evident that the tapered bolt was not engaged in the front fitting (Figure 13). These two scenarios were demonstrated on the comparison glider but could not be replicated on G-DDGX.

Rear tailplane mechanism partially engaged, front fitting disengaged

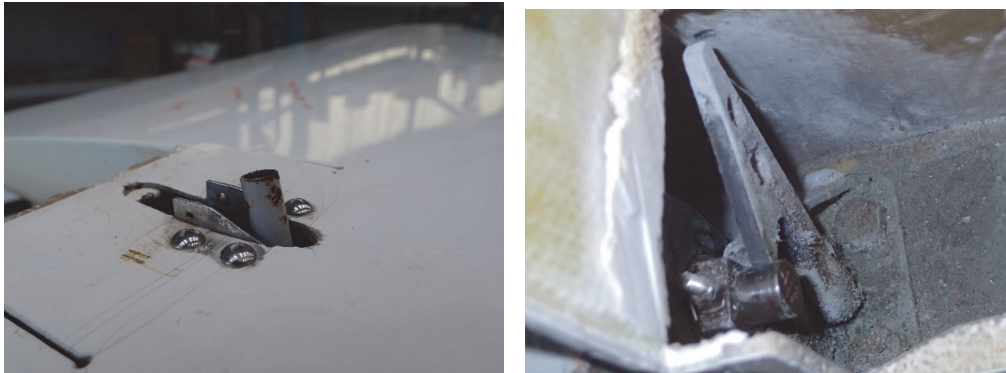
However, it was possible on G-DDGX to achieve a condition where the locking lever was in the fully forward position and the tapered bolt was only partially engaged in the front fitting (Figure 14). In this condition neither the rear mechanism nor the front fitting were properly engaged and the tailplane could be easily dislodged.

Position of locking lever and locking hooks when lever in fully forward position (safety pin not shown) and forward fitting partially engaged.

Rigging trials also demonstrated that it was possible to achieve partial engagement of the rear mechanism (locking lever forward of safety pin), while the tapered bolt was entirely disengaged from the front fitting. Although visually identifiable due to a large gap between the tailplane and moveable fairing, in this condition it is possible the tailplane could pivot upwards, applying spring force to open the locking lever and hooks.

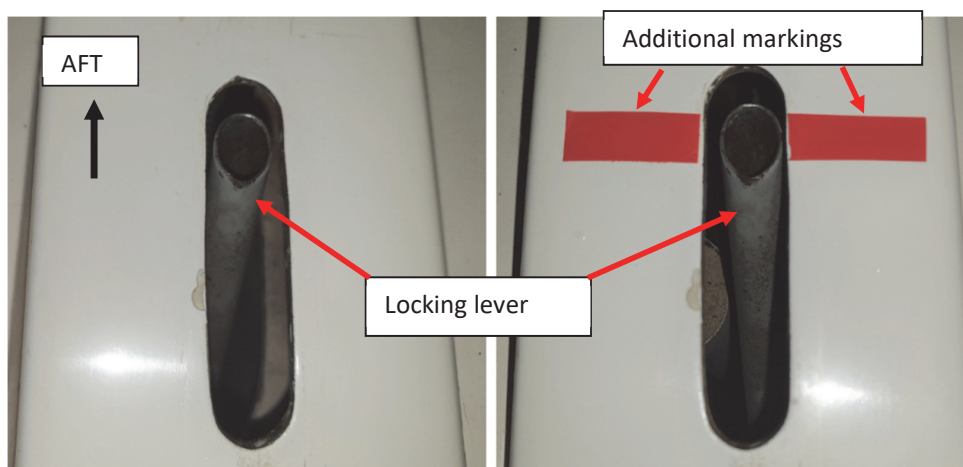
Standard Cirrus tailplane (original T-fitting elevator connection) with and without (left) locally-applied indicator for correct locking lever alignment

Following this accident, for gliders with similar tailplane locking features to that of the Standard Cirrus 75, the gliding club introduced tell-tale markings to show the approximate required position of the locking lever and make it easier to detect incorrect alignment. The EASA recommended that such markings indicating the correct position for locking levers should be green in colour. Similar tailplane attachment mechanisms are known to be used on other types of glider and therefore, the following Safety Recommendation is made:
