ACCIDENT

Aircraft Type and Registration:	Quik GT450, G-CFKJ	
No & Type of Engines:	1 Rotax 912ULS piston engine	
Year of Manufacture:	2008 (Serial no: 8405)	
Date & Time (UTC):	2 December 2019 at 0840 hrs	
Location:	Field approx 2 miles north-east of Caernarfon Airport, Gwynedd	
Type of Flight:	Private	
Persons on Board:	Crew - 1	Passengers - 1
Injuries:	Crew - None	Passengers - None
Nature of Damage:	Damage to pod, windshield, wheel spat. and electrical systems	
Commander's Licence:	National Private Pilot's Licence	
Commander's Age:	61 years	
Commander's Flying Experience:	534 hours (of which 534 were on type) Last 90 days - 17 hours Last 28 days - 0 hours	
Information Source:	Aircraft Accident Report Form submitted by the pilot

Synopsis

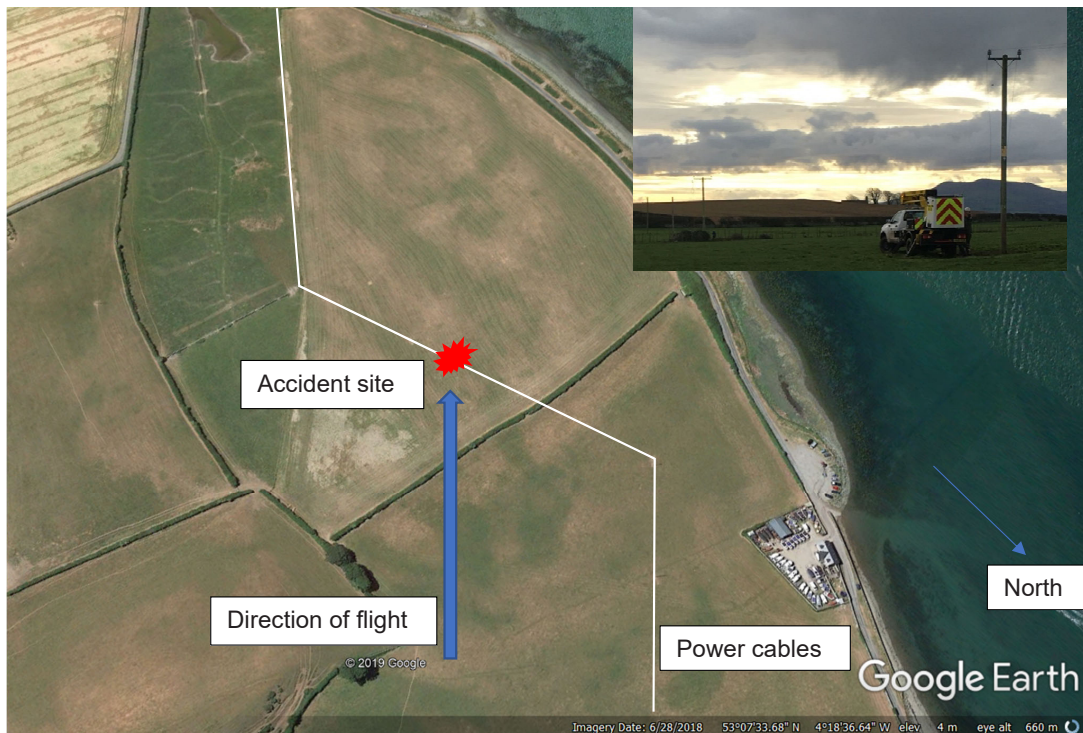
Figure 1
Accident site location

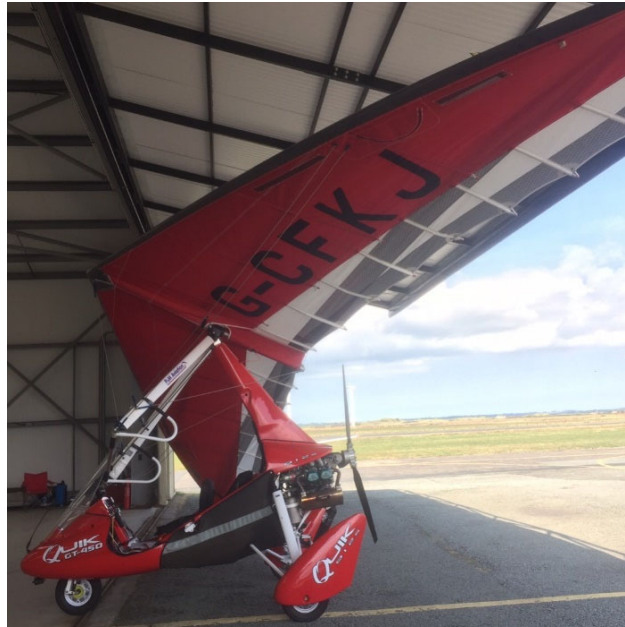
The aircraft (Figure 2) was taken to a maintenance organisation where it was found that all the electronic systems had been damaged when the aircraft struck the power cables. The ignition system was replaced, the engine was tested and ran satisfactorily. The maintenance organisation suspected that the engine stopped due to carburettor icing.

Figure 2
Accident aircraft
