Accident

Aircraft Type and Registration:	DJI Inspire 2 (UAS registration n/a)	
No & Type of Engines:	4 DJI 3512 electric motors	
Year of Manufacture:	2016 (Serial no: 095XDAX002024M)	
Date & Time (UTC):	8 February 2020 at 1328 hrs	
Location:	Sampson House, London	
Type of Flight:	Aerial Work	
Persons on Board:	Crew - N/A	Passengers - N/A
Injuries:	Crew - N/A	Passengers - N/A
Nature of Damage:	Extensive damage	
Commander's Licence:	N/A	
Commander's Age:	39 years	
Commander's Flying Experience:	More than 1,000 hours (of which 430 were on type) Last 90 days - 30 hours Last 28 days - 7 hours	
Information Source:	Aircraft Accident Report Form submitted by the pilot

Synopsis

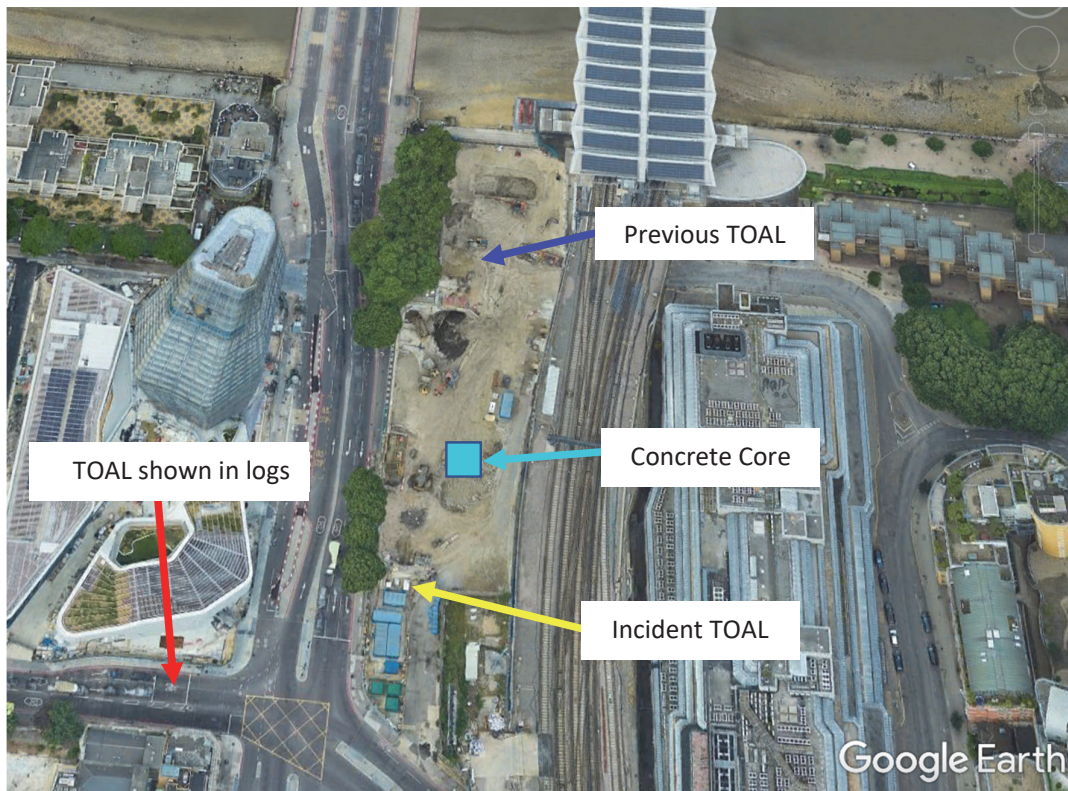
Figure 1

The remote pilot had completed five flights at the site on the day of the accident from a takeoff and landing area (TOAL) at the north of the site (Figure 1). To ensure safe flight in relation to a crane, the TOAL was then moved to the south quadrant. Pre-flight checks on the drone indicated that a full GPS signal had been acquired and that the new 'home-point'

The area of operation of the drone showing the TOALs for the flights and the collision structure

Subsequent examination of the flight logs showed that the 'home-point' set by the drone for the accident flight was outside of the site (shown in red in Figure 1). The data showing distance flown was also incorrect. The logs showed that the GPS and compass had poor signal strength once the flight had commenced. The remote pilot commented that he may have missed that the drone was showing the incorrect home position before takeoff as he may have relied on the messages showing the drone was ready for flight provided on the interface and the navigational lighting.

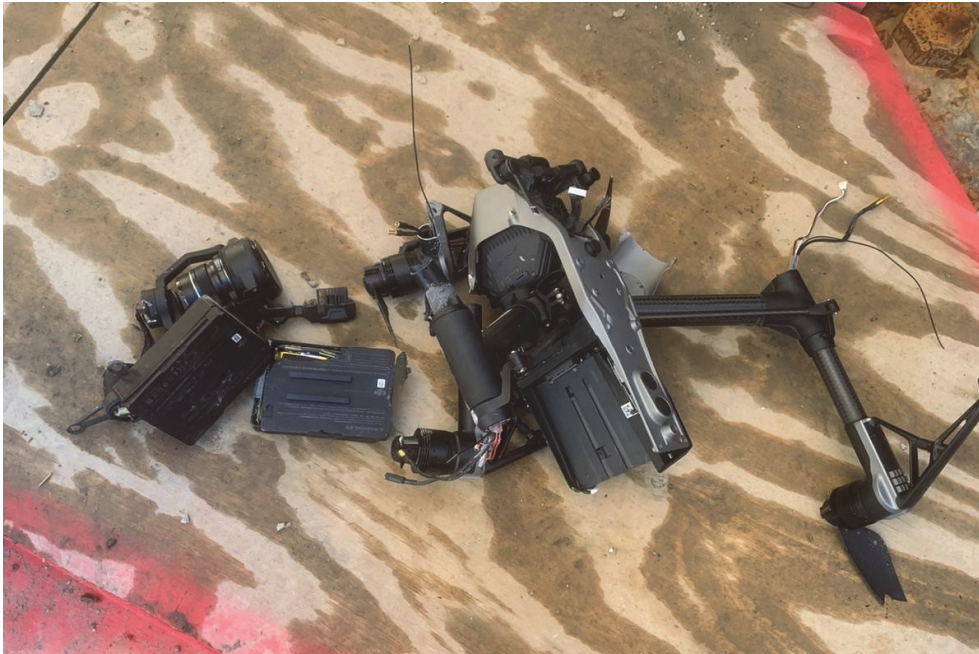
During an operation to take photographs at height on a construction site the drone became erratic. The remote pilot attempted to land the drone immediately, but it became uncontrollable. The remote pilot then attempted to fly the drone away from obstructions, but it collided with a concrete structure on the site and was catastrophically damaged.

Figure 2
Damage to the drone

Due to a position error, as well as poor GPS and compass signal strength, the drone became erratic and uncontrollable after takeoff before colliding with a concrete structure within the sterile zone of the operation.
