Accident

Aircraft Type and Registration:	Chaser S 447, G-MYBU	
No & Type of Engines:	1 Rotax 447 piston engine	
Year of Manufacture:	1992 (Serial no: CH837)	
Date & Time (UTC):	4 July 2019 at 1300 hrs	
Location:	Mendlesham Airfield, Suffolk	
Type of Flight:	Private	
Persons on Board:	Crew - 1	Passengers - None
Injuries:	Crew - 1 (Minor)	Passengers - N/A
Nature of Damage:	Extensive damage to airframe; monopole broken; keel, seat tubes and base bar bent; spats broken.	
Commander's Licence:	National Private Pilot's Licence	
Commander's Age:	56 years	
Commander's Flying Experience:	240 hours (of which 6 were on type) Last 90 days - 8 hours Last 28 days - 2 hours	
Information Source:	Aircraft Accident Report Form submitted by the pilot

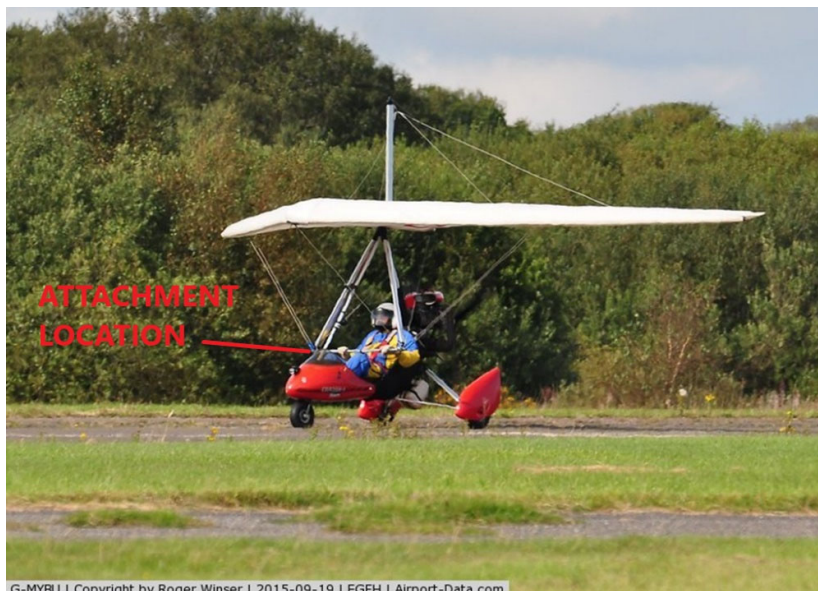
Figure 1
Attachment location

The pilot, who had not owned the aircraft for long, had rigged the aircraft the day before the accident, following a wing cleaning. It was the first time that the pilot had rigged the aircraft, so he asked for assistance from a friend he considered to be very experienced with this type of aircraft. The friend believed he had secured the front strut from the wing structure to the trike body. The strut is secured to the nose of the aircraft by a pin which passes through the tube of the strut and through holes on the mounting point on the aircraft nose (Figures 1 to 3).

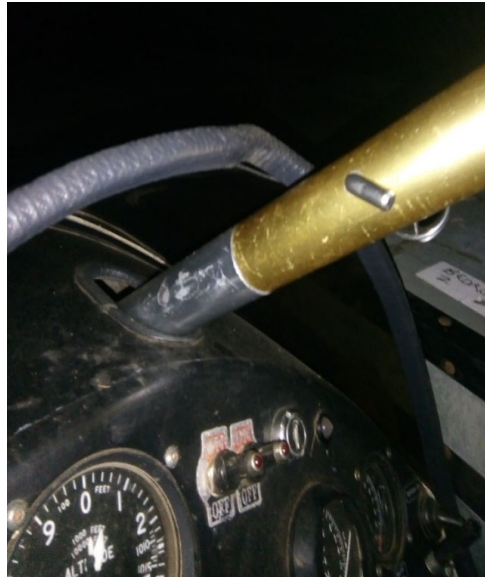
Figure 2
Correct attachment

The front strut is secured to the trike by means of a pin which passes through both the tube of the strut and the attachment point. A correctly routed pin locks the strut to the attachment point, and the correct fastening of the strut is shown in Figure 2.
