AAIB Bulletin

4/2016

Eurocopter AS332 L2 Super Puma	G-WNSB	23-Aug-13	3
--------------------------------	--------	-----------	---

Agusta Bell 206B Jet Ranger III	G-OMDR	27-Jun-14	19
---------------------------------	--------	-----------	----

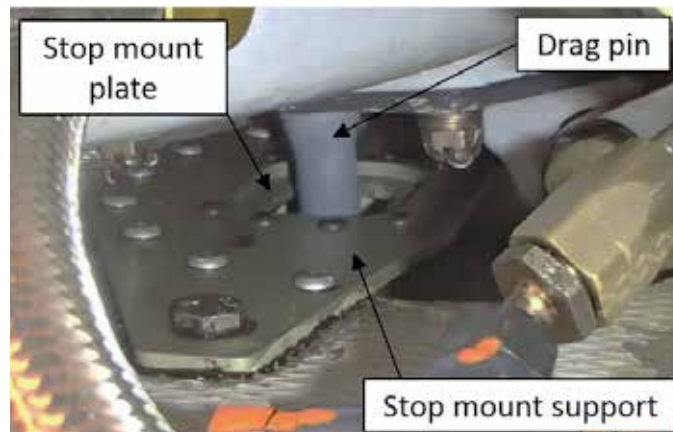
Figure 1

Transmission stop mount assembly (not accident aircraft)

The bottom of the transmission housing features a vertical steel drag pin that projects through an opening in a stop mount assembly (see Figure 1). The stop mount assembly consists of a stop mount plate that is attached to a stop mount support by eight rivets. These rivets are intended to fail in shear and the stop mount plate to detach from the support plate when heavy contact with the drag pin occurs during extreme movement of the main rotor transmission.

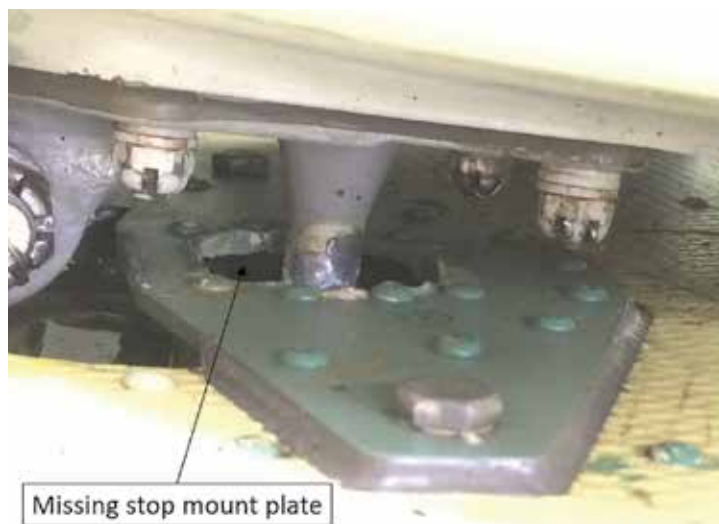
Figure 2

Amongst the photographs the pilot sent by email were images of the transmission drag pin and stop mount, and the main transmission driveshaft, forward coupling and isolation mount. The maintenance manager examined the photographs and, when looking at the stop mount support plate (see Figure 2), he did not see any damage or cracked paint on the domed heads of the attachment rivets. Furthermore, he did not see any disturbance of the sealant between the stop mount support and the fuselage upper deck. He observed that the drag pin attachment hardware appeared undamaged, as did the drag pin itself, apart from some loss of paint on the side of the pin. This, in his experience, was not an abnormal condition. He did not notice the absence of the stop mount plate, which had detached.

Pilot's photograph of damage to transmission drag pin and stop mount assembly

The transmission drag pin had made heavy lateral contact with the stop mount plate and the rivets attaching the stop mount plate to the support plate had failed in shear, releasing the stop mount plate which was found lying loose beneath the support plate. The drag pin's paint finish had been abraded, revealing the bare metal surface beneath.

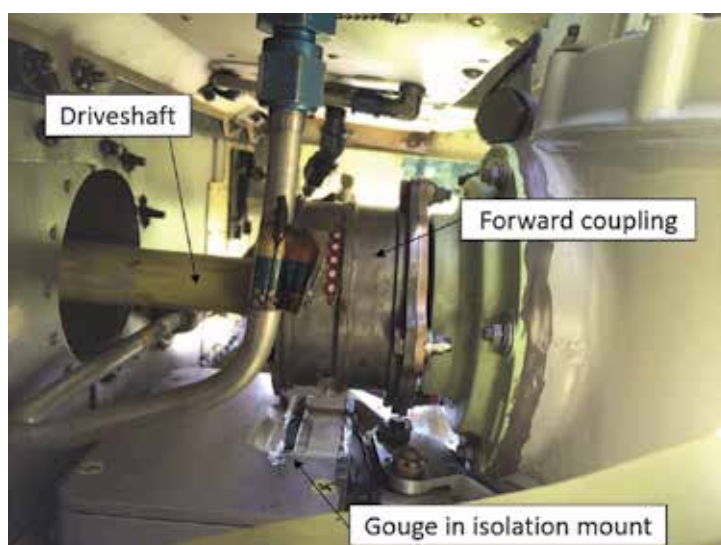
Figure 3

When looking at the driveshaft area (see Figure 3), the maintenance manager observed that the dots on the red temperature indicator stickers, on the forward driveshaft coupling, were white, indicating that the coupling had not been overheated excessively. He noted a gouge in the isolator mount top plate, which was similar in his experience to previous B206 heavy landing events, but he did not ask the pilot to measure the gouge depth and did not refer to the AMM for allowable damage limits. The pilot advised the maintenance manager that the mast was “free to move left and right” and photographs taken by the pilot showed no visible contact marks on the main rotor pitch links or the mast cowling. The maintenance manager verbally approved the helicopter to fly back to Biggin Hill Airport for further examination at the owner's maintenance facility, and no defects were recorded in the helicopter's technical log either before or after these flights.

Pilot's photograph of damage to isolation mount

states that the maximum allowable depth of damage to the isolation mount top cover plate is 0.080" (2.0 mm). The top cover plate thickness is 5.2 mm.

One of the required checks is to inspect the isolation mount for any contact with the main rotor driveshaft coupling and, if the isolation mount is damaged beyond permitted limits, to overhaul the main driveshaft. The Bell 206 Component Repair and Overhaul Manual

Elevated coupling temperature is indicated. Determine probable cause of elevated temperature indication and take corrective action before continued operation. Accomplish checks in steps a. and b. If probable cause is not revealed from steps a. and b., perform steps c. and d. Replace affected TEMP-PLATE⁴.

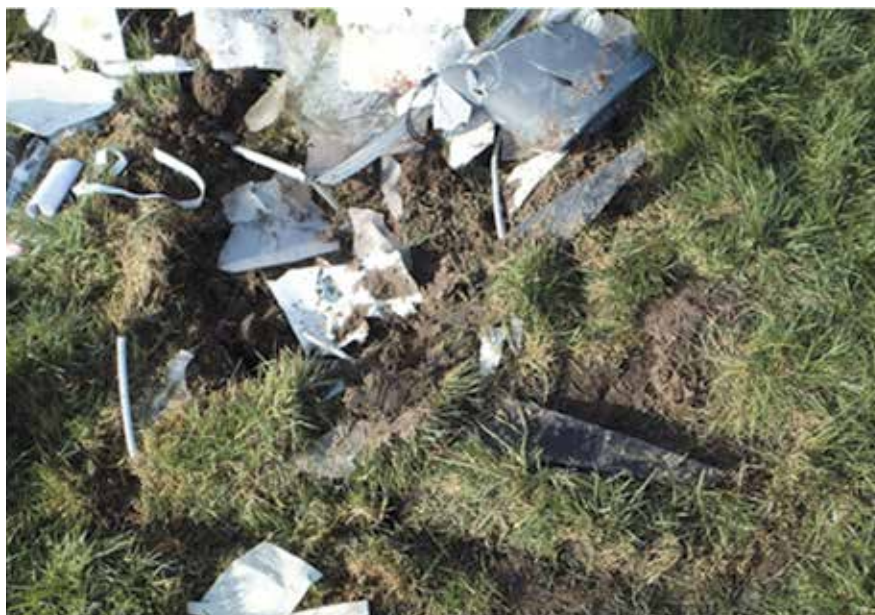
Figure 1

Propeller blades embedded in the ground

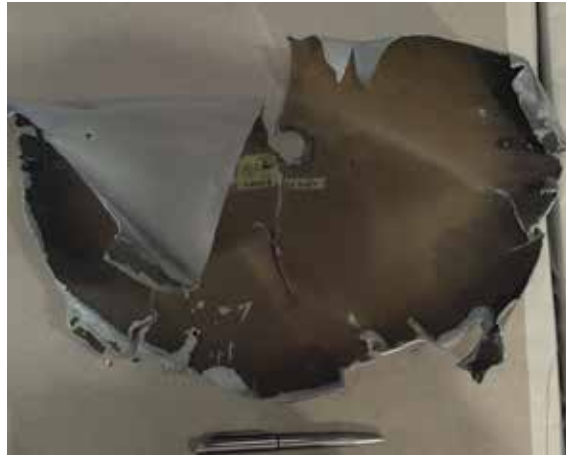
Figure 1

It was discovered that the fenestron unit on the tail of the helicopter had been significantly damaged. The hub cover had detached and was found distorted and lacerated (Figure 1). Also, a damaged piece of metal, measuring approximately 20 cm square, was found nearby. The pilot concluded that this had been sucked into the fenestron duct, hitting the hub cover. The hub then detached and one, or both, of these metal objects appeared to have been ingested by the fenestron fan. The duct surface was deeply cut, the paintwork was badly scraped and the fan blades bore signs of foreign object damage (Figure 2).

Remains of fenestron hub cover

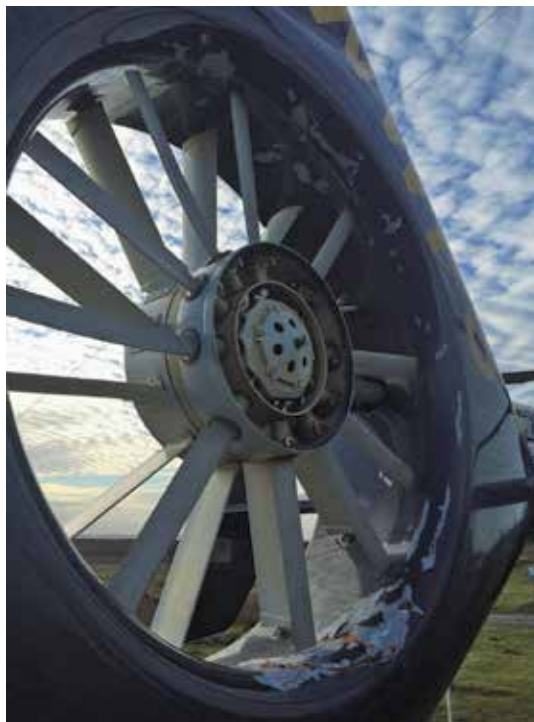
Figure 2

Damaged fenestron duct with hub cover missing
