Near miss with a track worker near Leighton Buzzard, Bedfordshire, 16 June 2020

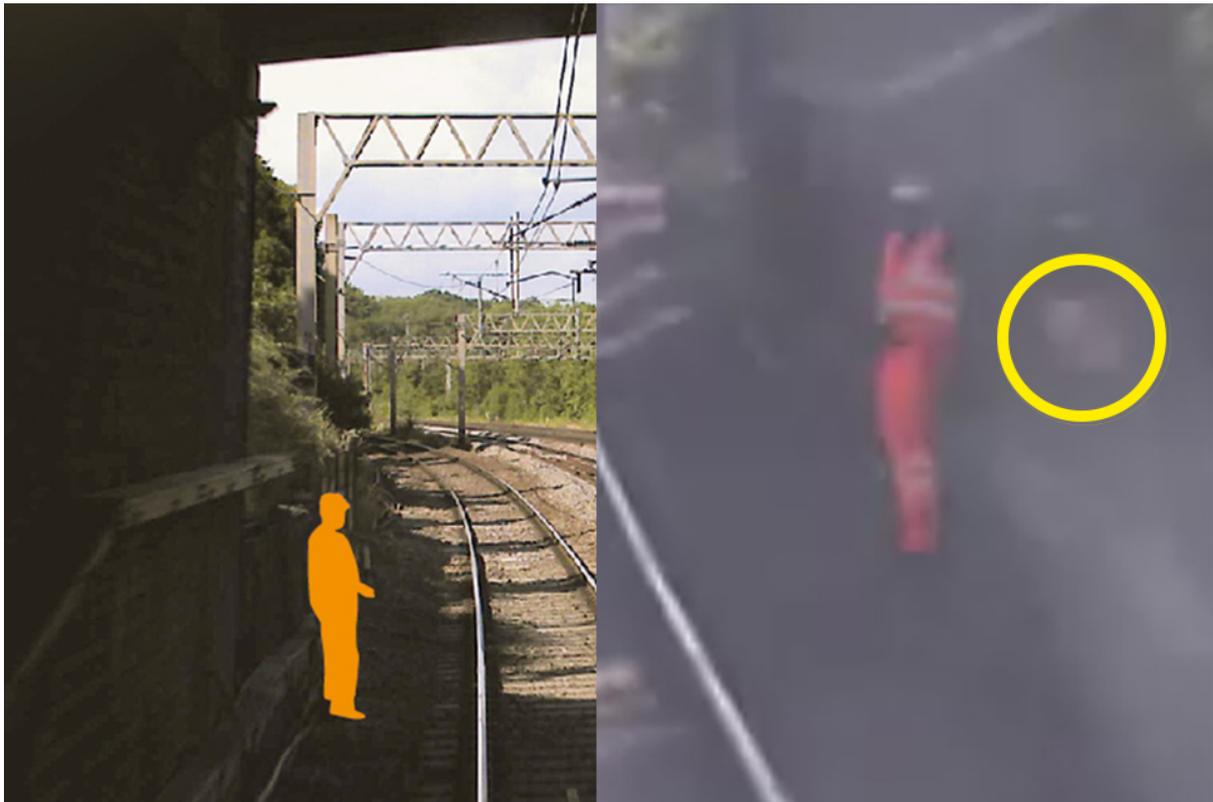
At around 16.20 hrs both workers were seen walking onto the platforms at Leighton Buzzard station (40 miles 14 chains) and then continuing northwards towards Linslade tunnel. When the worker who was walking in the down fast line cess reached the Soulbury Road overbridge (40 miles 30 chains), he became distracted, either by his video equipment or his mobile telephone, and stopped in an area where there was no position of safety, because of the restricted clearance created by the presence of the bridge abutment. The area of restricted clearance is marked by the sign highlighted in the picture below. The Rule Book (Handbook 1, section 10) says that this sign means that there is no position of safety on this side of the railway for the length of the structure it is attached to, and people must not enter or stand at that location when a train is approaching. The track worker had not made any arrangements for protection from moving trains to enable him to pass through this area safely.

At 16:28 hrs the driver of a northbound train, travelling at the permitted line speed of 125 mph (200 km/h), observed the track worker and sounded his horn. The worker was seen to react and move swiftly out of the way of the oncoming train, but not to a defined position of safety, which must be at least 2 metres from the nearest running rail. The train driver stopped his train and reported the near miss to the signaller, who then cautioned other trains in the area. Two Network Rail operations managers were asked to investigate, but they were initially unable to locate anyone in the area and at 17:45 hrs normal working was resumed.

Images from the front (left) and rear (right) facing closed circuit television system of a northbound train taken at 16:28 hrs, showing the position of the track worker within an area of limited clearance, which is denoted by the sign in the yellow circle (images courtesy of Avanti West Coast).
