Construction noise and vibration Monthly Report – June 2020

London Borough of Ealing

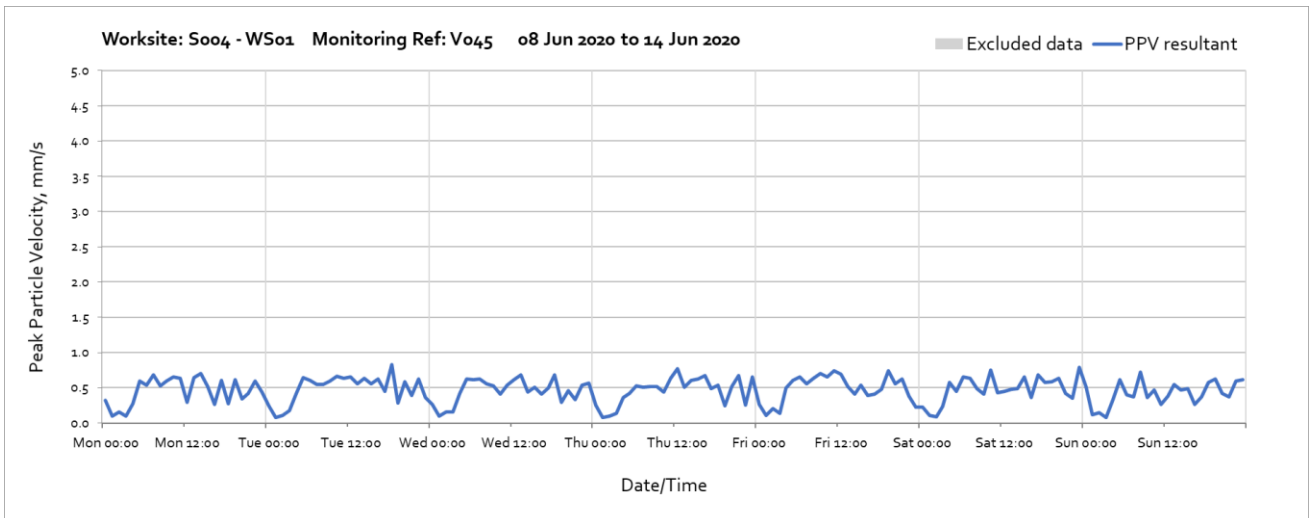
Worksite: S004-WS01 – Monitoring Ref: V045

Note: High vibration levels measured at 12:00 on Wednesday 3rd June were due to local disturbance of the vibration monitor and are not representative of HS2 vibration levels.
