Signals passed at danger due to reduced brake performance, near Crofton West Junction, West Yorkshire, 7 May 2020

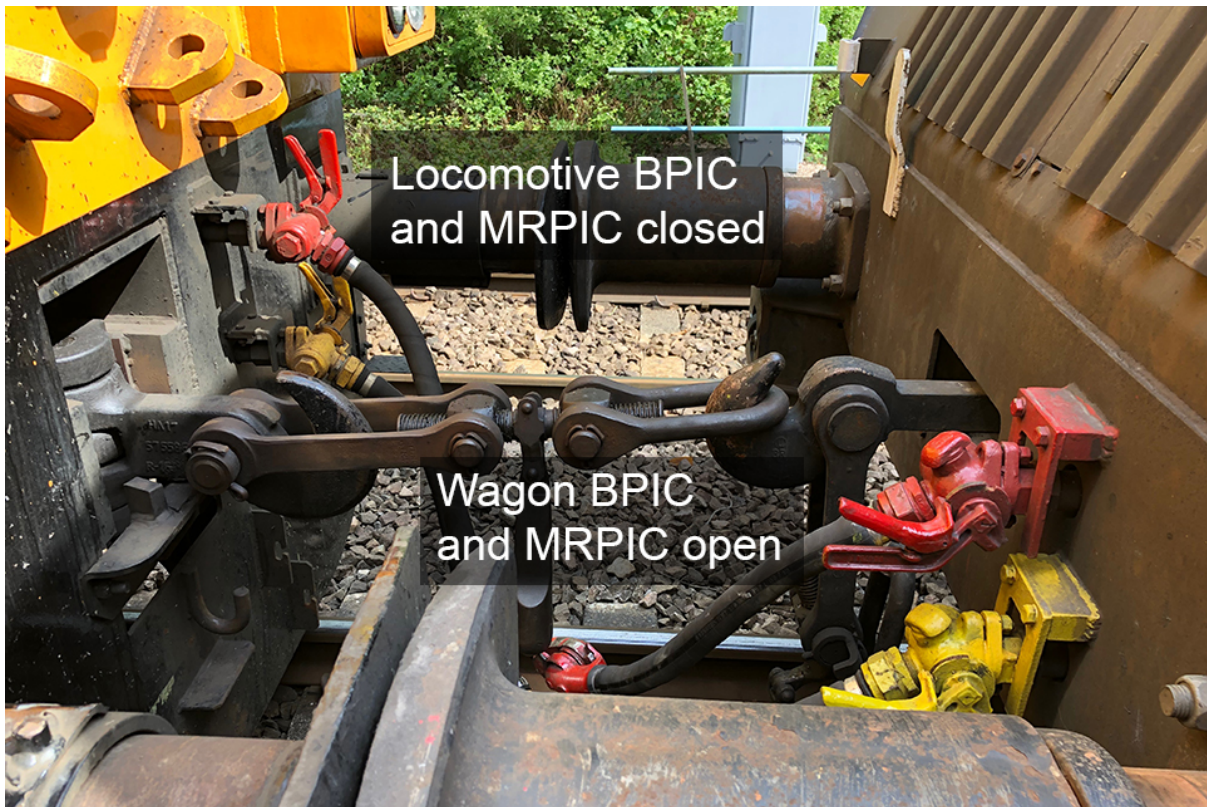
The incident occurred because the brake pipe isolating cock (BPIC) and the main reservoir pipe isolating cock (MRPIC) on the rear of the locomotive had been closed prior to the train departing from Doncaster Down Decoy sidings, with no air pressure in the brake system on the wagons. This meant that none of the brakes on the wagons were operational, and that only the locomotive brakes were available to control the train's speed. An ineffective running brake test failed to alert the driver to this reduced brake performance.

Position of the BPIC and MRPIC after the incident (image courtesy of GB Railfreight)

The BPIC and MRPIC were in the closed position because the train condition was altered after completion of train preparation, and after a successful static brake continuity test.
