ACCIDENT

Aircraft Type and Registration:	Glos-Airtourer 150, G-AXIX	
No & Type of Engines:	1 Lycoming O-320-E2A piston engine	
Year of Manufacture:	1969 (Serial no: A527)	
Date & Time (UTC):	25 March 2020 at 1619 hrs	
Location:	Almeley Wootton, Herefordshire	
Type of Flight:	Private	
Persons on Board:	Crew - 1	Passengers - 1
Injuries:	Crew - None	Passengers - None
Nature of Damage:	Nosewheel, propeller, wing and canopy damaged	
Commander's Licence:	Private Pilot's Licence	
Commander's Age:	73 years	
Commander's Flying Experience:	1,101 hours (of which 760 were on type) Last 90 days - 3 hours Last 28 days - 2 hours	
Information Source:	Aircraft Accident Report Form submitted by the pilot

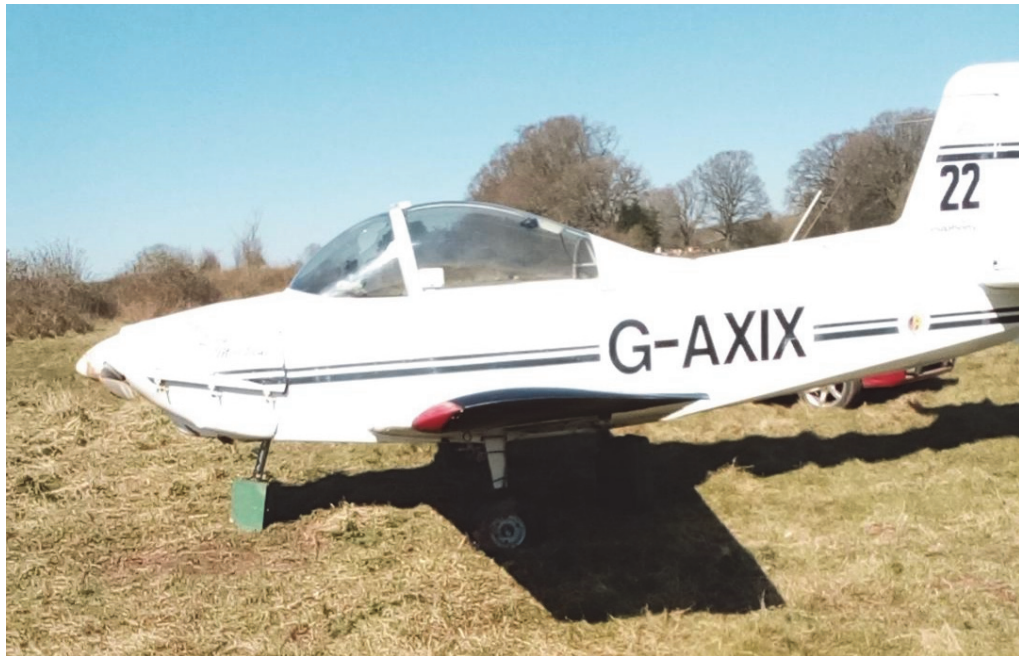
The pilot reported he landed on the main wheels but as the nosewheel touched down the aircraft started to oscillate in pitch. The nosewheel detached, the propeller struck the ground and the aircraft came to a sudden stop. Neither occupant was injured and they were both able to exit the aircraft normally.

The pilot believes the accident was caused by a slightly higher groundspeed than he was use to, due to the lack of headwind, and him closing the throttle slightly early causing the aircraft to drop onto the runway. He was aware he was landing on a short runway so did not want to land too far along it.

The pilot reported that as the aircraft came to a sudden halt the fire extinguisher, which was mounted at the back of the baggage compartment, came loose and travelled past the passenger's head and through the windscreen. When the aircraft is repaired, he intends to relocate the fire extinguisher behind the seats to ensure it is secure.

Figure 1
G-AXIX after the accident
