SERIOUS INCIDENT

Aircraft Type and Registration:	Airbus A319-111, G-EZNM	
No & Type of Engines:	2 CFM56-5B5/P turbofan engines	
Year of Manufacture:	2005 (Serial no: 2402)	
Date & Time (UTC):	11 May 2019 at 0630 hrs	
Location:	En route to Bristol Airport	
Type of Flight:	Commercial Air Transport (Passenger)	
Persons on Board:	Crew - 6	Passengers - 107
Injuries:	Crew - None	Passengers - None
Nature of Damage:	None	
Commander's Licence:	Airline Transport Pilot's Licence	
Commander's Age:	41 years	
Commander's Flying Experience:	9,159 hours (of which 5,737 were on type) Last 90 days - 54 hours Last 28 days - 26 hours	
Information Source:	AAIB Field Investigation

Synopsis

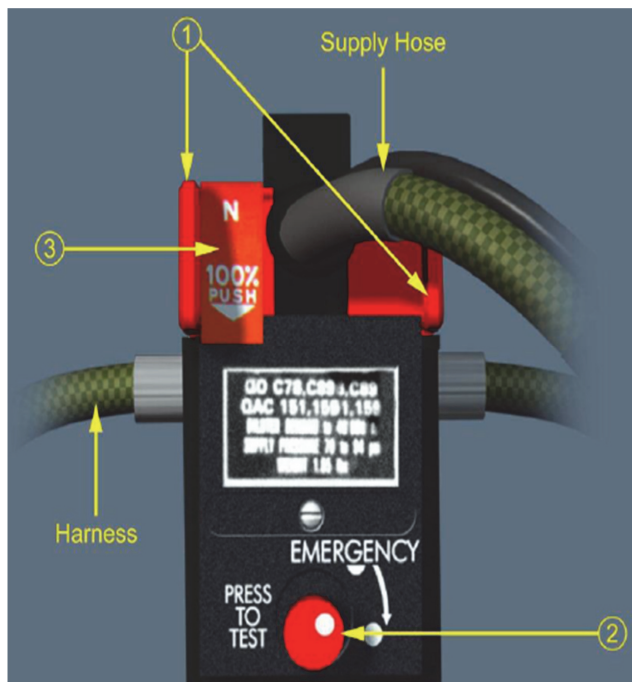
Figure 2
Oxygen regulator controls

Pushing the N/100% (N - normal flow) selector into the 100% position, on the regulator control, supplies 100% oxygen (item 3 in Figure 2). After pushing the N/100% rocker into 100% position, rotating the emergency pressure selector in the direction of the arrow to the EMERGENCY position provides 100% oxygen with an overpressure (item 2 on Figure 2). The overpressure eliminates condensation or fogging of the mask, and prevents smoke, smell or ashes from entering the mask.

Both masks had 100% selected and the emergency pressure selector had not been rotated in the direction of the arrow; a state in which no overpressure was provided.

Both emergency pressure selectors were found not to have been rotated to the EMERGENCY position. The commander was unable to recall if he had selected EMERGENCY. However, if they both had, even for a short period, it is likely the condensation would have been removed, enabling the commander to keep his mask on and breath 100% oxygen during the remainder of the flight. This would probably have improved the physiological condition he reported, which may have been caused by inhaling fumes. Removing the condensation in this way would also have allowed the co-pilot to properly monitor the aircraft's flight path. The option to select EMERGENCY was stated in the QRH checklist. The Flight Crew Operating Manual (though not as readily accessible) contained the additional information that this selection would remove condensation.

The operator has added a practical demonstration on the use of the mask and its selectors during its recurrent training cycle.
