SERIOUS INCIDENT

Aircraft Type and Registration:	Diamond DA 42 NG Twin Star, G-SLCT	
No & Type of Engines:	2 Austro E4-B piston engines	
Year of Manufacture:	2005	
Date & Time (UTC):	4 March 2020 at 1310 hrs	
Location:	Stapleford Aerodrome, Essex	
Type of Flight:	Training	
Persons on Board:	Crew - 2	Passengers - None
Injuries:	Crew - None	Passengers - None
Nature of Damage:	Nosewheel, left and right propellers damaged	
Commander's Licence:	Commercial Pilot's Licence	
Commander's Age:	49 years	
Commander's Flying Experience:	2,312 hours (of which 784 were on type) Last 90 days - 63 hours Last 28 days - 11 hours	
Information Source:	Aircraft Accident Report Form submitted by the pilot

Synopsis

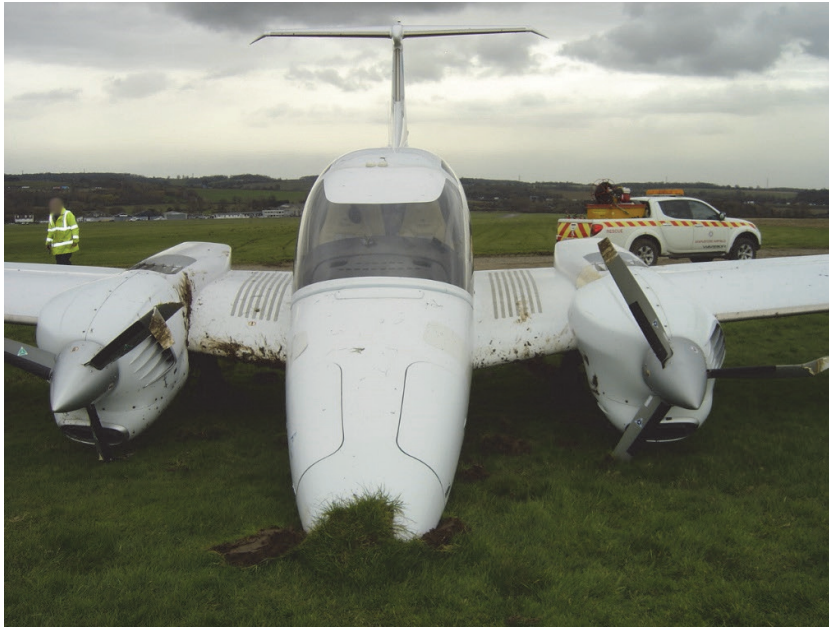
Figure 1

adequate runway remaining to safely complete the takeoff and continued to apply full power to try and accelerate the aircraft, but the airspeed did not increase. Not having achieved the desired increase in airspeed, he closed the throttles and applied gentle braking to bring the aircraft to a controlled stop. During the latter part of the deceleration, the aircraft nosewheel sank into the soft grass and separated from the aircraft. The nose lowered, both propellers struck the ground and the aircraft subsequently came to rest close to the end of the runway (Figure 1 and 2). Both occupants were uninjured and exited the aircraft without assistance.

G-SLCT after coming to rest

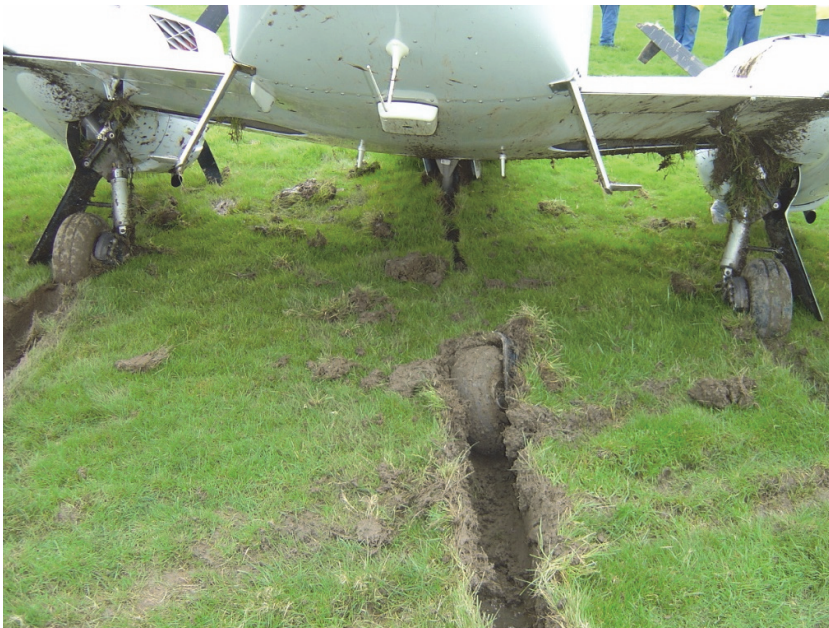
Figure 2

G-SLCT's nosewheel

While performing a touch-and-go the aircraft ballooned on landing, increasing the landing distance required and causing the instructor to take control. During the ensuing takeoff roll the aircraft travelled past the point where the runway surface changed from asphalt to grass. The soft ground conditions on the grass surface prevented the aircraft from accelerating sufficiently to achieve takeoff speed. As the aircraft was being brought to a stop the nosewheel detached.

- Abort the takeoff if the aircraft transitioned, or he assessed that it could transition, onto the grass section of Runway 21L.
- Set the flaps to the approach setting, in accordance with the procedure for short field departures in the aircraft flight manual.
- Not conduct circuit training details if there was no headwind component.
