ACCIDENT

Aircraft Type and Registration:	Cessna 182RG, M-GOLF	
No & Type of Engines:	1 Lycoming O-540-J3C5D piston engine	
Year of Manufacture:	1980 (Serial no: FR18200046)	
Date & Time (UTC):	13 March 2020 at 1449 hrs	
Location:	Private airstrip, Mount Rule, Isle of Man	
Type of Flight:	Private	
Persons on Board:	Crew - 1	Passengers - 1
Injuries	Crew - None	Passengers - None
Nature of Damage:	Damaged beyond economical repair	
Commander's Licence:	Private Pilot's licence	
Commander's Age:	75 years	
Commander's Flying Experience:	600 hours (of which 300 were on type) Last 90 days - 5 hours Last 28 days - 4 hours	
Information Source:	Aircraft Accident Report Form submitted by the pilot

Synopsis

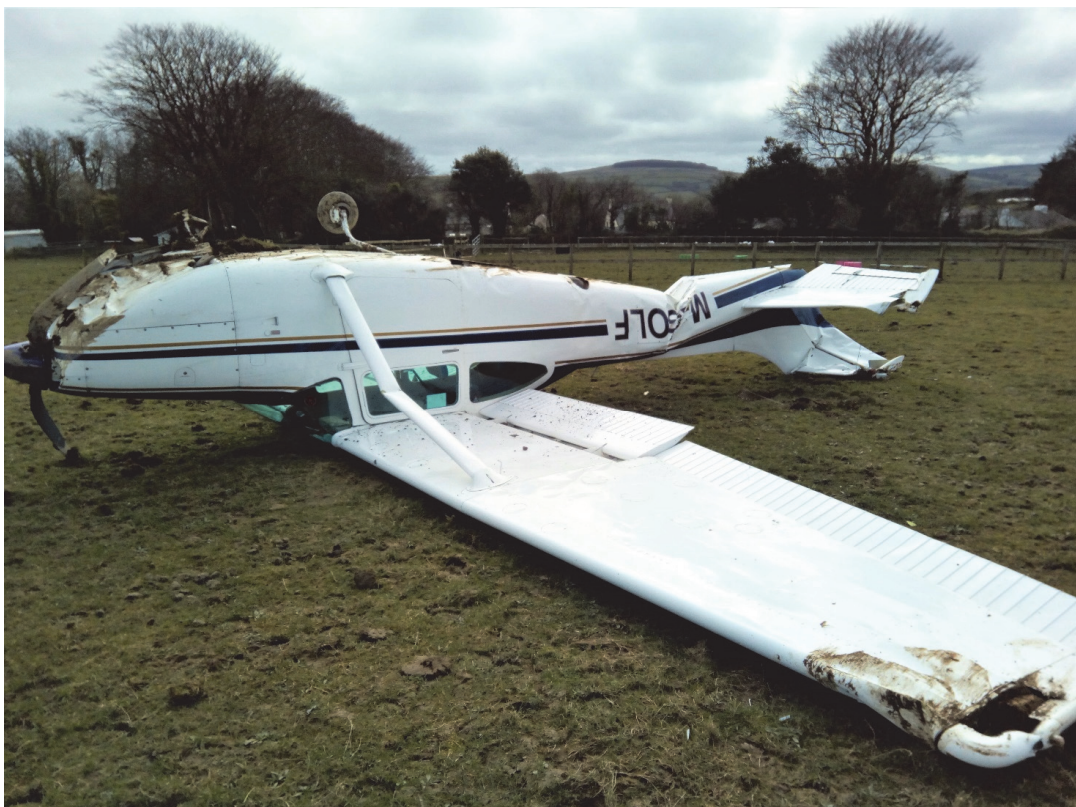
The accident occurred during a baulked landing and go-around. Shortly after touching down the pilot applied full power but reported that the aircraft did not accelerate or climb as expected. The aircraft struck farm gates before touching down in a field where it overturned and came to rest inverted.

The pilot stated that, as the aircraft touched down, he saw a horse appear near the end of the runway¹ and almost immediately initiated a baulked landing. At the same time, the passenger also verbalised the need to go around as the aircraft had landed further along the runway than intended. The pilot stated that he then set the flaps to 20° and advanced the throttle to the full power position but the aircraft did not accelerate as expected. As the aircraft approached the end of the runway it started to become airborne but then hit the farm gates. The aircraft subsequently touched down in the adjacent field where it overturned and came to rest inverted (Figure 1). The pilot and passenger were uninjured and vacated the aircraft unaided, but the aircraft was damaged beyond economic repair.

Figure 1
M-GOLF after the accident
