ACCIDENT

Aircraft Type and Registration:	Britten-Norman Islander, VP-MNI	
No & Type of Engines:	2 Lycoming 0-540-E4C5 piston engines	
Year of Manufacture:	1971 (Serial no: 183)	
Date & Time (UTC):	23 September 2019 at 2020 hrs	
Location:	John A Osborne Airport, Montserrat	
Type of Flight:	Commercial Air Transport (Passenger)	
Persons on Board:	Crew - 1	Passengers - 6
Injuries:	Crew - None	Passengers - None
Nature of Damage:	Left tailplane spar and elevator bent, left wingtip and aileron damaged	
Commander's Licence:	Commercial Pilot's Licence with Montserrat Certificate of Validation	
Commander's Age:	30 years	
Commander's Flying Experience:	660 hours (of which 303 were on type) Last 90 days - 85 hours Last 28 days - 21 hours	
Information Source:	AAIB Field investigation

Synopsis

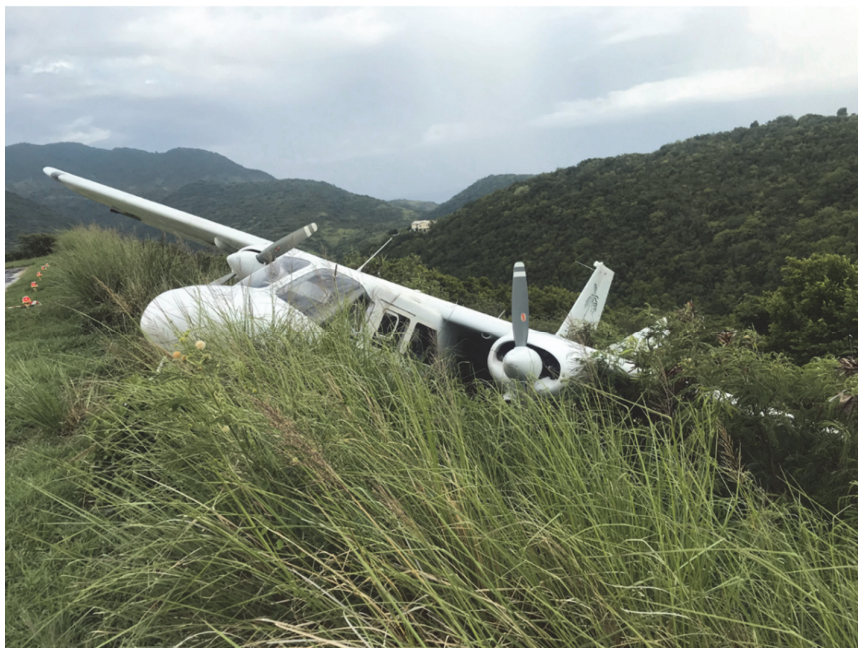
Figure 1
Aircraft accident site

Faint scald marks made by the tyres on the runway showed the aircraft skidded approximately 150 m before veering on to the grass approximately 19 m from the end of the runway. The aircraft continued across the grass whilst braking, leaving discoloured tyre marks in the grass. The right main wheels struck one of the runway threshold lights. During the transit across the grass the aircraft rotated through 180° immediately before dropping backwards down the sloping side of the ravine at the end of the runway. The aircraft's rearward motion was slowed by dense reeds and bushes on the sides of the ravine. It stopped when the left tailplane and wingtip hit the barbed wire and chain link perimeter fence approximately 8 m below the level of the runway. As the aircraft stopped the Bendix-King KX165 Nav-Comm unit fell out of its rack mount onto the cockpit floor. Figure 1 shows the aircraft after the accident held by the fence and at an approximate angle of 30°.

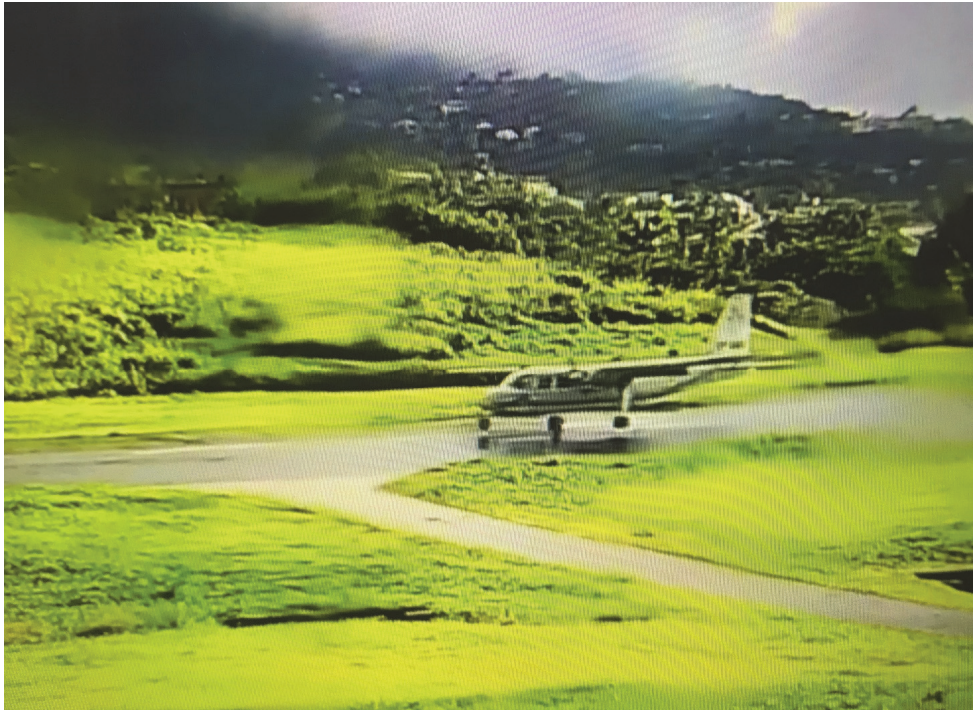
A CCTV camera was mounted on the ATC tower and recorded the latter stages of the final approach and touchdown. From these images, the touchdown groundspeed was estimated to be 79 kt. Figure 2 shows a single frame of the recording at the point of touchdown with the wet runway and water spray being produced by the main landing gear wheels.

VP-MNI at the point of touchdown on Runway 10

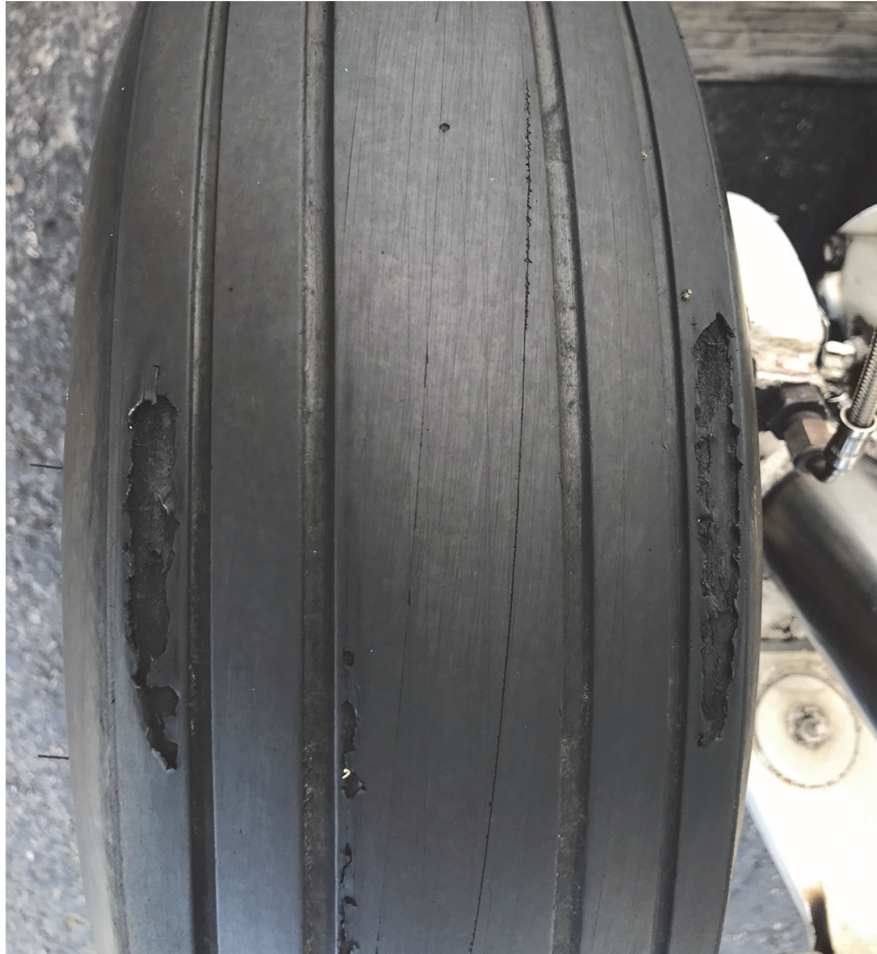
Figure 4
Tyre wear and damage

The landing gear and wheel brakes were undamaged. The tyres did not deflate but the nose and right inner mainwheel had tufts of grass trapped between the tyre bead and rim. Blistering was present on three of the mainwheel tyres; the right outer tyre rolling surface showed evidence of blistering, approximately 75 to 100 mm long, at its edges and to a lesser extent on its centre tread (Figure 4). In general, the tyres showed wear commensurate with normal use.

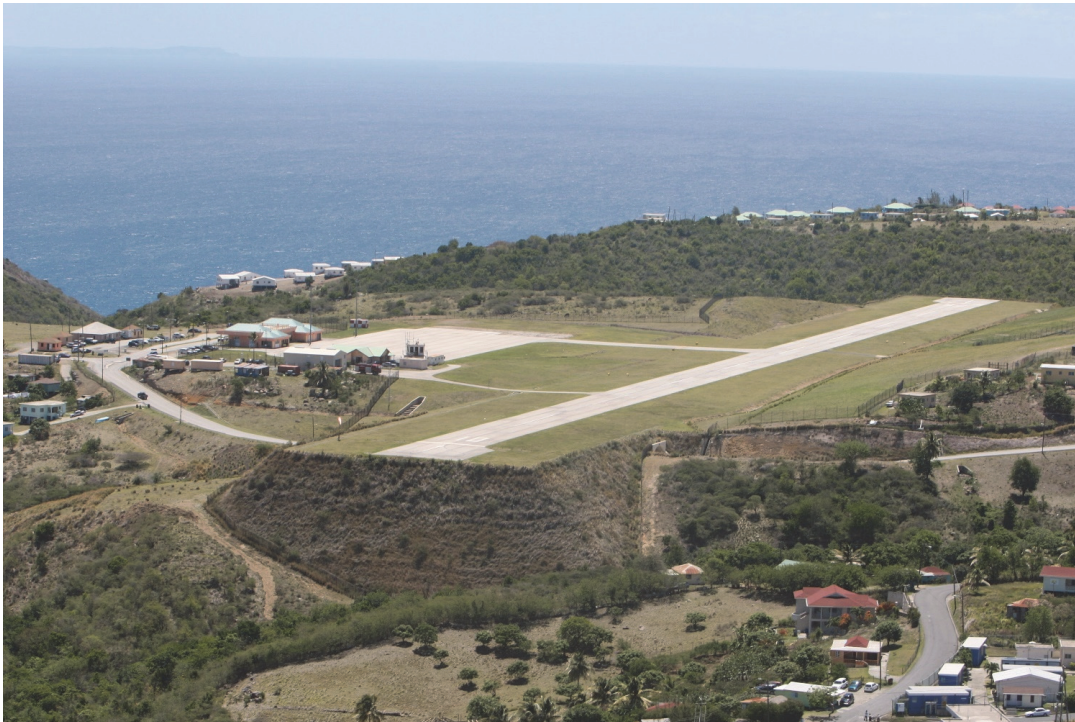
A significant aspect of the airport and its surroundings is the graded, downslopes at both ends of the runway, which in the event of an overrun have the potential to cause damage to an aircraft and injury to those onboard. Runway 28 has a clearway of 277 m and an open departure towards the sea; Runway 10 has a clearway of 70 m over a ravine, at the end of which is a hill rising to 67 ft above the threshold elevation, 350 m from the end of the runway.

Figure 6 shows the airport from south-west of the Runway 10 threshold end, revealing the proximity of the graded bank to the runway end and the hill at the far end.

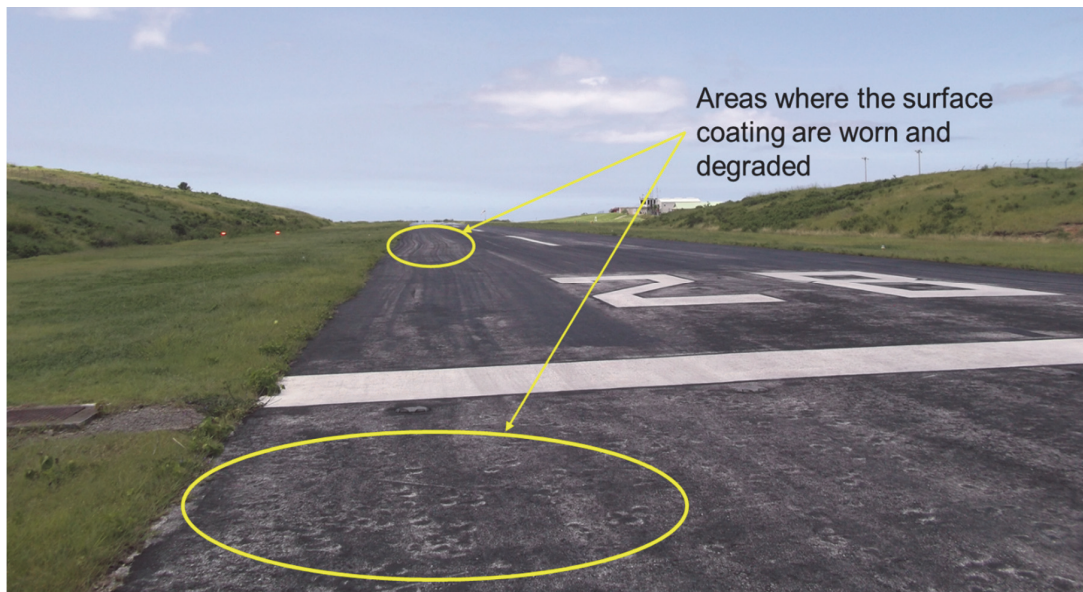
Figure 7

The runway has an asphalt on concrete surface 596 m long and 18 m wide. Over most of the runway surface the asphalt has been applied uniformly but showed evidence of mis-application and wear in some areas, examples of which are shown in Figure 7.

Examples of areas of surface degradation on the runway

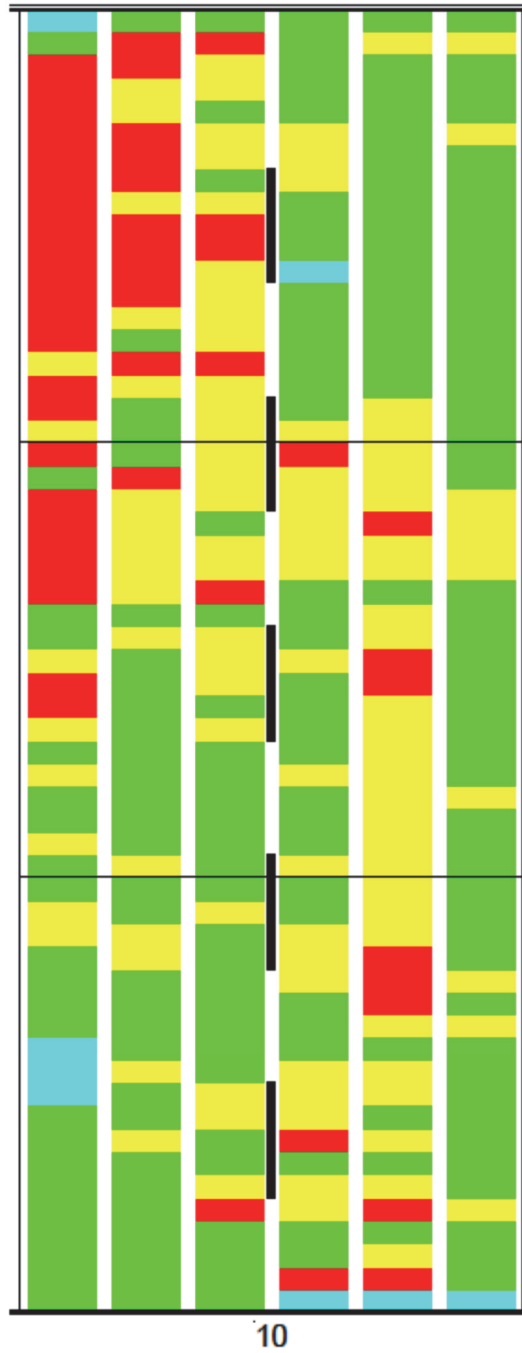
Figure 8

The test on 24 September 2019 showed that 54% of the surface was 'green' with a reading of above 0.63. There was insufficient information available to determine how much, if any, of the surface was also above the minimum design objective level of 0.74. 31% of the surface was 'yellow' with a reading between 0.55 and 0.63, indicating that it was above the minimum of 0.53 below which corrective maintenance activity should be considered. 15% of the surface was 'red' between 0 and 0.55. There was insufficient information available to determine how much of that surface was below the 0.53 maintenance planning level, and how much was below the minimum friction level.

Runway surface friction map (24 Sep 19) and colour key

The Grip Tester map (Figure 8) shows that the friction characteristics of part of the runway may have been below the maintenance planning level or below the minimum friction level, especially to the right of the centre line on Runway 28 adjacent to the '28' marking. Surface friction was not uniform and the surface preparation was wearing out, so plans were in place for resurfacing. A NOTAM was issued warning pilots the runway may be slippery when wet

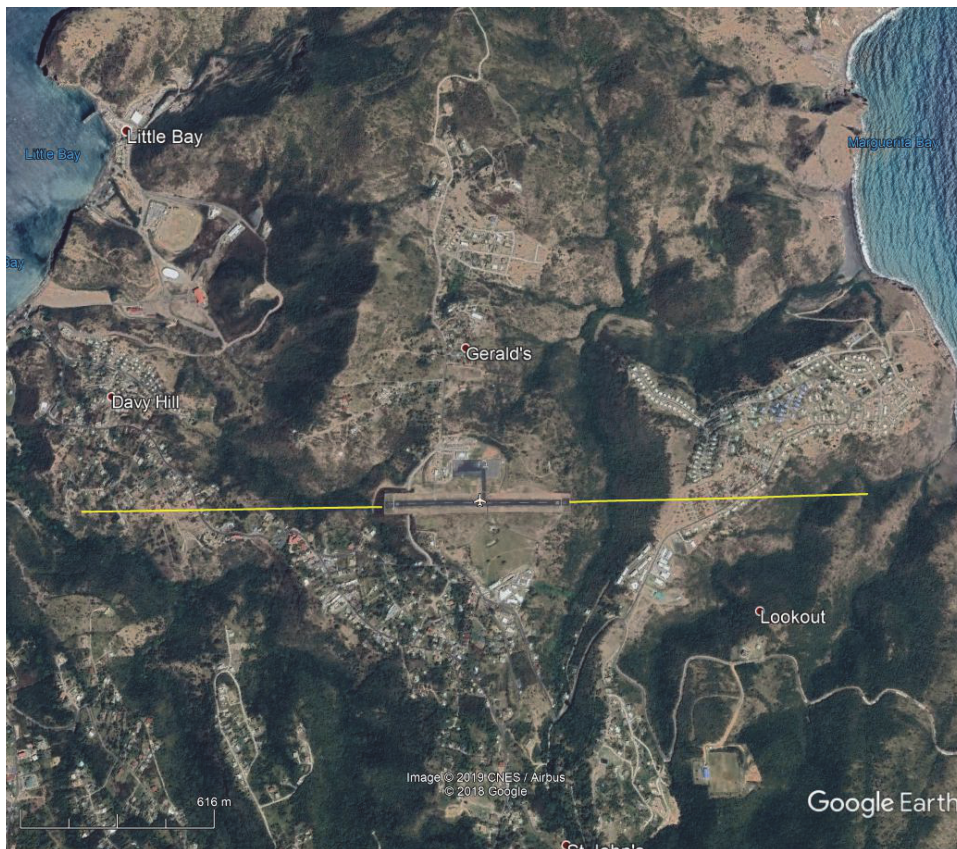
Figure 9

The Runway 10 undershoot can be reached from the airfield boundary from above and by vehicles accessing the base of the slope from below. There are various level or gently sloping areas navigable by RFFS vehicles, and access roads in the immediate area of the base of the slope. The Runway 28 undershoot has a ravine, some 260 m across, and is more difficult for vehicle access, which is limited to the level area of the airport and possibly as far as the security fence. Any other access to the ravine would be by rescue and firefighting personnel only, with hand carried equipment. Figure 9, shows the airport runway (North is at the top of the figure) with the yellow centrelines extending 1,000 m from each runway threshold.

John A Osborne Airport, showing centrelines extended 1,000 m from each runway threshold

It is recommended that the operator of John A Osborne Airport provide adequate access to the Difficult Environs at the east end of Runway 10 to ensure that emergency services can reach expeditiously the location of an aircraft which has overrun the end of the runway.

It is recommended that the operator of John A Osborne Airport install a means of arresting the progress of an aircraft that has overrun either end of the runway in order to minimise the risk of injury to those onboard and to ensure that emergency services can reach them expeditiously.
