ACCIDENT

Aircraft Type and Registration:	AW109SP, G-VIVE	
No & Type of Engines:	2 Pratt & Whitney Canada PW207C turboshaft engines	
Year of Manufacture:	2019 (Serial no: 22393)	
Date & Time (UTC):	4 November 2019 at 1800 hrs	
Location:	Robins Farm, Chiddingfold, Surrey	
Type of Flight:	Private	
Persons on Board:	Crew -1	Passengers -3
Injuries	Crew - None	Passengers - None
Nature of Damage:	Nose landing gear door damaged	
Commander's Licence:	Airline Transport Pilot's Licence	
Commander's Age:	45 years	
Commander's Flying Experience:	3,657 hours (of which 186 were on type) Last 90 days - 26 hours Last 28 days - 12 hours	
Information Source:	Aircraft Accident Report Form submitted by the pilot

Synopsis

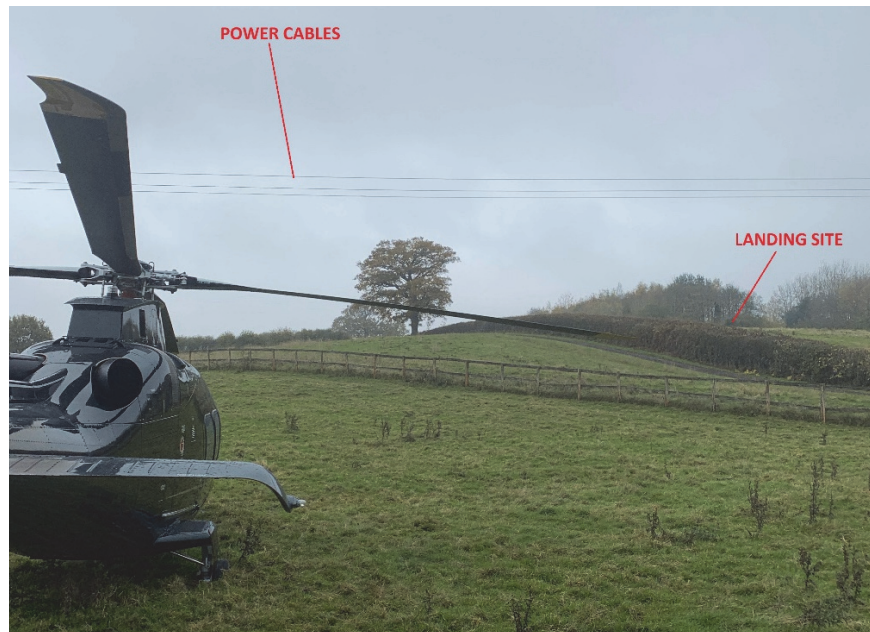
The planned landing site and the aircraft actual landing site are shown at Figure 2.

Figure 2
Landing site photograph

The aircraft is parked on an approximately westerly heading which was also the heading used for the approach.
