## ACCIDENT

<b>Aircraft Type and Registration:</b>	Pegasus Quasar IITC, G-MYJT	
<b>No &amp; Type of Engines:</b>	1 Rotax 582-40 piston engine	
<b>Year of Manufacture:</b>	1993 (Serial no: 6582)	
<b>Date &amp; Time (UTC):</b>	27 August 2019 at 1950 hrs	
<b>Location:</b>	Brindle, Lancashire	
<b>Type of Flight:</b>	Private	
<b>Persons on Board:</b>	Crew - 1	Passengers - None
<b>Injuries:</b>	Crew - 1 (Minor)	Passengers - N/A
<b>Nature of Damage:</b>	Destroyed	
<b>Commander's Licence:</b>	National Private Pilot's Licence (Microlight)	
<b>Commander's Age:</b>	62 years	
<b>Commander's Flying Experience:</b>	349 hours (of which 229 were on type) Last 90 days - 6 hours Last 28 days - 3 hours	
<b>Information Source:</b>	Aircraft Accident Report Form submitted by the pilot and additional enquiries

The aircraft collided with power lines and was destroyed during a precautionary landing at dusk. The pilot departed with little contingency time before night fell and was delayed by navigation difficulty.

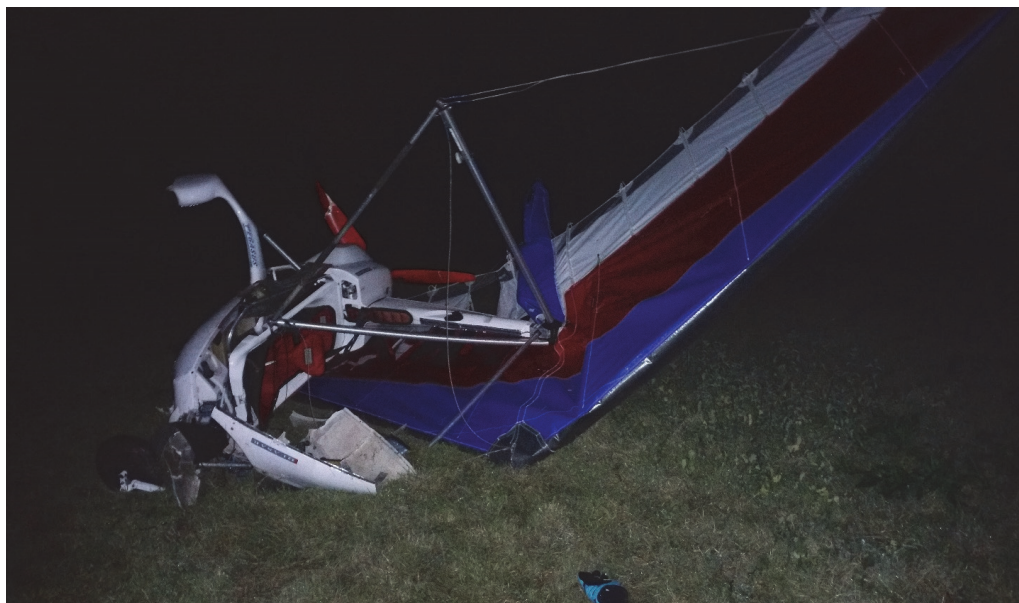
to panic. He decided his only option was to land in a field but in his emotional state he struggled to choose one. Eventually he settled on a field but, due to the low light levels, did not see power lines across the approach. According to the electricity provider, the aircraft struck the power lines at 1950 hrs. The aircraft struck the ground and was destroyed. The pilot was injured but he was able to escape from the aircraft.

**Figure 2**  
G-MYJT after the accident
