ACCIDENT

Aircraft Type and Registration:	LBL 360A balloon, G-LLGE	
No & Type of Engines:	None	
Year of Manufacture:	2013 (Serial no: 1401)	
Date & Time (UTC):	30 April 2019 at 1905 hrs	
Location:	Near Little Sampton, Essex	
Type of Flight:	Commercial Air Transport (Passenger)	
Persons on Board:	Crew - 1	Passengers - 14
Injuries:	Crew - None	Passengers - None
Nature of Damage:	Minor damage to a house	
Commander's Licence:	Commercial Pilot's Licence	
Commander's Age:	61 years	
Commander's Flying Experience:	3,203 hours (of which 176 were on type) Last 90 days - 26 hours Last 28 days - 9 hours	
Information Source:	Aircraft Accident Report Form submitted by the pilot and additional enquiries by AAIB

Synopsis

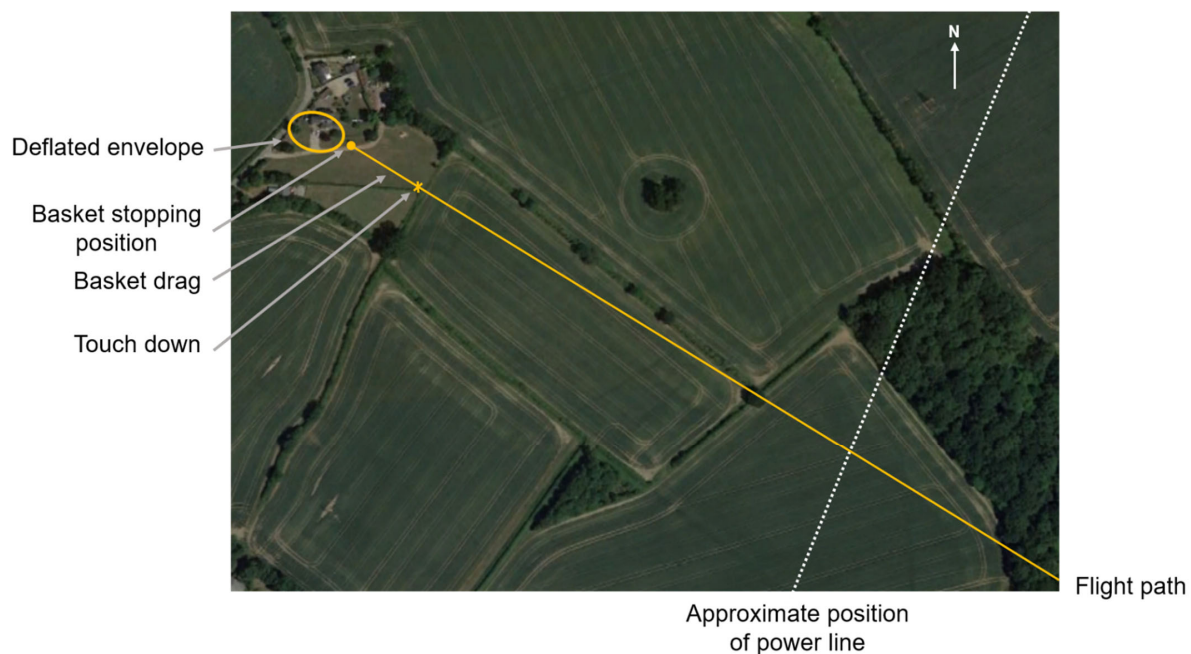
Figure 1
G-LLGE incident site

The pilot sighted a suitable grass landing field beyond a set of high-voltage pylons. Just under 500 m from the intended landing field, the balloon was over the pylons at a height of 166 ft agl with a ground speed of 10 kt. At the field boundary, at 5 ft agl and 8.5 kt ground speed, the pilot deployed the rapid deflation system. The landing was at 2005 hrs BST and the pilot estimated there was 60 m landing distance available. The basket did not stop as quickly as expected and dragged across the field. It stopped on its side just before a tree and the deflating envelope draped over the roof of a house and garage (Figure 1). No one was injured and the basket and envelope were not damaged. There was some minor damage to the property.

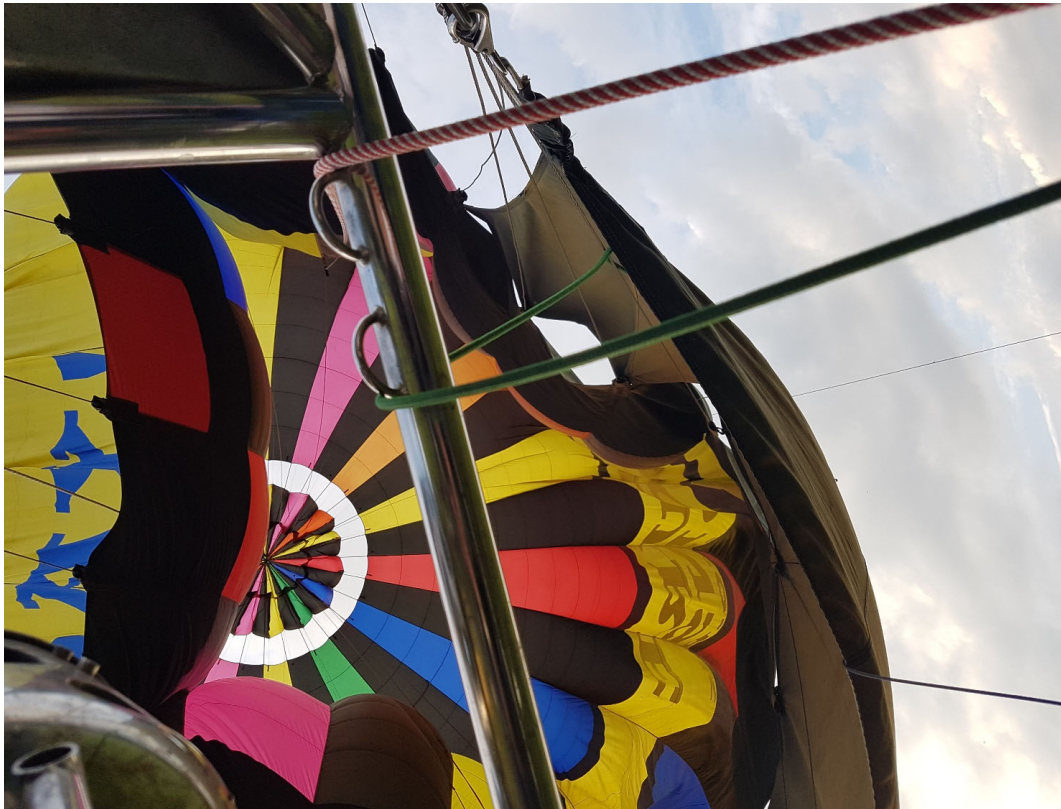
Figure 2

At the end of the 2018 flying season, the pilot reported that the Q-vent system was not able to fully operate because there was not enough slack in the candy stripe line (Figure 2). The red and candy stripe deflation lines are made of poly sheathed Kevlar which shrinks with time due to the heat of the burner and the operating temperature within the envelope.

G-LLGE maximum operation of the rapid deflation system showing the candy stripe line at full stretch taken by the pilot in October 2018. The green line is the turning vent line and is not relevant to the accident.

The chief pilot was experienced at flying an identical balloon and stated that it would have stopped within that distance in similar conditions. After the accident, the pilot and chief pilot inspected the balloon. They both believed that the work to lengthen the candy stripe line had not been successfully completed and that this contributed to the long drag. The chief pilot stated he and the pilot both trusted that the requested work to lengthen the line had been completed because an entry about it had been made in the aircraft logbook.

The pilot completed a landing under pressure of reducing light and low fuel and the balloon stopped too close to obstructions that were draped by the deflating envelope. The balloon may have taken a longer distance to stop than the pilot expected because the rapid deflation system did not operate fully due to insufficient slack in one of the control lines. The operator and pilot interpreted an entry in the maintenance paperwork as indicating work had been done as requested to lengthen the line. The pilot performed a pre-flight check of the rapid deflation system but a full check of the operation of the rapid deflation system was not performed. The second part of the pre-flight check is to *'Ensure that there is sufficient slack in the parachute line to allow it to feed into the envelope as the red rapid deflation line is pulled.'* In practice, this is difficult to judge visually because the parachute (candy stripe) line has a large amount of slack in it. The pilot had flown the balloon since the maintainer's work on it but had not needed to use full rapid deflation. This system is rarely used to its full extent because it is only required in stronger wind conditions. It is inconvenient to check pre-flight because of the risk of deflating the balloon when doing so. There was no way to determine whether the control line lengthening work had been satisfactorily completed without fully operating the rapid deflation system.

The operator asked for their maintenance organisation to rectify this alongside the certificate of airworthiness renewal performed in December 2018. The Certificate of Release to Service form stated 'Allow spare out of candy stripe end termination' suggesting that an adjustment had been made as requested.
