ACCIDENT

Aircraft Type and Registration:	Robinson R44 II Raven II, G-LLIZ	
No & Type of Engines:	1 Lycoming IO-540-AE1A5 piston engine	
Year of Manufacture:	2008 (Serial no: 12140)	
Date & Time (UTC):	2 October 2019 at 1058 hrs	
Location:	Sherburn-in-Elmet Airfield, Yorkshire	
Type of Flight:	Training	
Persons on Board:	Crew - 1	Passengers - None
Injuries:	Crew - 1	Passengers - N/A
Nature of Damage:	Beyond economic repair	
Commander's Licence:	Student	
Commander's Age:	34 years	
Commander's Flying Experience:	47 hours (of which 2 were on type) Last 90 days - 8 hours Last 28 days - 5 hours	
Information Source:	Aircraft Accident Report Form submitted by the pilot

Synopsis

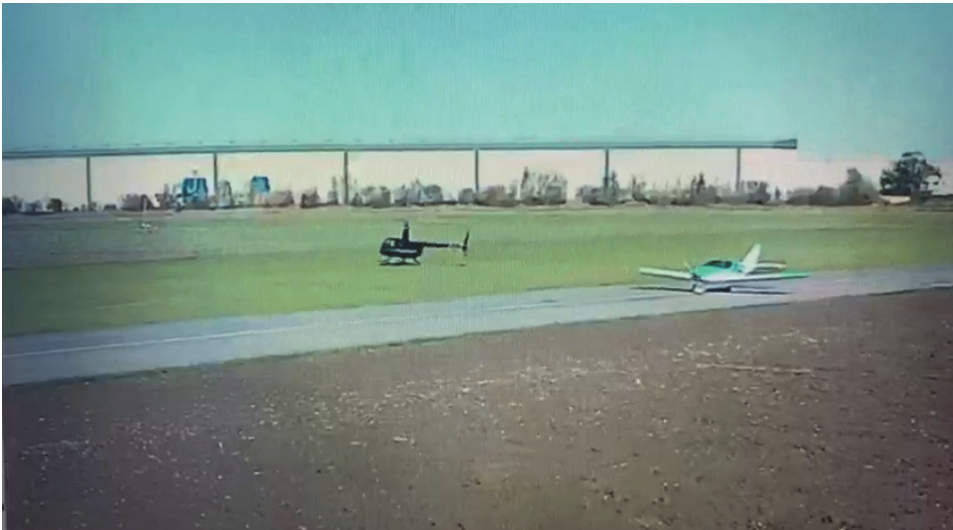
Figure 1

G-LLIZ begins to pitch nose up

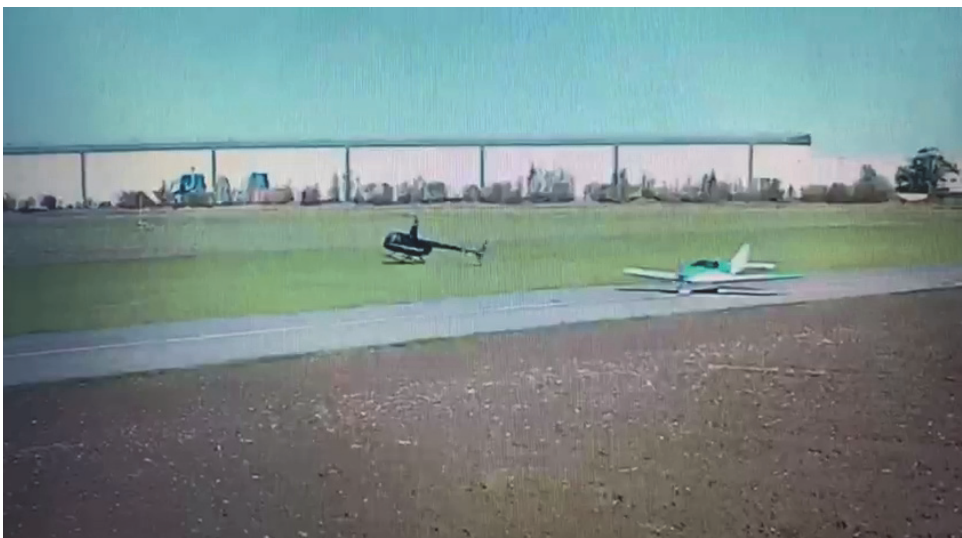
Figure 2

The tail stinger contacts the ground

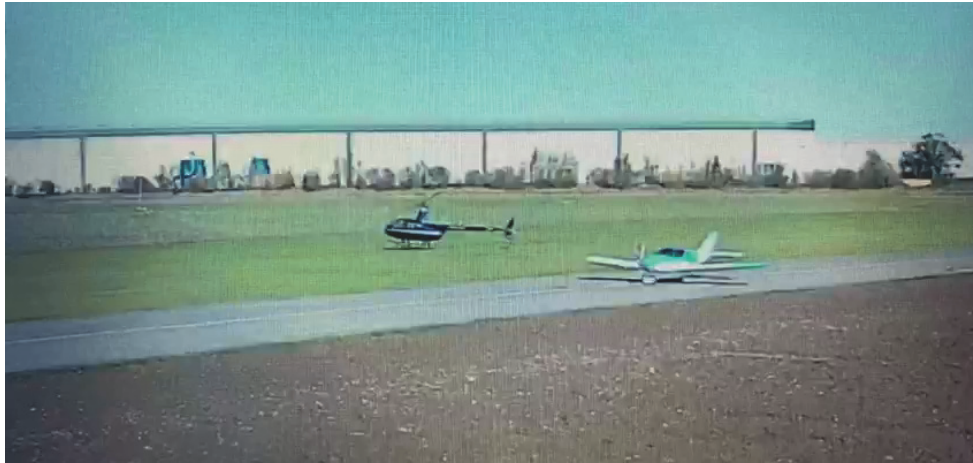
Figure 3
G-LLIZ begins to yaw to the left

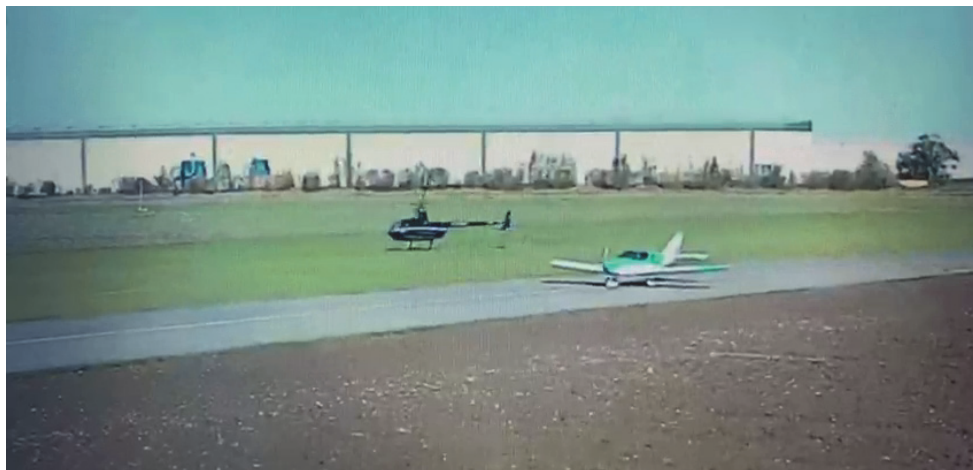
Figure 4
G-LLIZ yaws to the left and begins to roll right

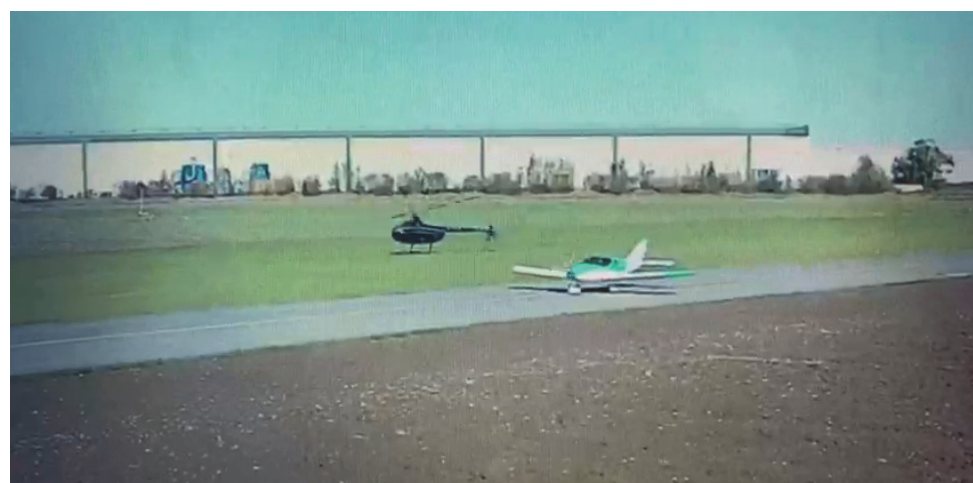
Figure 5
First blade impacts the ground

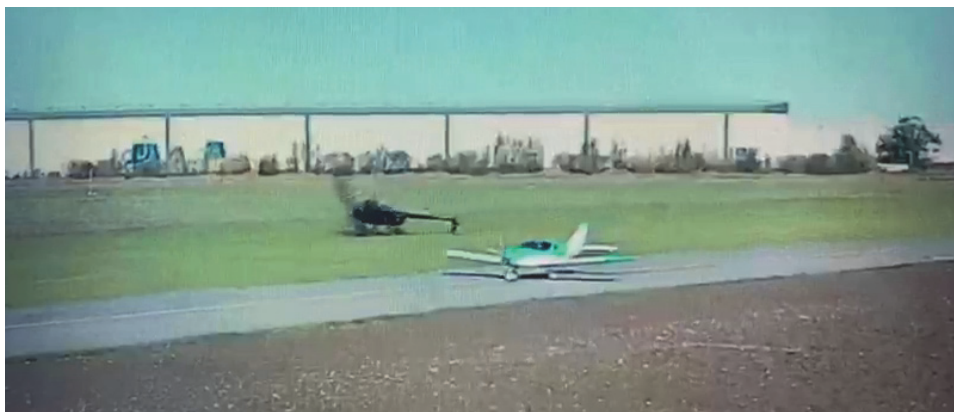
Figure 6
Second blade impact

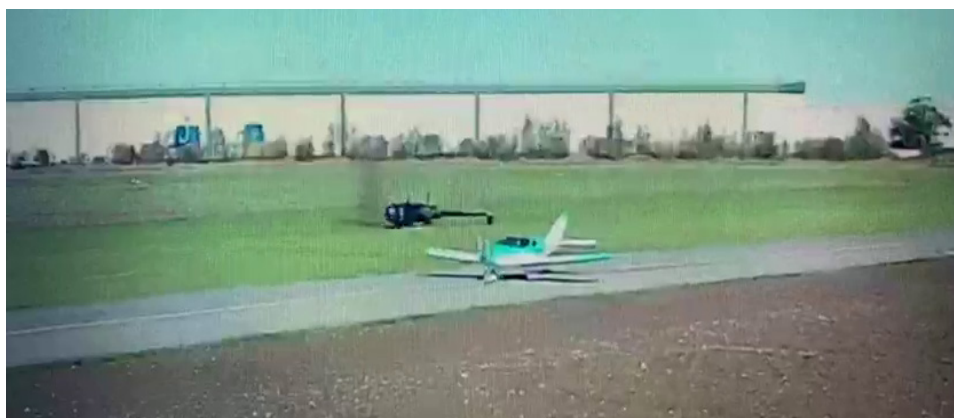
Figure 7
G-LLIZ comes to rest on its right side

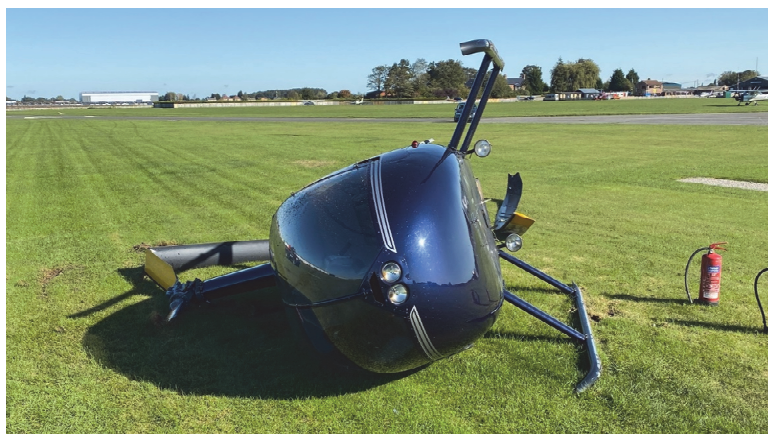
The pilot was able to vacate the helicopter via the left door although he had suffered a head injury. The helicopter was damaged beyond economic repair. Figure 8 shows G-LLIZ after the accident.

Figure 8
G-LLIZ after the accident
