ACCIDENT

Aircraft Type and Registration:	Aeroprakt A22-LS Foxbat Supersport 600, G-CHSY	
No & Type of Engines:	1 Rotax 912ULS piston engine	
Year of Manufacture:	2013 (Serial no: LAA 317B-15186)	
Date & Time (UTC):	16 July 2019 at 1515 hrs	
Location:	Otherton Hall Farm, Staffordshire	
Type of Flight:	Private	
Persons on Board:	Crew - 1	Passengers - 1
Injuries:	Crew - 1 (Serious)	Passengers - 1 (Serious)
Nature of Damage:	Aircraft destroyed	
Commander's Licence:	Private Pilot's Licence (Aeroplanes)	
Commander's Age:	67 years	
Commander's Flying Experience:	621 hours (of which 524 were on type) Last 90 days - 8 hours Last 28 days - 6 hours	
Information Source:	Aircraft Accident Report Form submitted by the pilot and further enquiries made by the AAIB

Synopsis

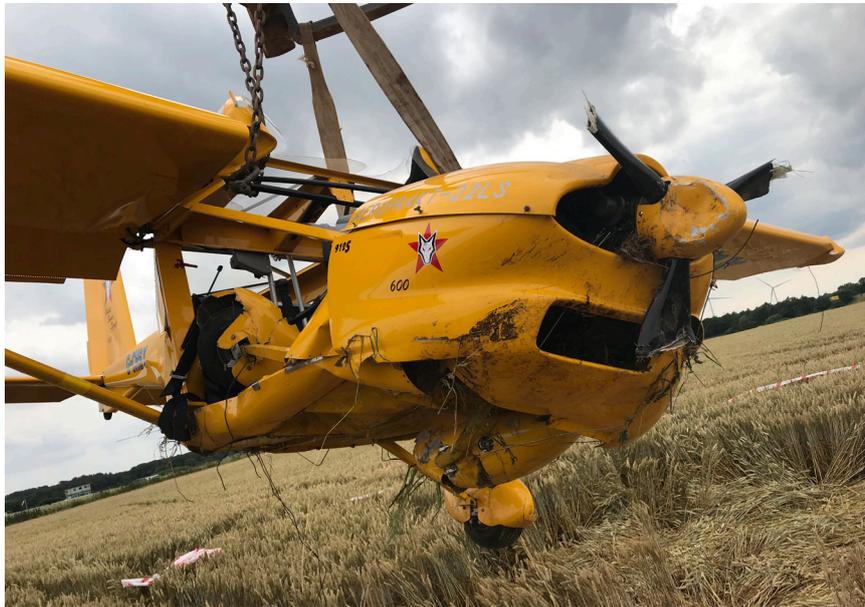
Figure 1

Photographs showed that the aircraft came to rest upright in a crop field immediately beyond the end of the runway. They indicated that the aircraft struck the ground with very little forward speed and with the right wing low. Damage sustained by the propeller indicated that it was turning when the aircraft hit the ground.

General view of damage sustained in the accident
