## ACCIDENT

<b>Aircraft Type and Registration:</b>	1) Learjet 31, N127VL 2) Cessna T206H, N35014
<b>No &amp; Type of Engines:</b>	1) 2 Garrett TFE731-2-3B turbofan engines 2) 1 Lycoming IO-540-AC1A piston engines
<b>Year of Manufacture:</b>	1) 1991 2) 2002
<b>Date &amp; Time (UTC):</b>	4 January 2020 at 1416 hrs
<b>Location:</b>	Terence B Lettsome Airport, British Virgin Islands
<b>Type of Flight:</b>	1) Commercial Air Transport (Passenger) 2) Private
<b>Persons on Board:</b>	1) Crew - 2                      Passengers - None 2) Crew - None                Passengers - None
<b>Injuries</b>	1) Crew - None                Passengers - N/A 2) Crew - N/A                Passengers - N/A
<b>Nature of Damage:</b>	1) None reported 2) Small tear on rudder trailing edge
<b>Commander's Licence:</b>	1) Airline Transport Pilot's Licence 2) N/A
<b>Commander's Age:</b>	1) 62 years 2) N/A
<b>Commander's Flying Experience:</b>	1) 8,415 hours (of which 1,744 were on type) Last 90 days - 38 hours Last 28 days - 18 hours 2) N/A

## Synopsis

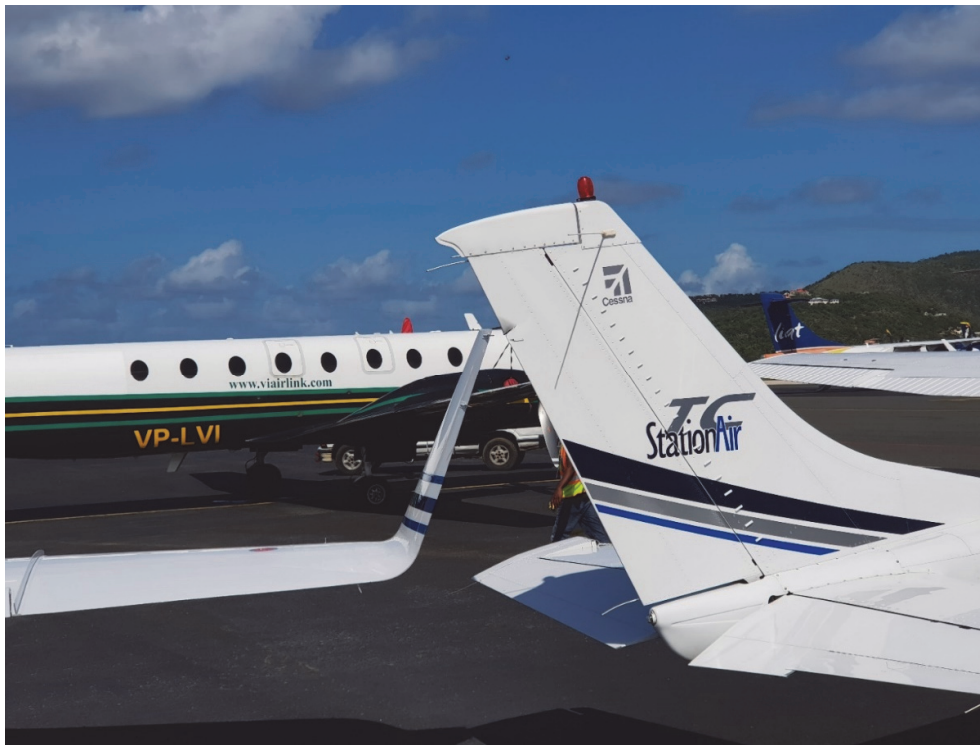
**Figure 1**

During a turn while under the direction of ground staff, the winglet of the Learjet 31 struck the tail of a parked Cessna T206H causing minor damage to the Cessna's rudder.

The winglet of the Lear jet contacted the rudder of the Cessna
