**SERIOUS INCIDENT**

<b>Aircraft Type and Registration:</b>	Boeing 747-436, G-CIVU
<b>No &amp; Type of Engines:</b>	4 Rolls-Royce RB211-524G2-T-19 turbofan engines
<b>Year of Manufacture:</b>	1998 (Serial no: 25810)
<b>Date &amp; Time (UTC):</b>	20 December 2019 at 1543 hrs
<b>Location:</b>	London Heathrow Airport
<b>Type of Flight:</b>	Commercial Air Transport (Passenger)
<b>Persons on Board:</b>	Crew - 17                      Passengers - 328
<b>Injuries:</b>	Crew - None                      Passengers - None
<b>Nature of Damage:</b>	Damage to the No 1 engine cowl and to the rear of a fuel transfer vehicle
<b>Commander's Licence:</b>	Airline Transport Pilot's Licence
<b>Commander's Age:</b>	60 years
<b>Commander's Flying Experience:</b>	28,400 hours (of which 14,800 were on type) Last 90 days - 201 hours Last 28 days - 56 hours
<b>Information Source:</b>	Aircraft Accident Report Form submitted by the pilot, reports submitted by the operator, the refuelling company and the airport authority, and further enquiries by the AAIB

**Synopsis**

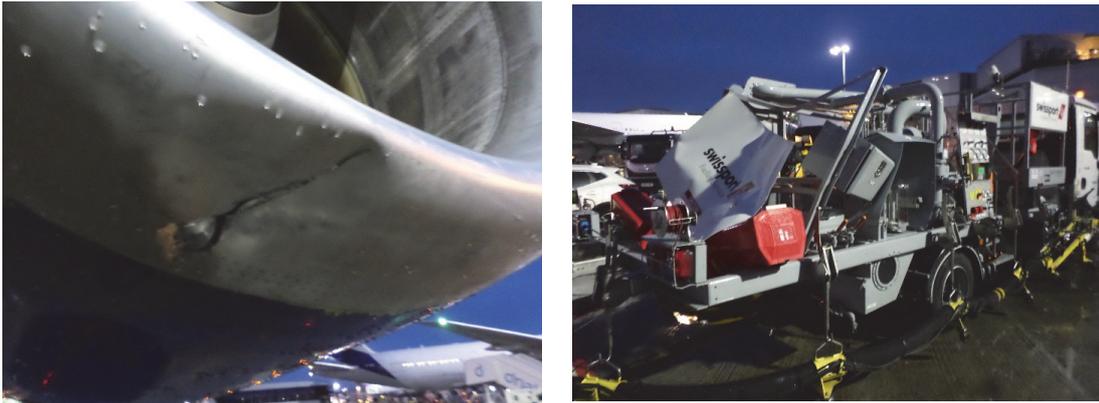
**Figure 1**

Damage to the aircraft and FTV are shown in Figure 1. Both were repaired and returned to service.

Damage to G-CIVU No 1 engine cowl and rear of the Fuel Transfer Vehicle

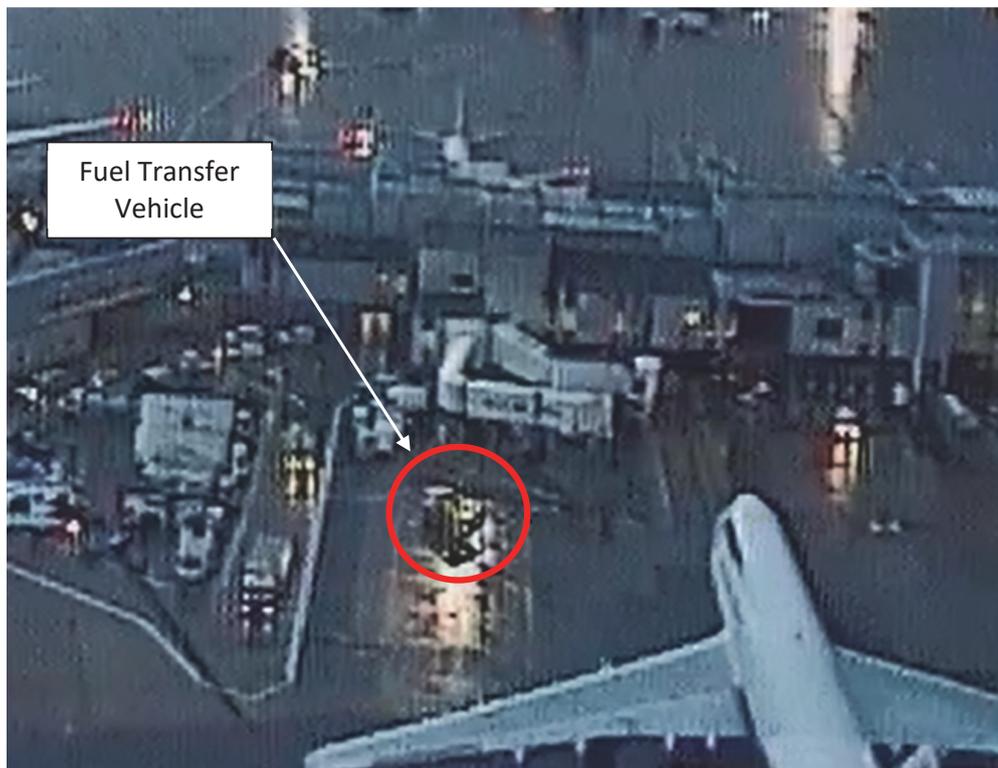
**Figure 2**

CCTV showed the Airbus commence push back at 1539 hrs. The FTV can be seen parked by the Airbus's left wingtip. The supervisor can be seen walking the centreline behind the pushback tug. The collision occurred at 1543 hrs. Figure 2 shows an image from the CCTV just prior to the collision.

CCTV image showing the B747 approaching the stand and the parked FTV

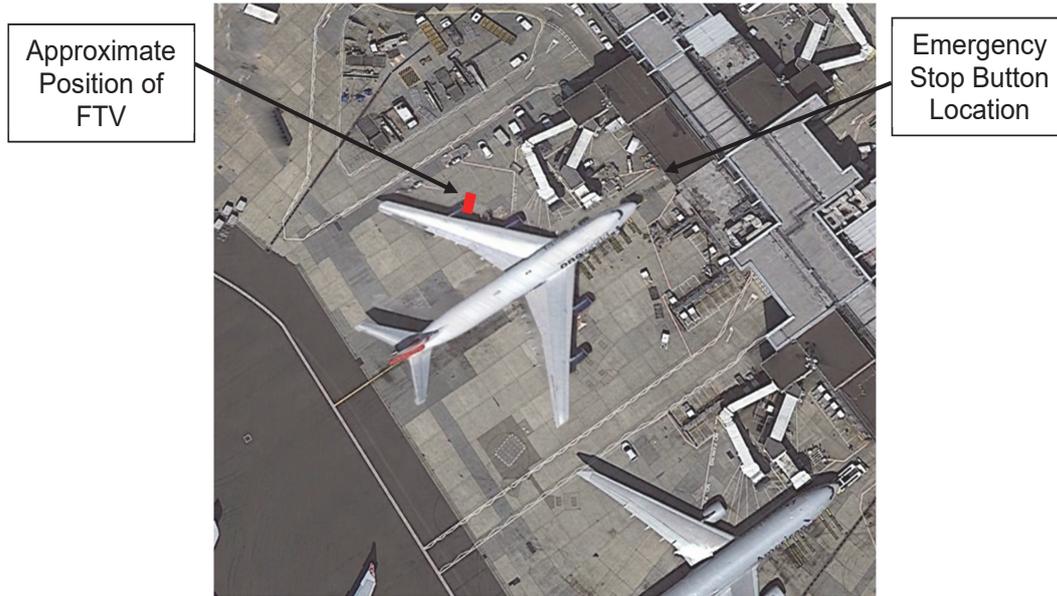
**Figure 3**

Figure 3 shows an aerial view of Stand 331 at Heathrow with a Boeing 747 superimposed on the image. The approximate position of the FTV when the collision occurred is shown.

Aerial view of Stand 331 with B747 superimposed

The airport authority has changed the parking arrangement on Stand 331 to prevent vehicles obscuring the view from the head of stand.

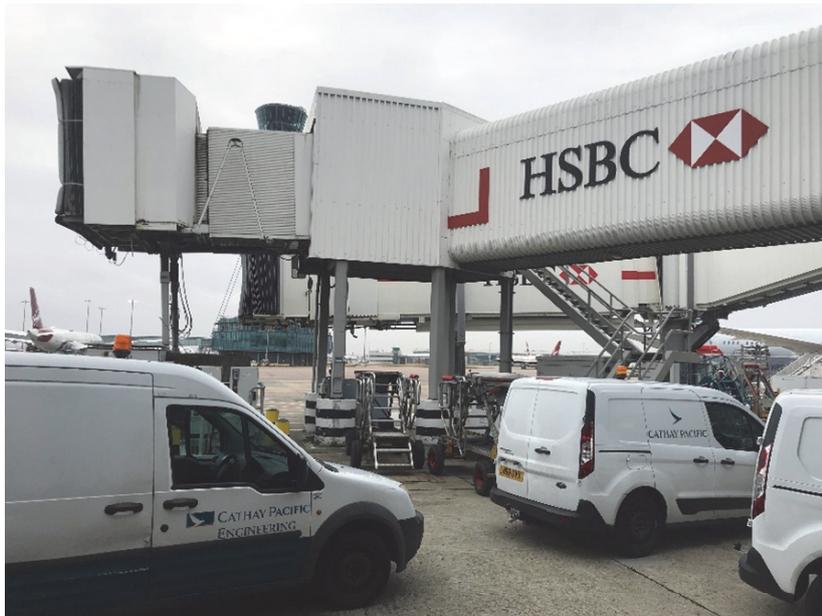
**Figure 4**

Figure 4 is a photograph taken from the emergency stop button position at the head of the stand looking towards the right where the FTV was parked. The photograph shows the obscured view in that direction.

View to the right of the stand from Emergency Stop Button Location

The ground staff remained near the emergency stop button during the arrival, but they could not see the FTV from this position. The jetty structure and parked vehicles obscured part of the stand from the stop button position. The operator will take the following safety action:

The operator will establish a procedure to ensure all visually restricted stands have a 'mid-man', in the line of sight, to act as an additional pair of eyes for the colleague manning the emergency stop button at the head of the stand.

The airport authority is undertaking a review of the emergency stop button locations on all stands.
