Report on the investigation of the grounding
and recovery of the container feeder vessel

Thea II

Svitzer Josephine

in the approaches to the Humber Estuary

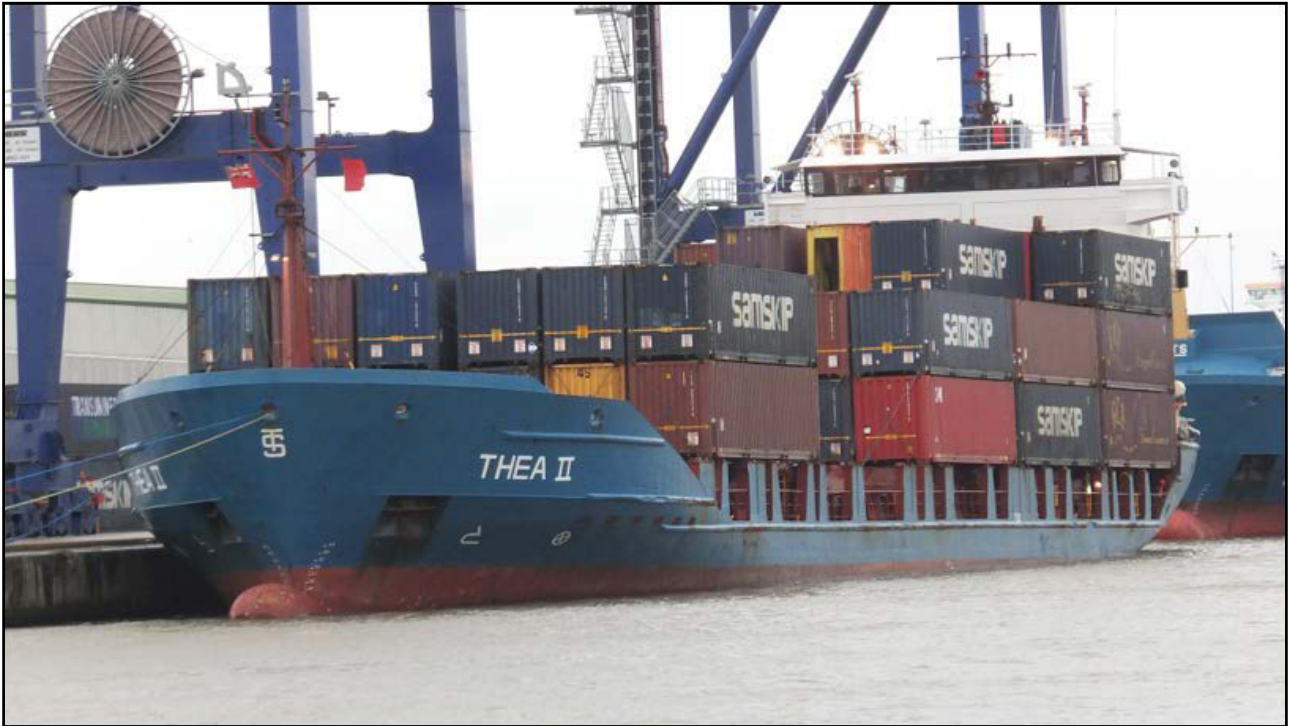
Figure 1: *Thea II*, post-grounding, alongside in Hull

- The rudder and steering gear were damaged, but operational.
- The vessel's hull was intact, but the hull bottom paintwork was damaged.
- There was minor damage to the propeller blades.
- Two quarter deck ventilation pipes had been broken by the tug's towline.

Thea II was out of service for 6 weeks for repair. The vessel resumed its charter in February 2019.

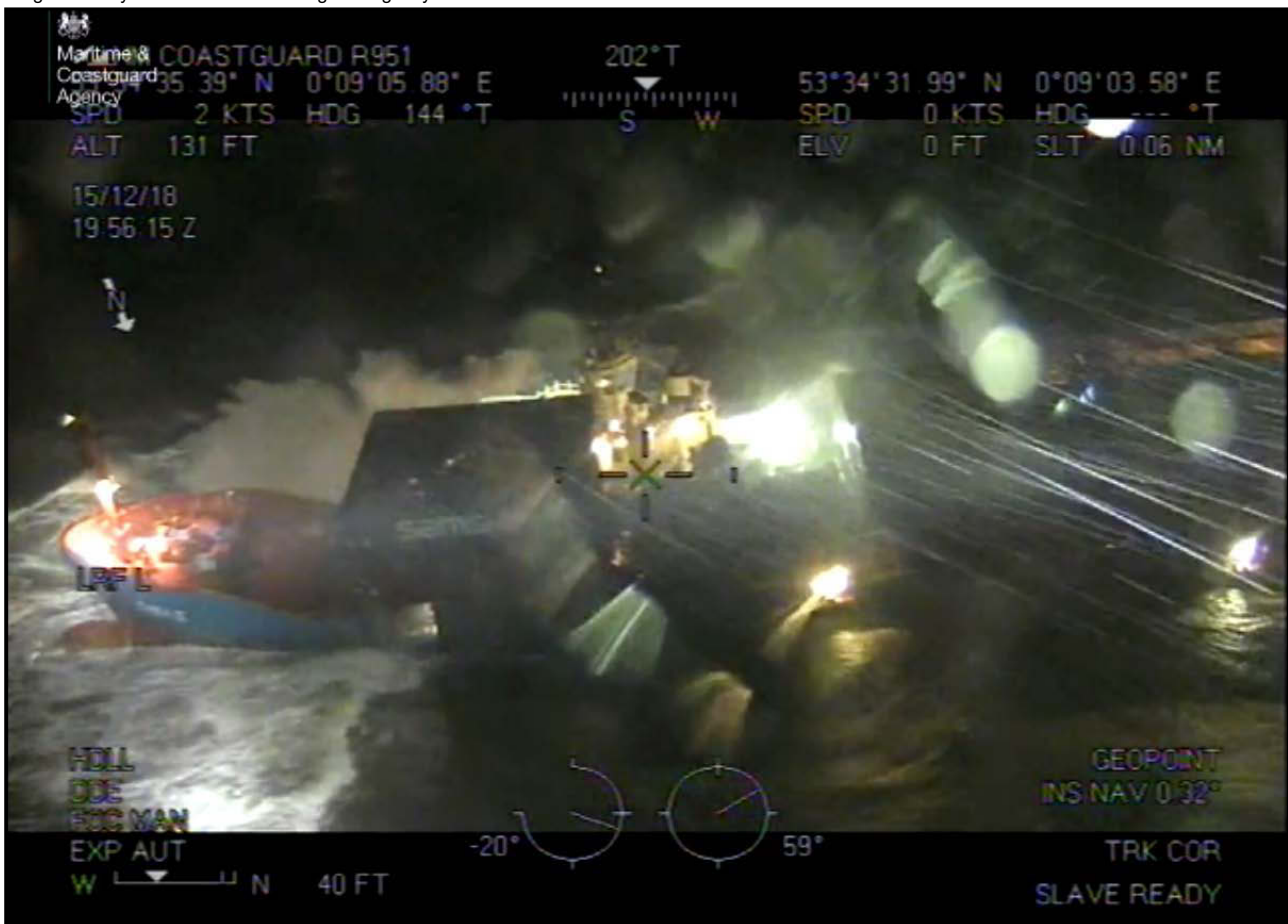
At 1739, as *Svitzer Josephine*'s master tried to tow *Thea II*, he found his tug was aground. He reported this to VTS Humber, who in turn contacted *Thea II*'s master, who responded that his vessel was also aground.

Figure 4: *Thea II* and *Svitzer Josephine* viewed from the search and rescue helicopter, aground on the Binks Shoal

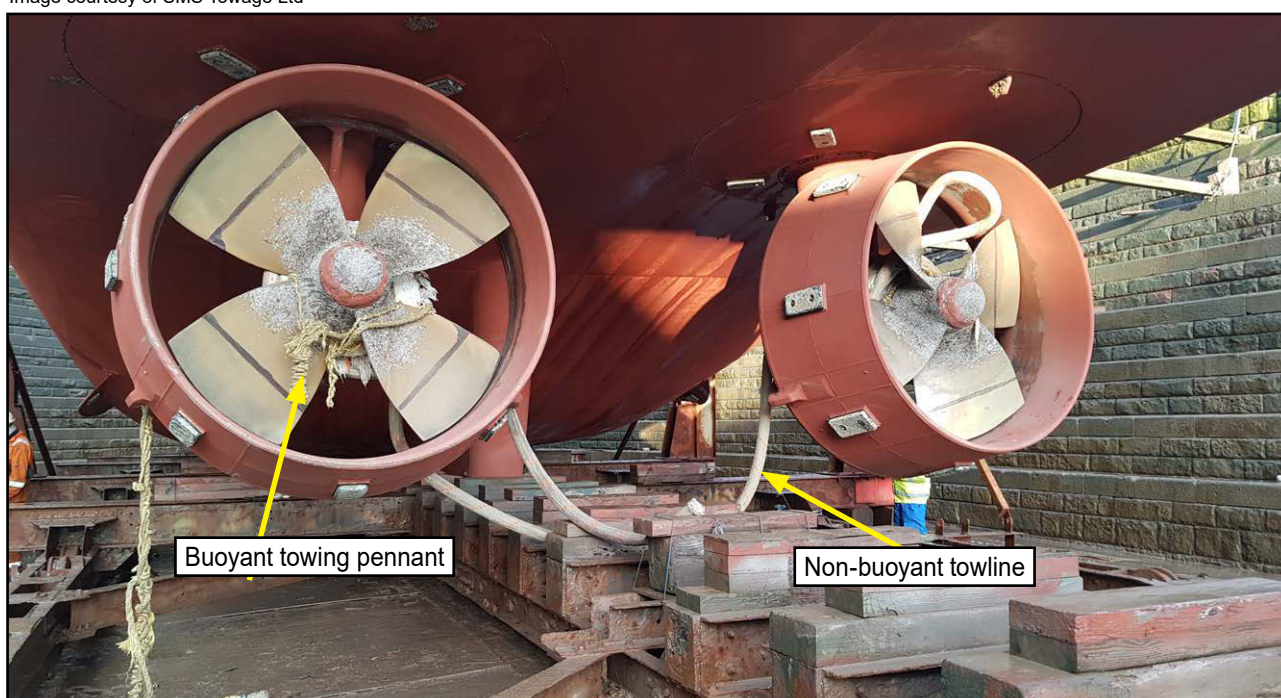
assumed that its propellers had been fouled by fishing gear. However, when *Yeoman* was in dry dock it was discovered that the port and starboard azimuth units had been fouled by a towline (**Figure 7**). The following damage was also discovered:

- The internal engine room mountings were out of tolerance.
- The starboard bilge keel and starboard side of the hull were damaged.

Post-accident inspection of the rope recovered from *Yeoman's* azimuth units suggests that it was an 80mm, 3-strand 'Strongline' polyester, Langhorst towing hawser, attached to a 15m yellow/orange towing pennant. This was similar to *Svitzer Josephine's* towline, which had been discarded by *Thea II's* crew.

Figure 7: *Yeoman's* propellers fouled by *Svitzer Josephine's* towline

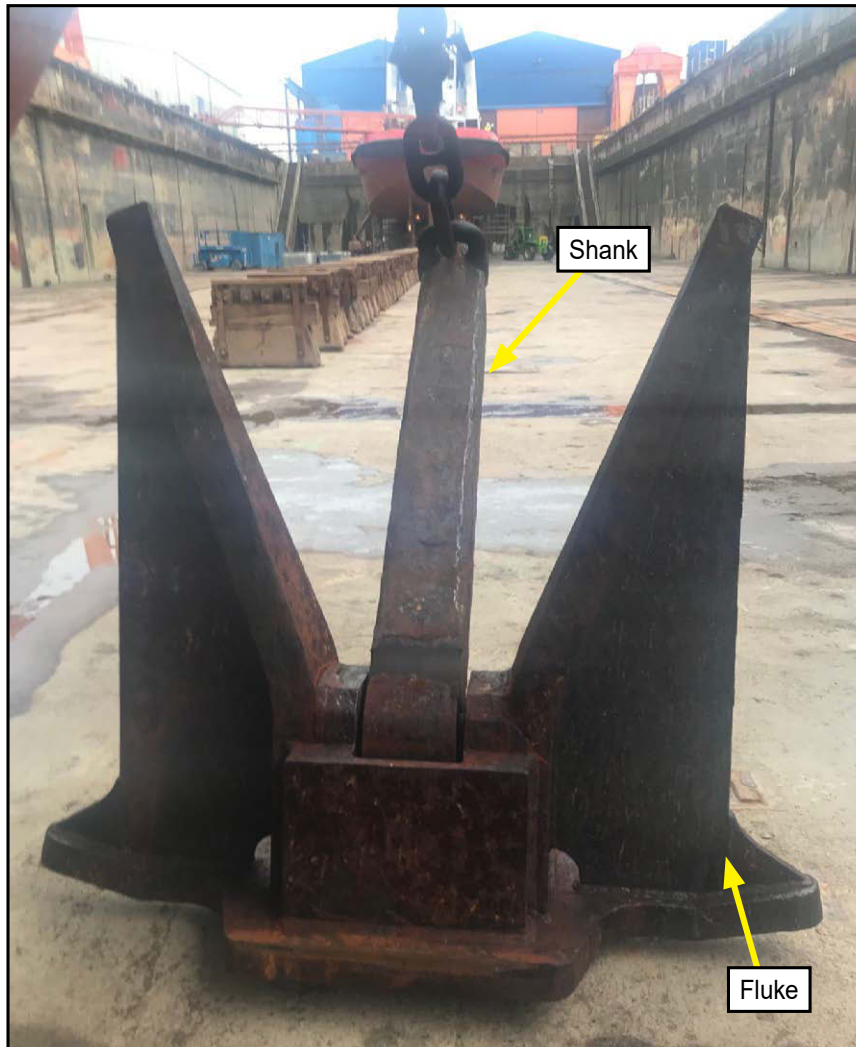
Thea II's anchor arrangements comprised a forecastle windlass and two 1998kg, high holding power, D'Hone anchors (**Figure 8**). The port anchor was attached to 12 shackles and the starboard anchor to 9 shackles of 40mm hardened steel cable.

Figure 8: *Thea II*'s D'Hone, high holding power anchor

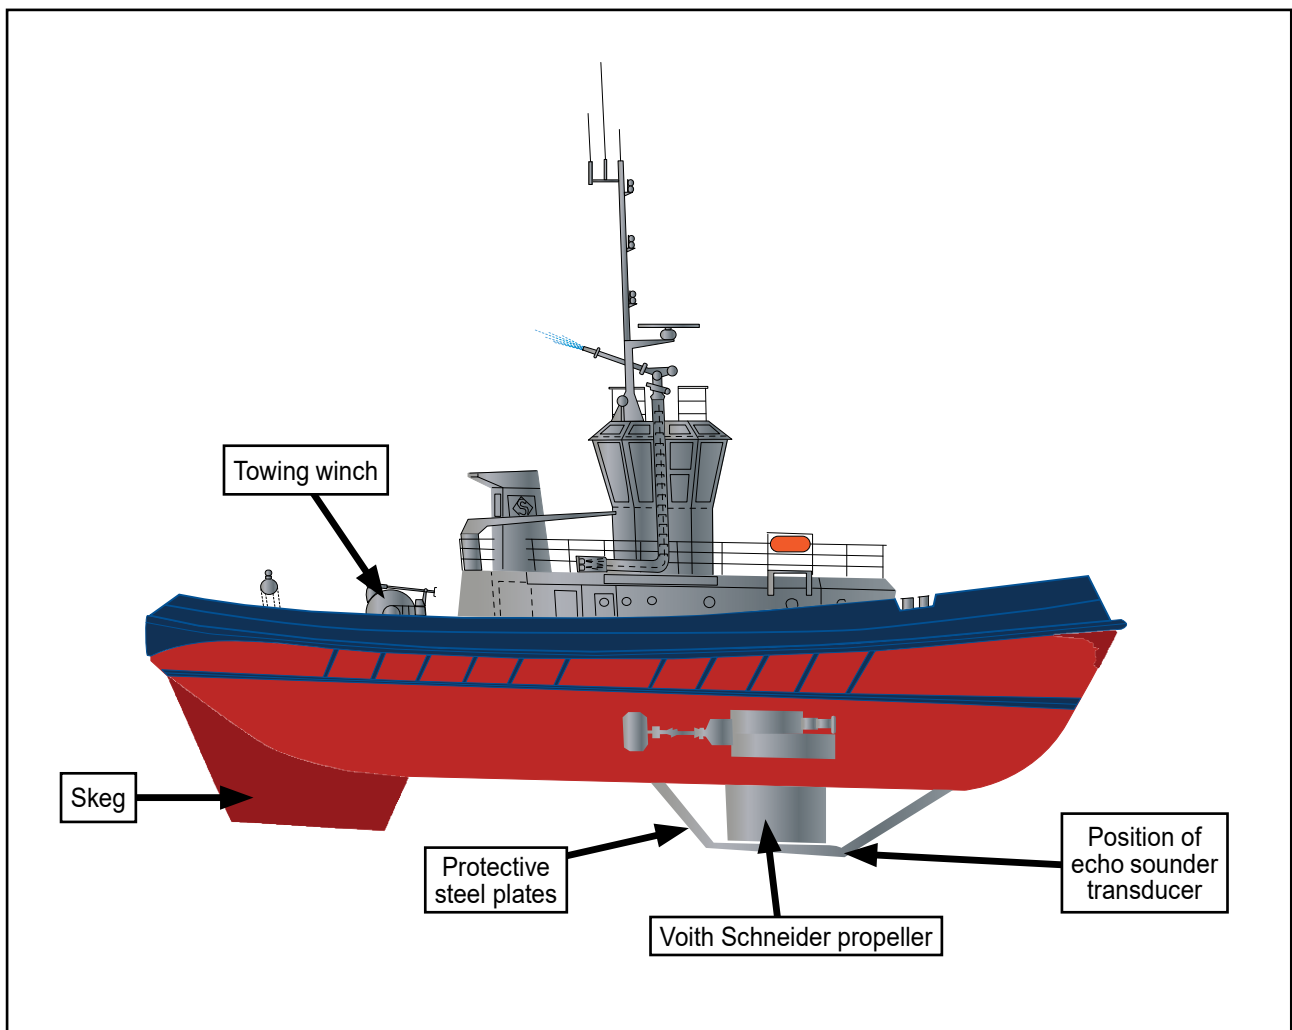
Post-accident in-water survey of *Svitzer Josephine* revealed that the void space containing the starboard engine room vent fan had flooded. This had shorted the fan motor and probably triggered the fire alarm. The starboard weather deck door had also vibrated open during the grounding, causing water damage to the tug's accommodation and recreational spaces. Initially it was thought that the tug's hull and Voith Schneider propellers (VSP) were undamaged. However, during the dry-docking of the vessel in June 2019, extensive cracking was identified along the skeg and adjoining keel plating, which had not been detected during the in-water survey.

Svitzer Josephine's echo sounder transducer was fitted in front of its VSPs. The echo sounder's minimum depth alarm was set at 1m. However, the position of its transducer, like many tugs, meant that it was prone to false alarm due to VSP wash and, on the day of the accident, the echo sounder's audible warning alarm had been silenced.

Figure 9: *Svitzer Josephine's* underwater arrangements

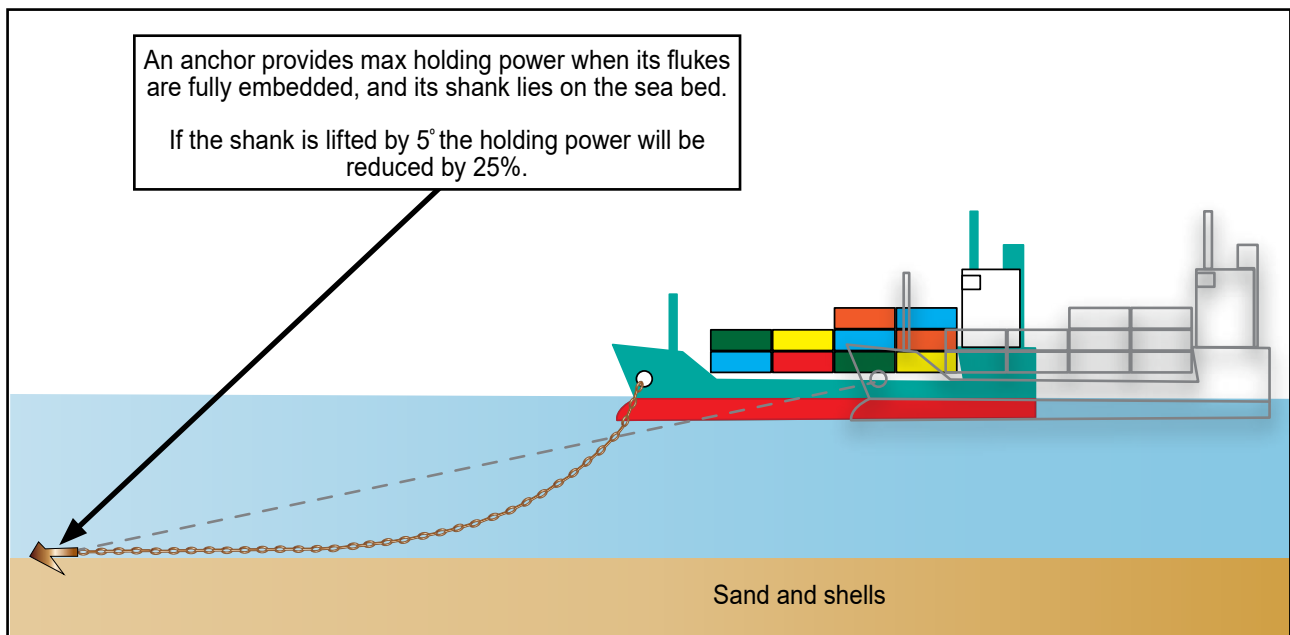
Using a charted depth of 12m these guidelines indicate that *Thea II*'s master should have deployed between 2.6 and 5.2 shackles of cable. When *Thea II* initially anchored, 5 shackles of cable were deployed, which was increased to 6 shackles once the vessel started to drag its anchor.

These guidelines recommend that in bad weather additional anchor cable be deployed. Furthermore, in strong winds, high-sided vessels like *Thea II*, with containers stowed on deck, can be prone to yaw either side of their anchor cable. At the extremity of each yaw, the vessel would snatch at the cable, placing it under

Figure 12: Scope of deployed anchor

considerable load and increasing the risk of the anchor breaking free and dragging. *Thea II* was yawing approximately 35° either side of its cable immediately prior to dragging its anchor.
