## Accident

<b>Aircraft Type and Registration:</b>	Beechcraft Super King Air 200, G-FLYW	
<b>No &amp; Type of Engines:</b>	2 Pratt & Whitney Canada PT6A-61 turboprop engines	
<b>Year of Manufacture:</b>	1977 (Serial no: BB-209)	
<b>Date &amp; Time (UTC):</b>	20 March 2020 at 1141 hrs	
<b>Location:</b>	Exeter Airport	
<b>Type of Flight:</b>	Training	
<b>Persons on Board:</b>	Crew - 2	Passengers - None
<b>Injuries:</b>	Crew - None	Passengers - N/A
<b>Nature of Damage:</b>	Propeller damage, engines shock-loaded, minor rear fuselage damage	
<b>Commander's Licence:</b>	Commercial Pilot's Licence	
<b>Commander's Age:</b>	59 years	
<b>Commander's Flying Experience:</b>	8,500 hours (of which over 3,000 were on type) Last 90 days - 26 hours Last 28 days - 26 hours	
<b>Information source:</b>	Aircraft Accident Report Form submitted by the pilot, engineering diagnostic report, ATC investigation report and further enquiries by the AAIB

## Synopsis

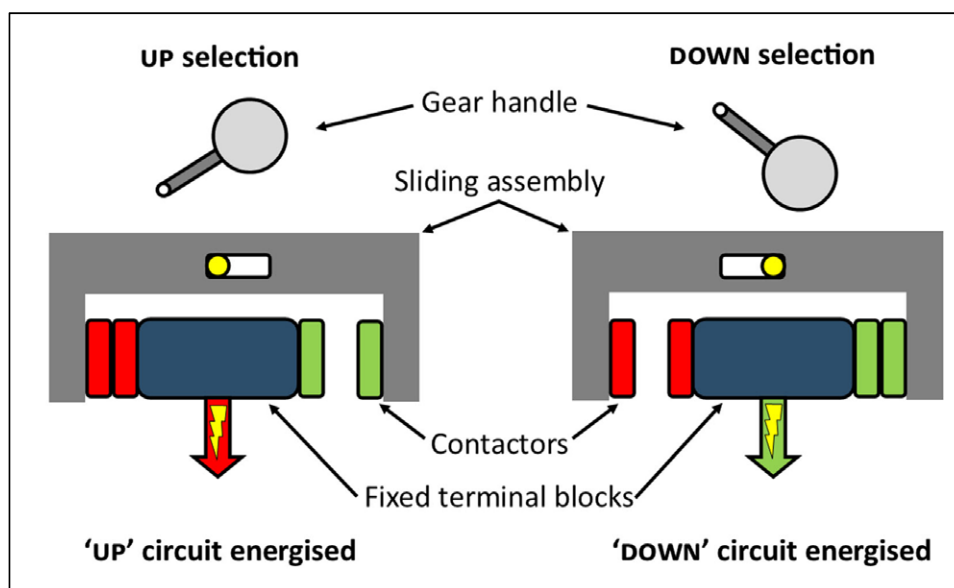
**Figure 4**

The landing gear selection handle controls a sliding assembly within an undercarriage electrical control unit (Figure 4). Contactor plates mounted at either end of the sliding assembly and on a fixed terminal block control electric current flow to the motor which lowers and raises the landing gear. One set of contactors is associated with landing gear UP selection and the other with DOWN. With the gear handle in either the UP or DOWN position, the respective contactor on the slider presses against its partner contactor on the fixed terminal block to create an electric circuit. If the landing gear is not in the commanded position the electric actuator motor is energised. When sensors detect that the gear has travelled to the required position, the current is interrupted and gear travel ceases. Whenever one set of contactors is made the opposite set is un-made, isolating that side of the circuit until the alternate gear position is selected. With the gear handle in the DOWN position, the sliding assembly's UP contactor is physically separated from the fixed terminal block and it is not possible to energise the landing gear UP circuit. The AAIB found no evidence of previous incidents where King Air landing gear self-retracted.

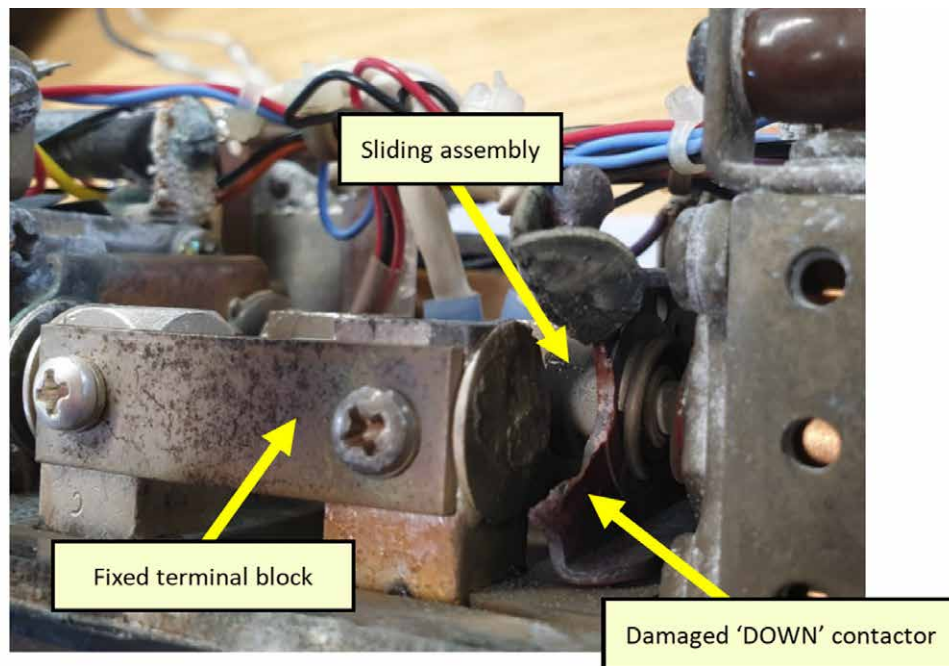
**Figure 5**

As part of the initial engineering fault diagnosis the aircraft was put on jacks and, when the landing gear was selected UP, it retracted normally but a subsequent DOWN selection failed. The fault was traced to a damaged down-select contactor in the undercarriage electrical control system (Figure 5). Once the damaged component had been replaced the landing gear operated correctly. The engineers did not find any fault with the landing gear warning system.

Damaged landing gear contactor

Post-accident engineering diagnosis confirmed a fault in the undercarriage electrical control system that prevented the landing gear from lowering when selected DOWN. Once the faulty component had been replaced the landing gear worked correctly. The electrical control unit design isolates the opposite actuator circuit when the landing gear operating lever is in the UP or DOWN detent and the sliding assembly is in the matched position. It was not possible to establish how landing gear self-retraction could have occurred when system design prevents it with the landing gear handle in the DOWN position. No fault was found with the undercarriage warning system.
