SERIOUS INCIDENT

Aircraft Type and Registration:	1) Fuji FA-200-180 Aero Subaru, G-HAMI 2) Cessna 172R Skyhawk, G-BXGV
No & Type of Engines:	1) 1 Lycoming IO-360-B1B piston engine 2) 1 Lycoming IO-360-L2A piston engine
Year of Manufacture:	1) 1973 (Serial no: FA200-188) 2) 1997 (Serial no: 17280240)
Date & Time (UTC):	23 June 2019 at 0955 hrs
Location:	Near Henley-on-Thames, Oxfordshire
Type of Flight:	1) Private 2) Private
Persons on Board:	1) Crew - 1 Passengers - 2 2) Crew - 1 Passengers - 3
Injuries:	1) Crew - None Passengers - None 2) Crew - None Passengers - None
Nature of Damage:	1) None 2) Damage to right wingtip
Commander's Licence:	1) Private Pilot's Licence 2) Private Pilot's Licence
Commander's Age:	1) 68 years 2) 76 years
Commander's Flying Experience:	1) 531 hours (of which 322 were on type) Last 90 days - 5 hours Last 28 days - 5 hours 2) 890 hours (of which 830 were on type) Last 90 days - 6 hours Last 28 days - 1 hour

Synopsis

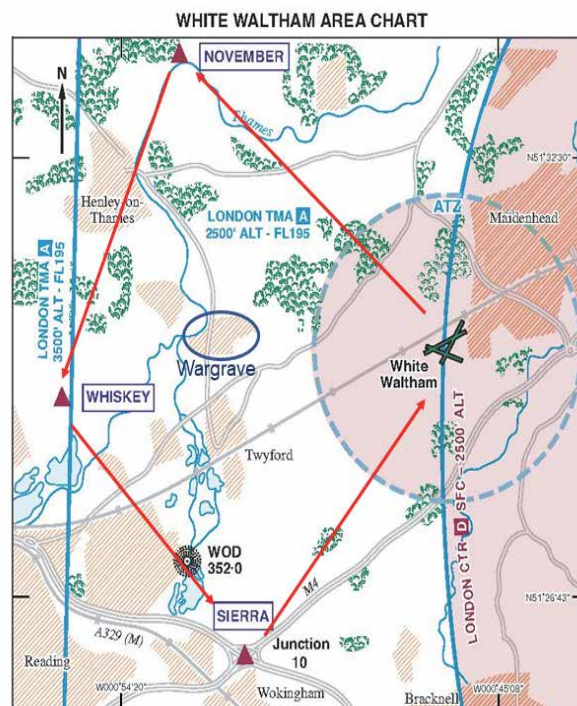
Figure 1

Briefed routing of flights

The charity event was operated from an airfield on the edge of London controlled airspace, and the route flown under controlled airspace, using the aerodrome’s standard visual reporting points as turning points. This increased the risk of a collision between participants and other aircraft by placing them in vertically restricted airspace and over geographical locations used for all departing and arriving aircraft.

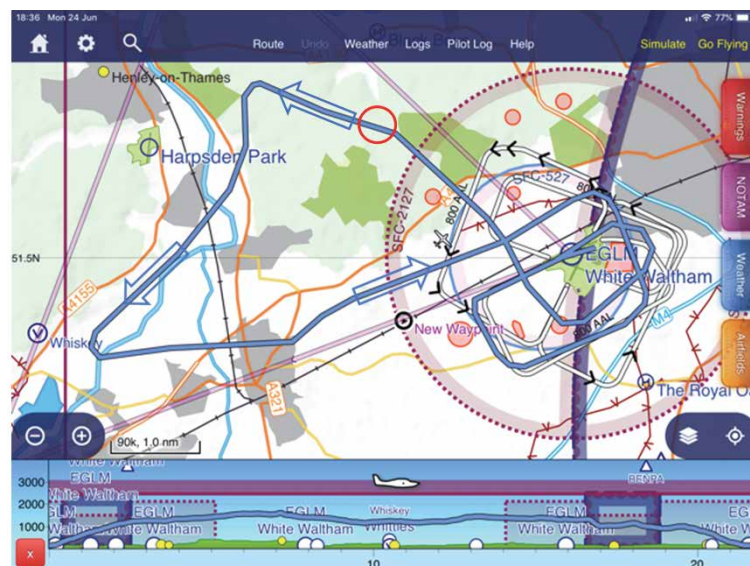
Figure 2

Once airborne the previously unsettled child became vocal. Fearing he may become physically disturbed again, the pilot decided to shorten the route by flying towards Henley-on-Thames, Oxfordshire. Shortly after leaving the Aerodrome Traffic Zone, while straight and level, the pilot noticed a bright red aircraft above, in his 8 o'clock position, converging on his aircraft. He then lost sight of it above and behind his aircraft's high-wing, becoming visual again when it was in his 1 to 2 o'clock position. It then was seen to descend before disappearing from his sight. He didn't have time to take avoiding action but filed an Airprox on White Waltham's A/G radio frequency. He continued the flight to Henley-on-Thames and Point Whiskey before returning to White Waltham without further event, landing at 1009 hrs (Figure 2).

G-BXGV's routing
(Red circle indicates approximate location of collision)
