ACCIDENT

Aircraft Type and Registration:	Piper PA-32-300, G-DIWY	
No & Type of Engines:	1 Lycoming LO-540-K1A5 piston engine	
Year of Manufacture:	1969 (Serial no: 32-40731)	
Date & Time (UTC):	23 June 2020 at 1655 hrs	
Location:	North Coates Airfield, Lincolnshire	
Type of Flight:	Private	
Persons on Board:	Crew - 1	Passengers - 3
Injuries:	Crew - 1 (Minor)	Passengers - 3 (Minor)
Nature of Damage:	Major damage to the nose landing gear, engine and airframe	
Commander's Licence:	Private Pilot's Licence	
Commander's Age:	58 years	
Commander's Flying Experience:	81 hours (of which 44 were on type) Last 90 days - 15 hours Last 28 days - 10 hours	
Information Source:	Aircraft Accident Report Form submitted by the pilot

Synopsis

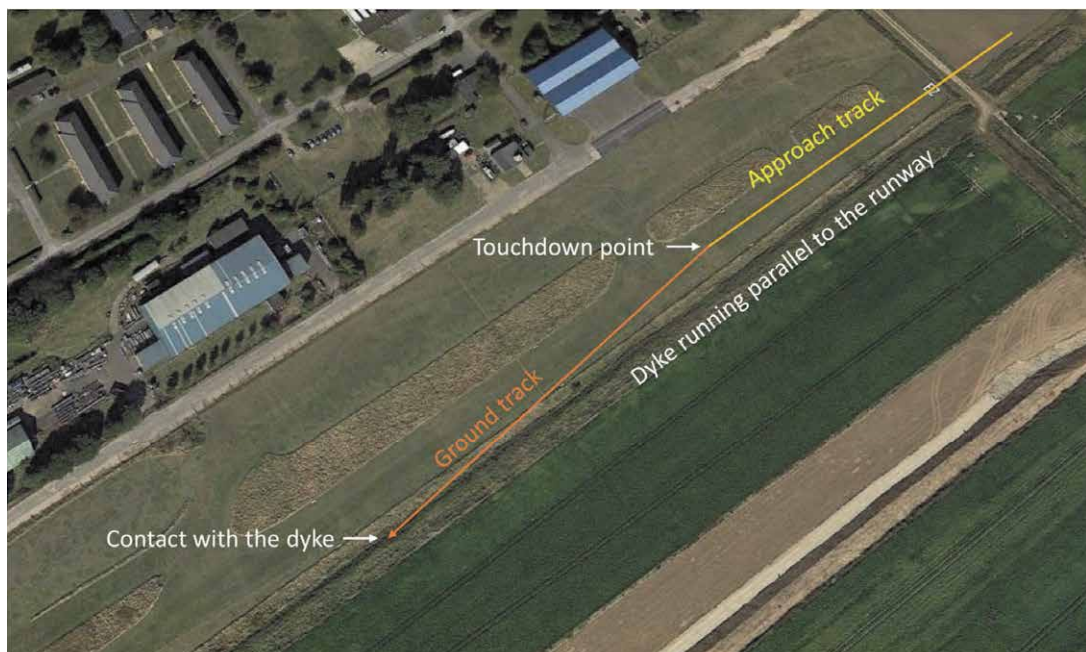
The pilot commented that none of the airfield charts available to him had mentioned the presence of the dyke and had he known about it, with the increased crosswind, he may have done things differently. The approach and ground tracks with the position of the dyke are shown at Figure 1 below.

North Coates Airfield showing the position of the dyke
