**SERIOUS INCIDENT**

<b>Aircraft Type and Registration:</b>	Reims Cessna F152, G-BTAL	
<b>No &amp; Type of Engines:</b>	1 Lycoming O-235-L2C	
<b>Year of Manufacture:</b>	1978 (Serial no: 1444)	
<b>Date &amp; Time (UTC):</b>	25 June 2020 at 1340 hrs	
<b>Location:</b>	Shobdon Aerodrome, Herefordshire	
<b>Type of Flight:</b>	Private	
<b>Persons on Board:</b>	Crew - 1	Passengers - None
<b>Injuries</b>	Crew - None	Passengers - N/A
<b>Nature of Damage:</b>	No damage	
<b>Commander's Licence:</b>	Private Pilot's Licence	
<b>Commander's Age:</b>	35 years	
<b>Commander's Flying Experience:</b>	83 hours (of which 64 were on type) Last 90 days - 0 hours Last 28 days - 0 hours	
<b>Information Source:</b>	Aircraft Accident Report Form submitted by the pilot and additional enquiries made by the AAIB

**Synopsis**

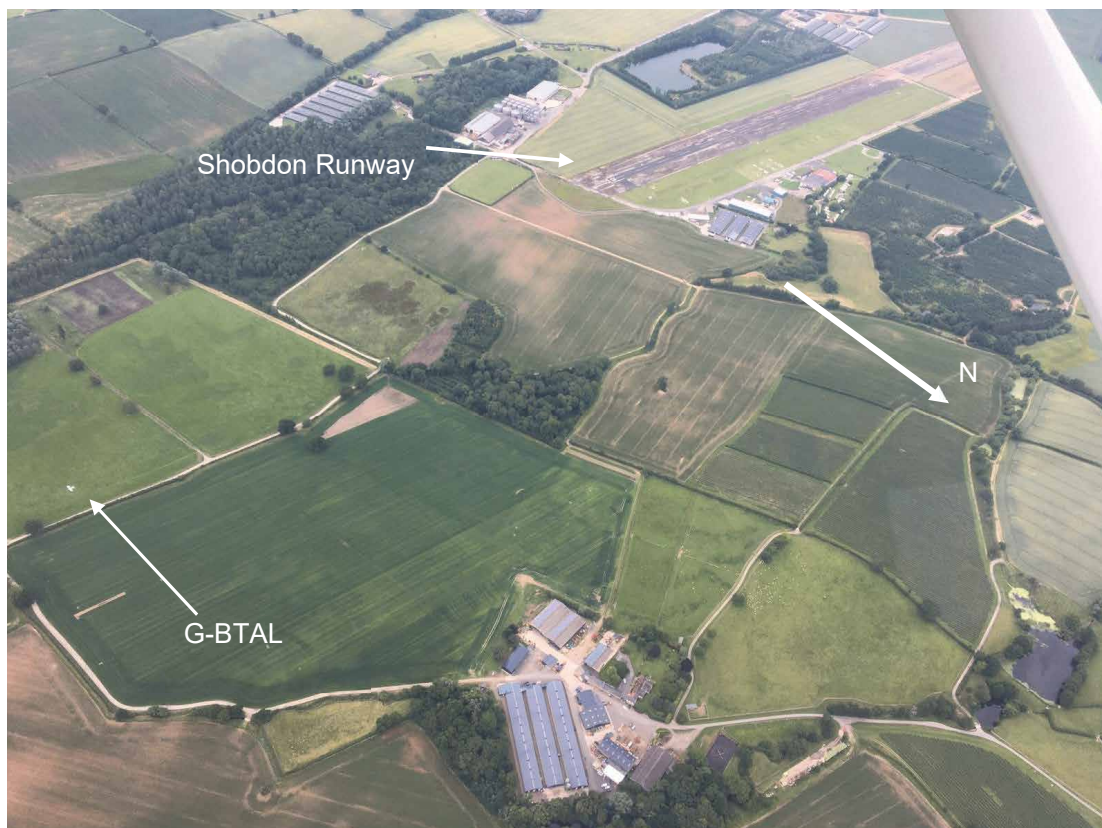
**Figure 1**

Aerial view of Shobdon Aerodrome showing G-BTAL in the field to the east

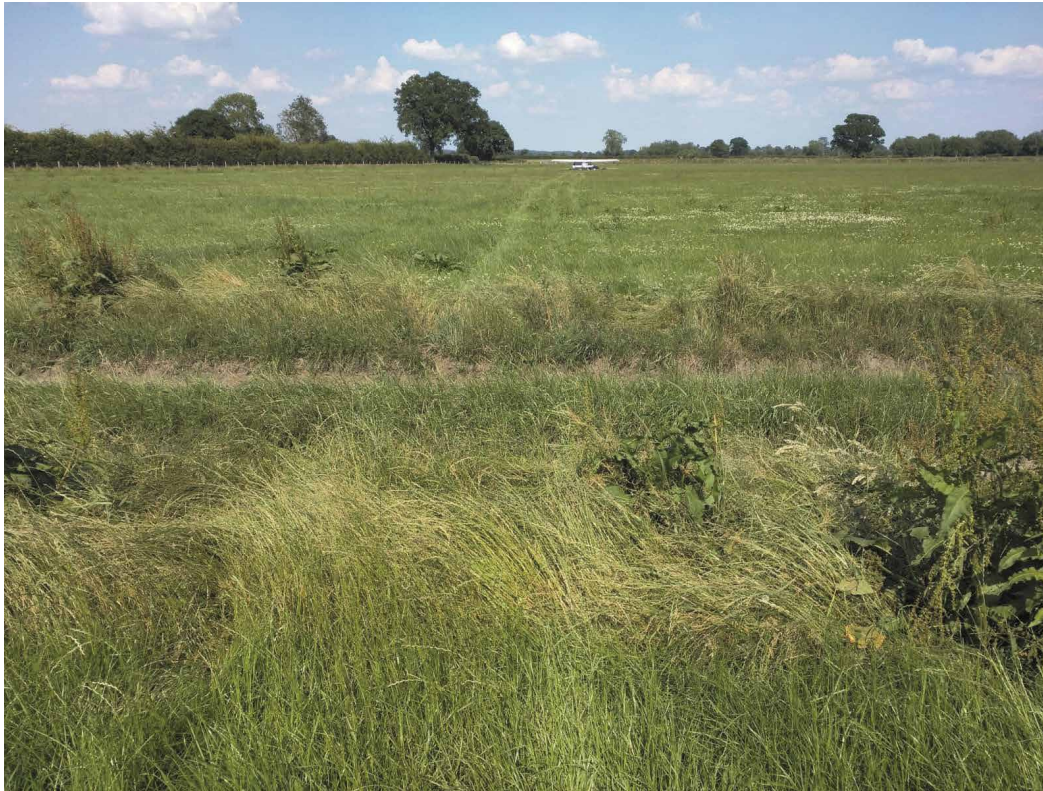
**Figure 2**

The pilot landed the aircraft with the flaps up in a slight crosswind. As the aircraft touched down he noticed a ditch crossing the aircraft's track and decided to pull back on the control column to pass over it. Once clear of the ditch he brought the aircraft to a halt and

G-BTAL ground track showing the ditch the aircraft crossed
