## ACCIDENT

<b>Aircraft Type and Registration:</b>	Jabiru UL-450, G-ROYC	
<b>No &amp; Type of Engines:</b>	1 Jabiru 2200A piston engine	
<b>Year of Manufacture:</b>	2003 (Serial no: PFA 274A-13990)	
<b>Date &amp; Time (UTC):</b>	27 October 2019 at 1421 hrs	
<b>Location:</b>	Gransden Lodge Airfield, Sandy, Cambridgeshire	
<b>Type of Flight:</b>	Private	
<b>Persons on Board:</b>	Crew - 1	Passengers - 1
<b>Injuries:</b>	Crew - 1 (Minor)	Passengers - None
<b>Nature of Damage:</b>	Substantial	
<b>Commander's Licence:</b>	National Private Pilot's Licence	
<b>Commander's Age:</b>	57 years	
<b>Commander's Flying Experience:</b>	267 hours (of which 28 were on type) Last 90 days - 6 hours Last 28 days - 4 hours	
<b>Information Source:</b>	AAIB Field Investigation

## Synopsis

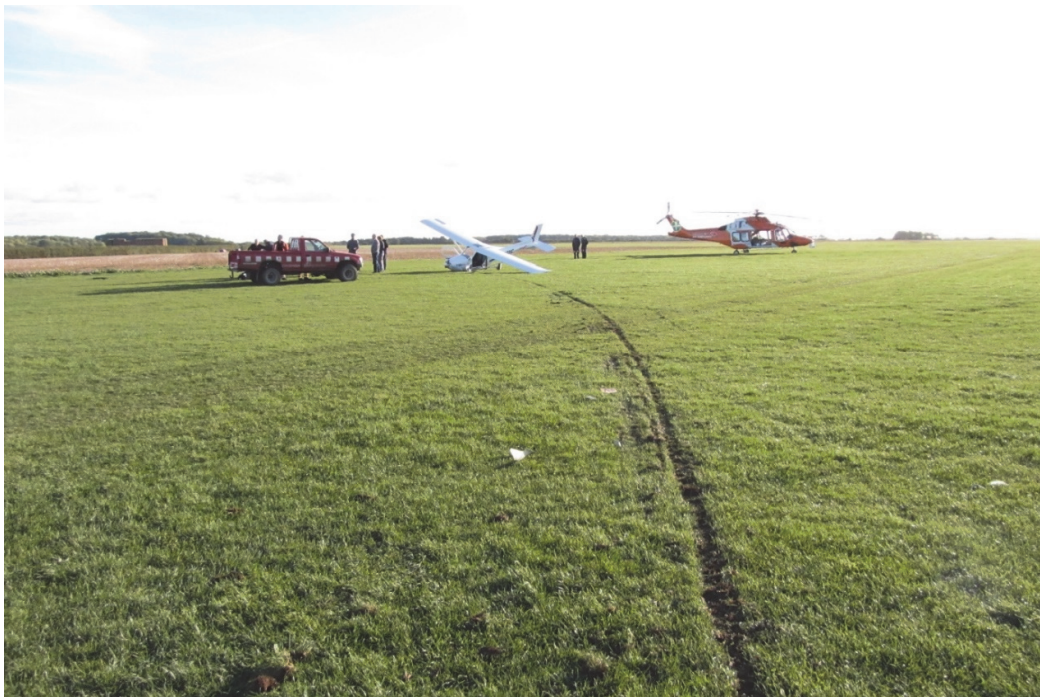
**Figure 3**

Final position of G-ROYC

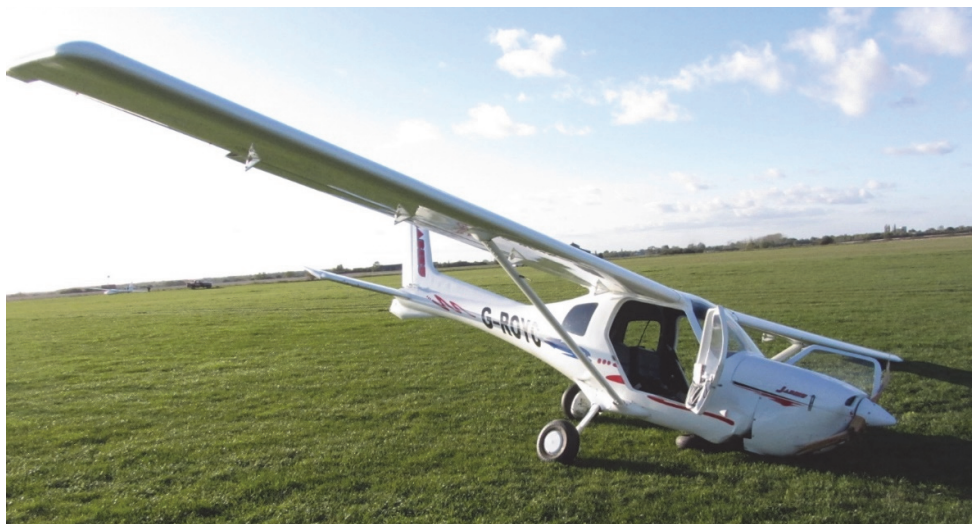
**Figure 4**

G-ROYC after the accident showing the flaps UP

G-ROYC was not examined in detail by the AAIB. However, both occupants of G-ROYC reported that the aircraft and engine appearing to be behaving normally. Photographs taken immediately after the accident show that the flaps were retracted, the flap switch was in the FLAPS UP position and the carburettor heat was pulled out.

The pilot reported that he initially operated the throttle in the incorrect direction which, whilst only resulting in a brief delay in the application of full power, may have caused the airspeed to reduce as the pilot tried to maintain height. The flap switch was selected to the FLAPS UP position but was not returned to the central position, causing the flaps to fully retract.

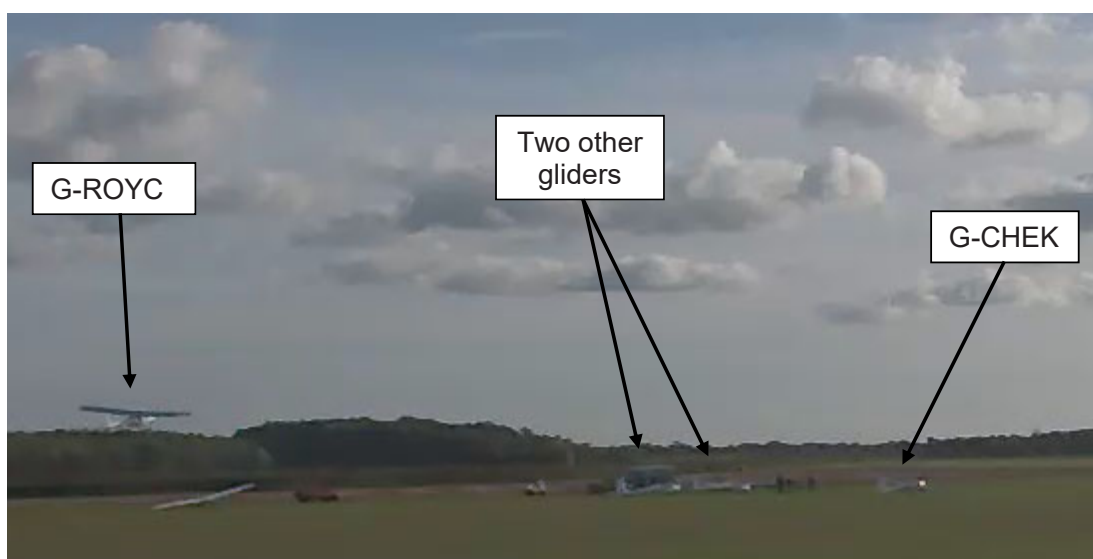
**Figure 5**

The accident was recorded on CCTV. However, the distance, frame rate and angle of the camera meant it was not possible to determine the aircraft speed, pitch angle or heading with any accuracy. The recording showed the landing motor glider touching down at 1420:19 hrs on the right side of the runway. After slowly rolling across a track that crosses the runway the motor glider started accelerating for another takeoff at 1421:09 hrs. G-ROYC entered the image at 1421:16 hrs and appeared to be in level flight at low level. At 1421:19 hrs G-ROYC started to sink and at 1421:22 hrs collided with the glider. Figure 5 is an image taken from the CCTV recording which shows G-ROYC in flight and the three gliders on the left of the runway. Several members of the gliding club can also be seen standing by the gliders.

CCTV image just prior to the accident

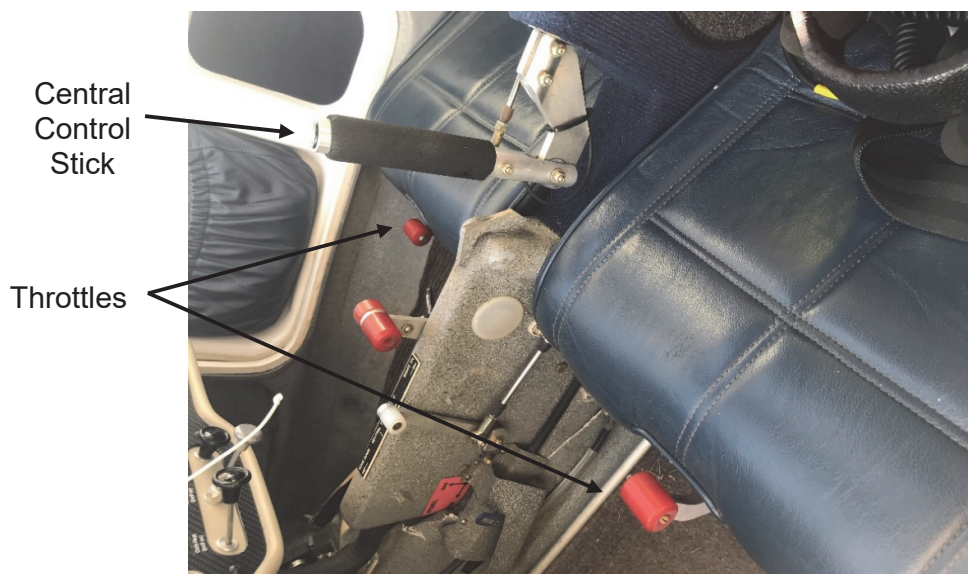
**Figure 6**

Jabiru UL-450 controls

The pilot reported that he moved the throttle lever in the incorrect direction. The throttle on a UL-450 is in an unusual position. For an experienced pilot, the act of applying more (or less) throttle is done without conscious thought. This is normally helpful as it requires less mental effort to fly the aircraft, but, when presented with a different or unusual control it can cause a problem if the pilot's instinct is to move the control in the wrong sense.

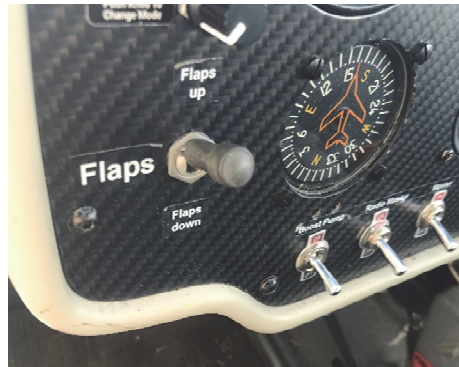
**Figure 8**

to other Jabiru models. The motor was controlled via a three-position switch mounted on the far left side of the instrument panel (Figure 8). The flaps were extended by holding the switch in the FLAPS DOWN position (the switch is spring loaded back to the middle position). To retract the flaps the switch is moved to the FLAPS UP position where the switch latches. If the switch is left in the FLAPS UP position, the flaps retract fully. To stop the flaps in the mid position the switch must be returned to the middle position.

G-ROYC flap switch (as found after the accident)

The aircraft had been modified with electric flaps, with a control switch that latched in the retraction position. This design meant that the flaps would retract fully once selected if the pilot was distracted and did not return the switch to the mid position.
