SERIOUS INCIDENT

Aircraft Type and Registration:	Boeing 737-86N, I-NEOT	
No & Type of Engines:	2 CFMI CFM56-7B26 turbofan engines	
Year of Manufacture:	2002 (Serial no: 33004)	
Date & Time (UTC):	1 June 2019 at 1319 hrs	
Location:	Bristol Airport	
Type of Flight:	Commercial Air Transport (Passenger)	
Persons on Board:	Crew - 6	Passengers -167
Injuries:	Crew - None	Passengers - None
Nature of Damage:	None reported	
Commander's Licence:	Airline Transport Pilot's Licence	
Commander's Age:	55 years	
Commander's Flying Experience:	14,750 hours (of which 10,770 were on type) Last 90 days – 174 hours Last 28 days – 60 hours	
Information Source:	AAIB Field Investigation

Synopsis

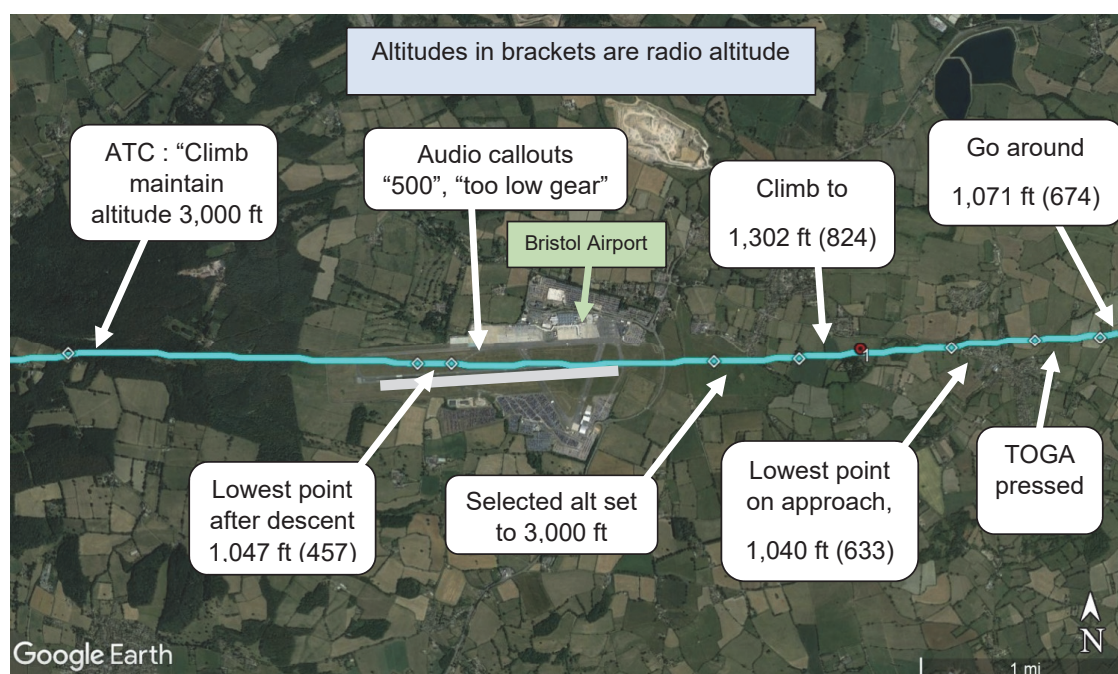
Figure 2

The PF followed the flight director, and the aircraft continued to descend for 32 seconds reaching a minimum of 1,047 ft, which was 457 ft radio altitude⁶. The crew then realised that the aircraft was not climbing as expected and adjusted the attitude of the aircraft to begin a climb. Almost at the same time, the tower controller noted that the aircraft was not climbing and instructed I-NEOT to climb to 3,000 ft which was acknowledged by the crew.

I-NEOT go-around

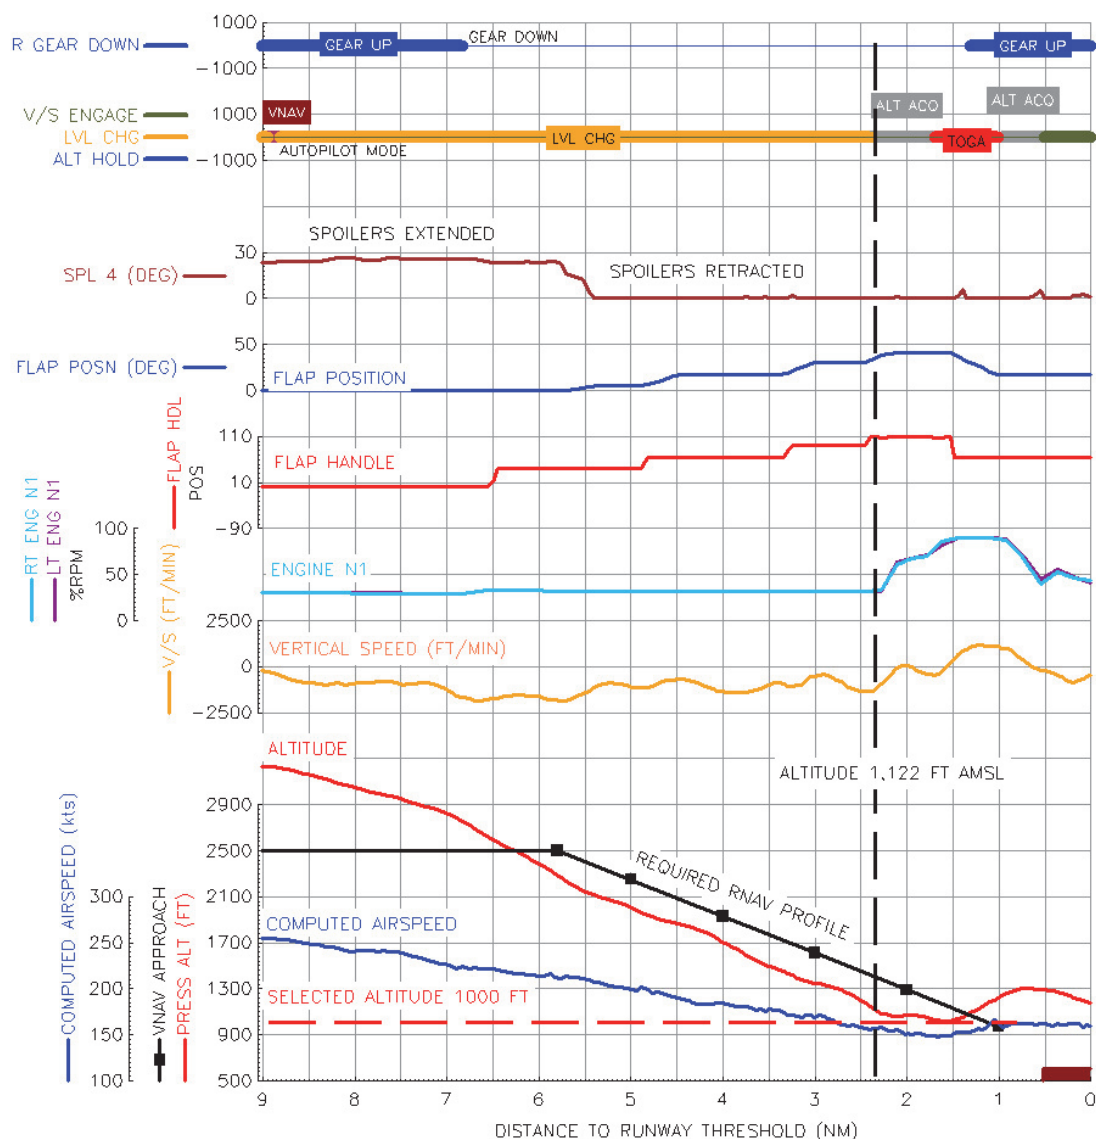
Figure 3

As the aircraft approached 1,000 ft, the AFDS vertical mode became ALT AQ as the system attempted to level off at the selected 1,000 ft. This led to a reduction in the rate of descent, and the aircraft path began to close slightly with the design 3° approach gradient. However, from 5.8 nm to 2 nm on the final approach, the minimum obstacle clearance altitude permitted by the procedure is 1,130 ft (shaded grey in Figure 1). Therefore, from a point 2.34 nm from the threshold until the aircraft passed inside 2 nm from the threshold, I-NEOT was below the minimum obstacle clearance altitude¹¹ in that segment of the approach.

I-NEOT FDR data for initial approach into Bristol Airport

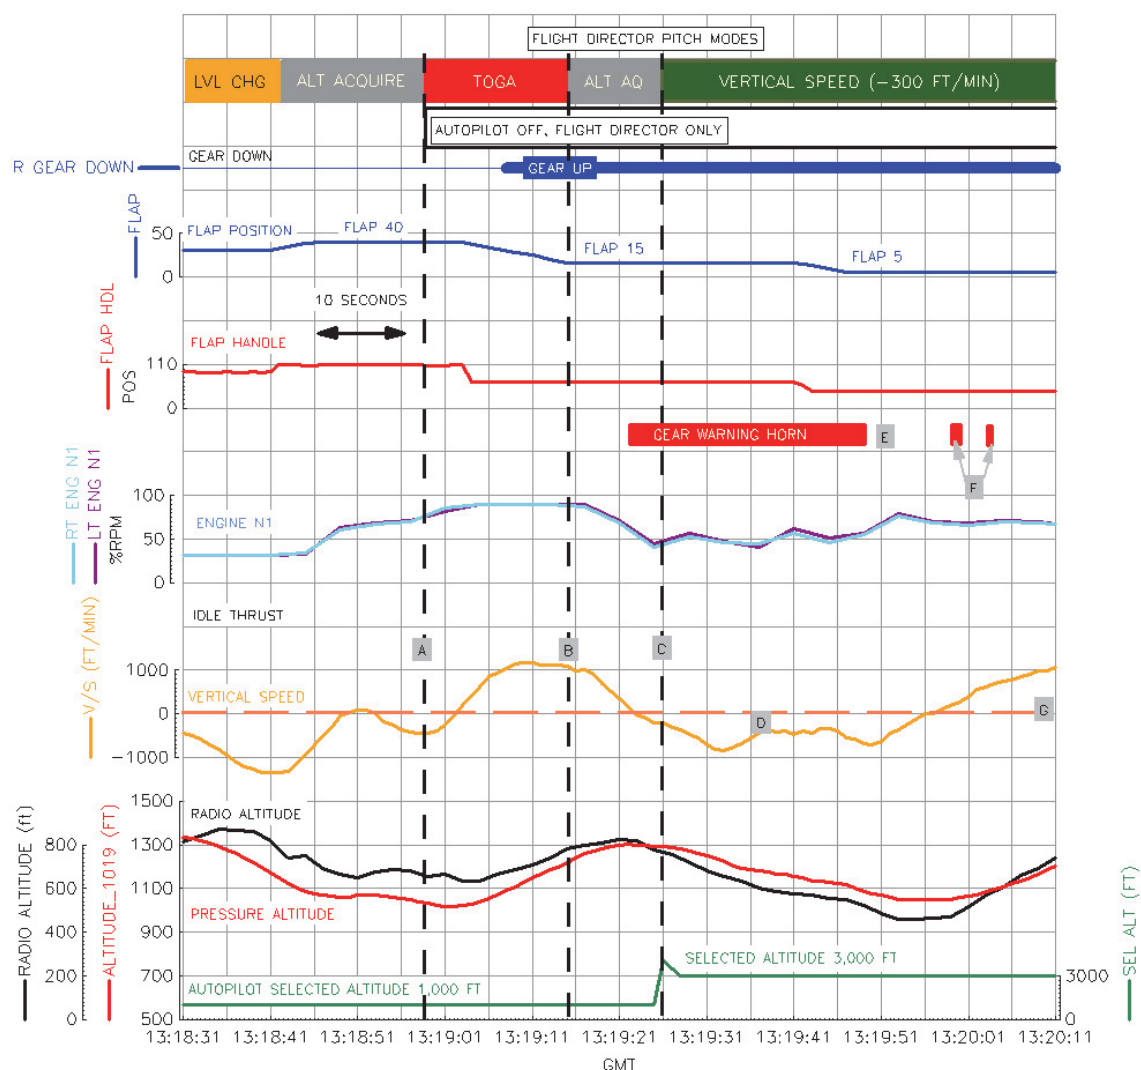
Figure 4

The PF pressed the TOGA button and the aircraft AFDS system transitioned into go-around modes (Figure 4, label [A]). The vertical and lateral modes became TOGA and the A/T increased the thrust to the calculated go-around setting. The autopilot disconnected as designed. The PF asked for the standard flap setting for the go-around (Flap 15) which was selected by the PM.

I-NEOT go-around salient parameters

The crew adjusted the MCP altitude to the actual go-around altitude of 3,000 ft. Mode reversions of the AFDS in the B737-8 mean that this adjustment of the MCP altitude led the vertical mode to change from ALT AQ to V/S. The vertical speed set in the MCP became that which existed at the moment of mode engagement, which in the case of I-NEOT was a descent of -300 ft/min (Figure 4 [C]).

Although 3,000 ft was now set correctly, I-NEOT was descending in V/S mode with the PF following the flight director commands (Figure 4 [D]). The gear warning horn was still active as the A/T continued to manage the speed with the aircraft in the descent and the thrust lever angle below 20°. As the crew reduced the flap setting to Flap 5, further thrust was applied and the gear warning horn, which had operated for 27 seconds, stopped. This was followed by the EGPWS gear warning call “TOO LOW GEAR, TOO LOW GEAR” which was triggered as the aircraft passed 500 ft radio altitude descending (Figure 4 [E]). The aircraft descended for a further 2 seconds.

The crew realised that the aircraft was not climbing. The commander took control and pitched the aircraft to climb (Figure 4 [G]). As the aircraft began to climb, two further short instances of the gear warning horn were triggered (Figure 4 [F]). This coincided with ATC, noticing the aircraft position, transmitting “ALL STATIONS BRISTOL STANDBY”. Eighteen seconds later, as the aircraft continued to climb, ATC transmitted “[CALLSIGN] CLIMB MAINTAIN ALTITUDE 3,000 FT QNH 1018”.
