# THAMES ESTUARY BUXEY SAND (TE10) ASSESSMENT TE10/2016-V3

An assessment of the 2016 hydrographic survey of the area TE10: to monitor recent seabed movement; to identify any implications for shipping; and to make recommendations for future surveys.

#### BUXEY SAND TE10, 2016

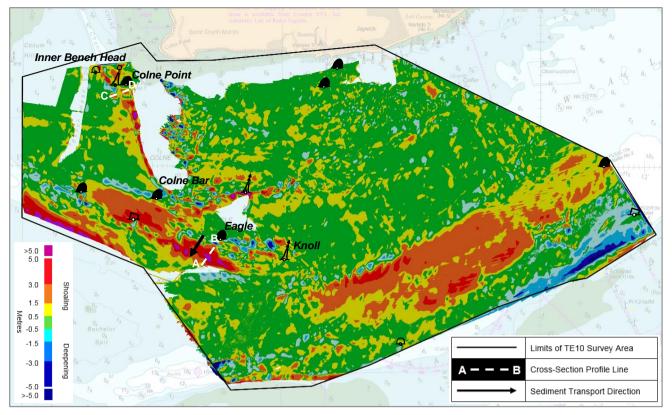
Figure 3 – Variability Plot showing Bathymetric Changes between the 1985 and 2016 surveys of TE10

- 8.2 The Variability Plot in Figure 3 indicates that there has been a variety of bathymetric change across area TE10 between 1985 and 2016. Depths have generally shoaled along approach routes towards River Colne where AIS indicates most vessels have transited in 2016. Depths have also shoaled between Colne Bar and Colne Point buoys by up to 3m along the approach that shipping uses. Given the conclusion of the 1993 Routine Resurvey Assessment that the area remaining essentially stable and the statistical analysis shows that the area tends to deepen, this shows a complete reversal. However, due to the time since the last survey this assessment is unable to make comment on when this reversal has begun nor the rate at which the changes are occurring.

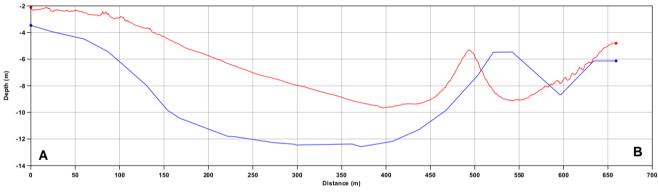
Figure 4 - Profile Comparison (A to B) between 1985 and 2016 survey data

8.3 The Profile Comparison in Figure 4 shows that the sand ridge between the Knoll and Eagle buoys has migrated southwest by approximately 30m between 1985 and 2016. It also shows that depths within the channel southwest of Eagle buoy have shoaled by up to 5.9m since 1985.

- 9.2 Southwest of Eagle buoy depths have shoaled by up to 5.9m since 1985 so a future multibeam survey would be required to confirm if the area in still becoming shallower as well as the rate which this is occurring and what implication this may have for shipping.

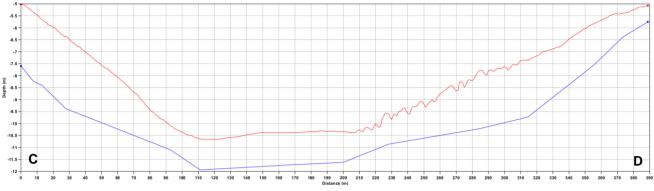
Figure 5 - Profile Comparison (C to D) between 1985 and 2016 survey data

8.4 The Profile Comparison in Figure 5 is an example of where depths have shoaled within the approach channel that shipping uses between Colne Bar and Colne Point buoys towards River Colne.

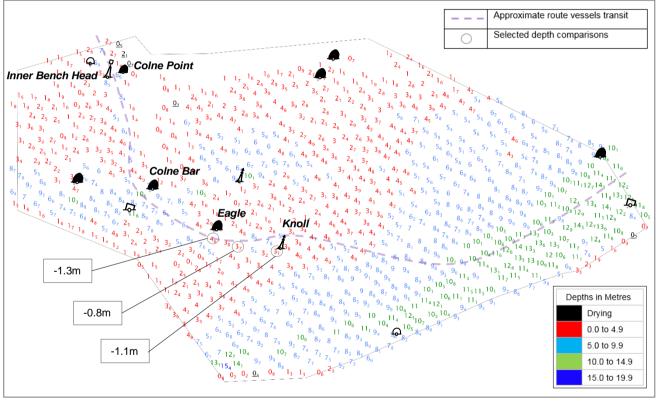
Figure 6 - Colour Banded Depth Plot from the 2016 survey with selected depths (Scale 1:40,000)

8.5 Figure 6 shows how some of the controlling depths between the Eagle and Knoll buoys have shoaled since 1985. For example, the shoal depth close to Knoll buoy has shoaled from 4.2m to 3.1m.
