SERIOUS INCIDENT

Aircraft Type and Registration:	Bell 429 GlobalRanger, G-WLTS	
No & Type of Engines:	2 Pratt and Whitney Canada PW207D1 turboshaft engines	
Year of Manufacture:	2014 (Serial no: 57191)	
Date & Time (UTC):	2 January 2019 at 1255 hrs	
Location:	Melksham Airbase, Wiltshire	
Type of Flight:	Commercial Air Transport (Passenger)	
Persons on Board:	Crew - 2	Passengers - None
Injuries	Crew - None	Passengers - N/A
Nature of Damage:	None reported	
Commander's Licence:	Commercial Pilot's Licence	
Commander's Age:	49 years	
Commander's Flying Experience:	3,890 hours (of which 360 were on type) Last 90 days - 8 hours Last 28 days - 4 hours	
Information Source:	AAIB Field Investigation

Synopsis

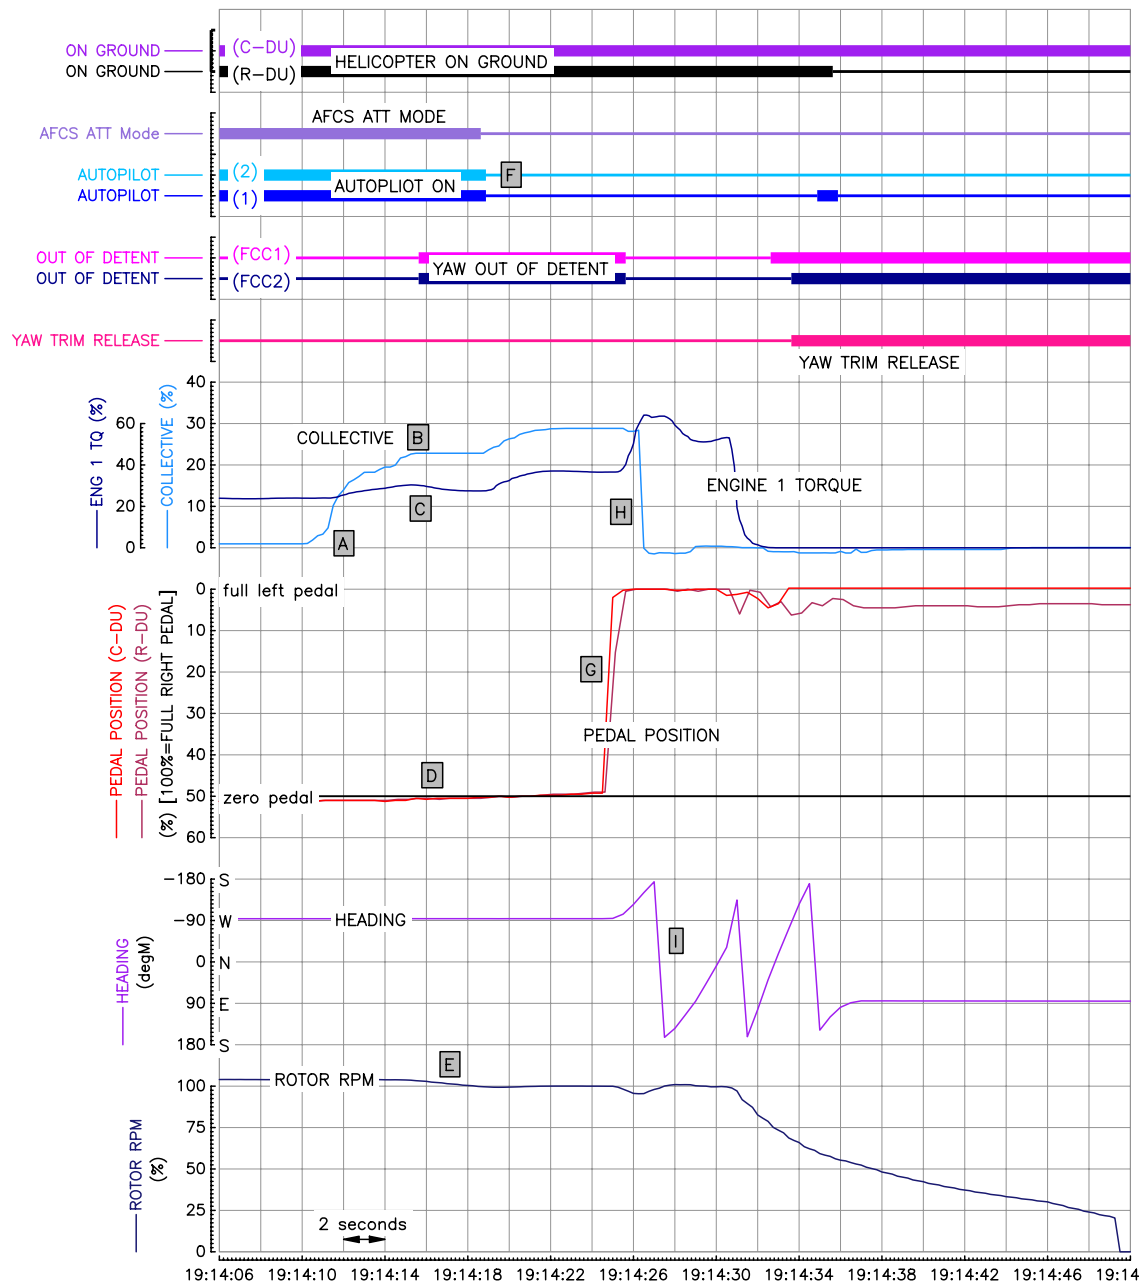
Figure 1
FDR data for 15 June 2018 event

Following the event on 15 June 2018, flight data from the combined recorder (ie a single flight recorder that combines the functions of the flight data recorder (FDR) and cockpit voice recorder (CVR)) was obtained by the operator, and a copy was subsequently given to the AAIB. The helicopter manufacturer analysed the data from the electronic data recorder (EDR) in the DUs which recorded the FDR data but at a lower sampling rate. The flight data for the event is plotted in Figure 1 and the key points are:

1. The collective was initially raised [A] with the AP engaged (in ATT mode).
2. The collective was held at about 23% of its range of movement for approximately 3 seconds [B].
3. Total torque (the No 2 engine was at idle, so all torque was from the No 1 engine) exceeds 30% [C].
4. During the three seconds the collective was held at about 23%, the pedals started to drift left [D], the pedal status changed to a yaw out-of-detent condition, the rotor speed reduced to 100% [E] (rpm switch on the collective), and the AP disengaged [F].
5. The yaw out-of-detent condition remained for approximately ten seconds during which time the pedals moved to the left by about 1.5% of their full range of movement.
6. The pedals then suddenly moved to left maximum deflection [G] in about one second.

7. The yaw out-of-detent condition cleared, and the collective was lowered [H] within one to two seconds of the pedal movement.
8. The helicopter made two and a half rotations to the left in approximately ten seconds [I] during which time both engines were shut down.

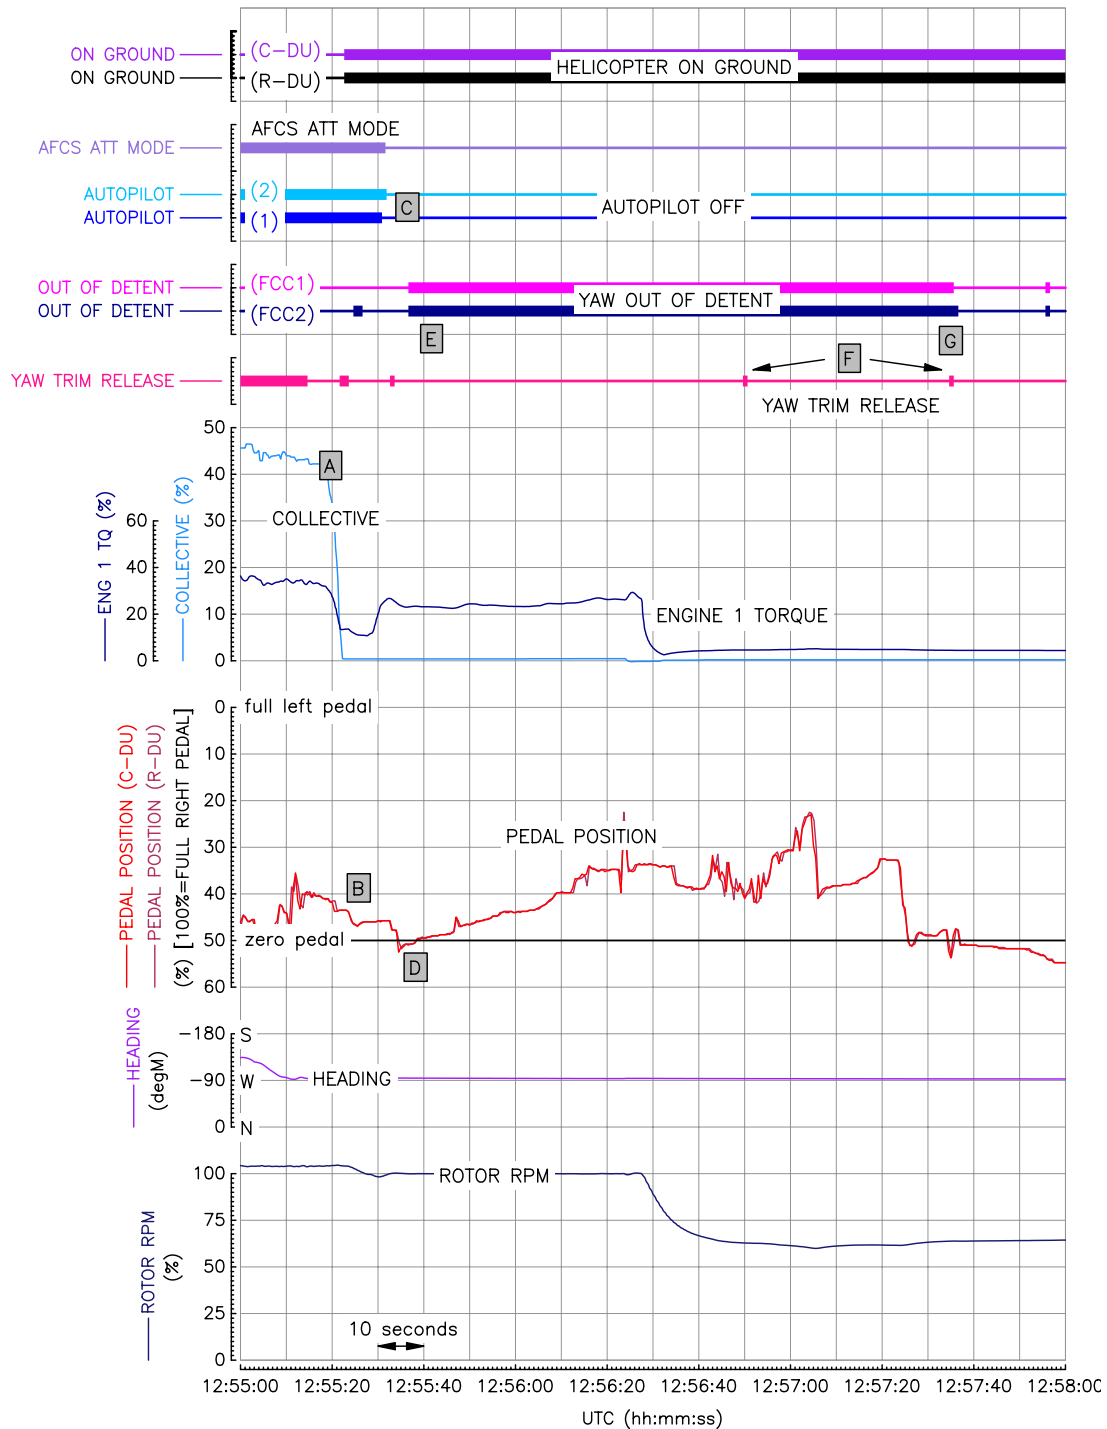
Figure 2
FDR data for 2 January 2019 event

The salient flight data for this event is plotted in Figure 2.

The key points shown in Figure 2 are:

1. The collective was lowered on touchdown [A].
2. A little left pedal input was made and held [B] as the AP was disengaged [C] ten seconds after touchdown.
3. A very brief right pedal input was made [D] before the pedals moved left and a yaw out-of-detent condition was detected [E].
4. The yaw out-of-detent condition remained active for nearly two minutes during which the TRIM RELEASE button was pressed on at least two distinct occasions [F].

Note: the sampling of the TRIM RELEASE is once every second so these button presses could have been anything from a single press of up to just under two seconds in duration, or multiple presses over the same period. Equally, unless the sampling occurs when the button is depressed, transient presses during any one second will not be recorded.

5. The yaw out-of-detent condition cleared after the second of the TRIM RELEASE button presses [G].

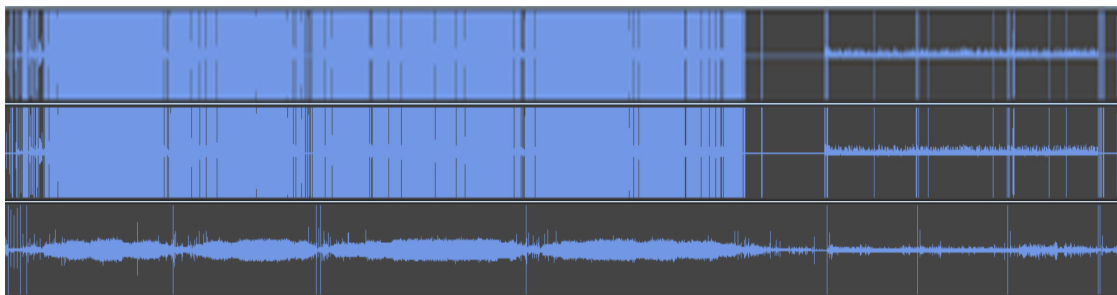
When listening to the CVR recordings for the January 2019 event, audio clipping was heard on both crew channels when the crew were speaking. Audio clipping is a form of waveform distortion where the amplitude of the signal waveform has been limited; for speech signals, this can affect the intelligibility⁴. No clipping during flight was evident on the cockpit area microphone (CAM) channel. Figure 3 shows the signal waveforms for the three channels for the two-hour duration of the CVR recording.

Signal waveforms for the three channels of CVR recording showing the two clipped crew channels (top and middle) and the CAM channel (bottom)

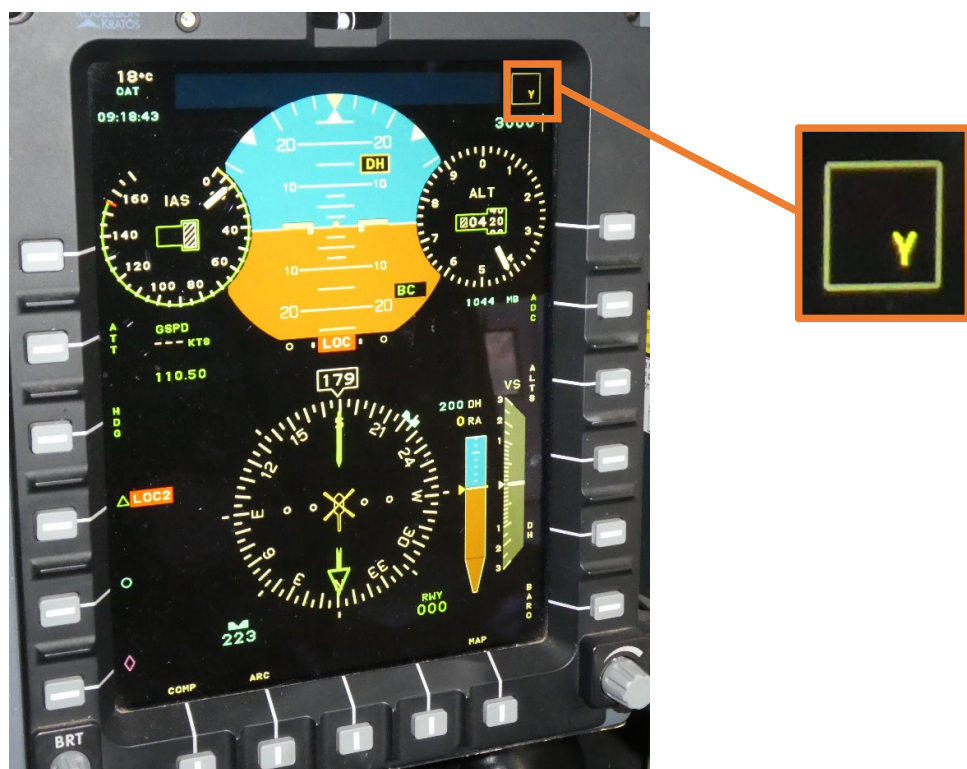
Figure 7

Yaw out-of-detent indication

The out-of-detent condition would have been indicated by a yellow 'Y' in the trim status box on the DU (Figure 7). However, the focus of the pilot's attention was elsewhere, and the trim status box has no attention getting qualities, so the indication was not noticed (and was unlikely to have been).

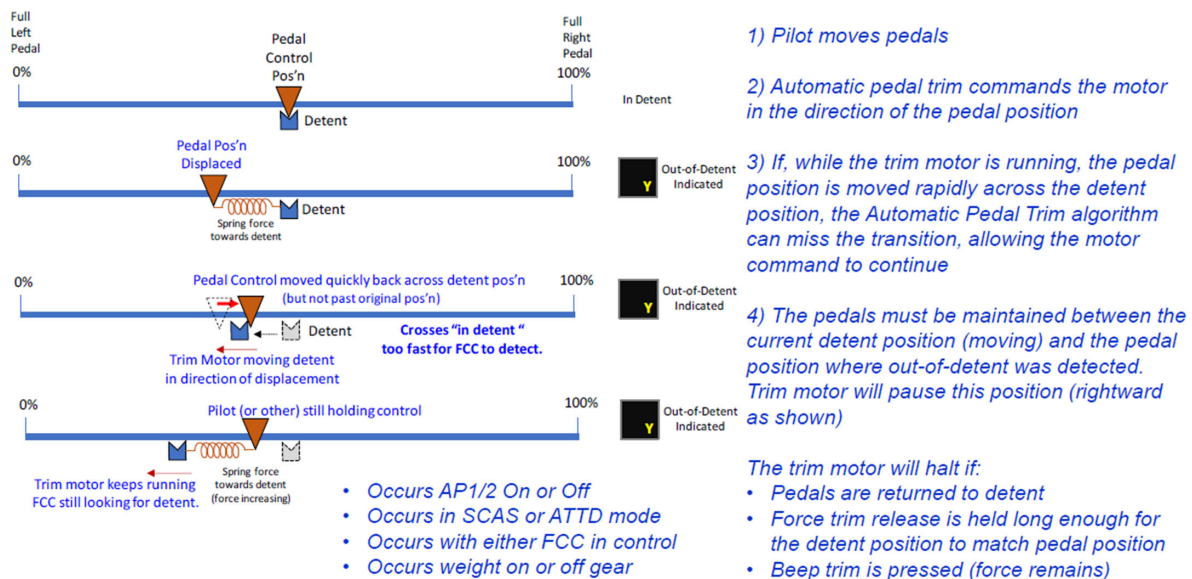
Figure 9

Additional tests were carried out after the recorded data from both incidents had been reviewed by the manufacturer and the AAIB. These tests identified a set of conditions where it was possible to induce a yaw trim runaway on G-WLTS. If the pedals were displaced away from the detent but reversed before the automatic trim had established a new detent, the AFCS would continue to drive the trim motor in the direction of the initial pedal movement. If the pedals were prevented from moving, the artificial feel spring 'wound up' and the force at the pedals increased. Testing found that when a maximum force of 40 to 60 lb occurred, the trim actuator clutch started to slip. The out-of-detent indication was displayed on the pilot's DU and the increased force at the pedals remained apparent until either of the following two events occurred:

1. The pedals were released. This allowed the spring to 'unwind' rapidly, driving the pedals to a new position. The out-of-detent indication cleared when the spring relaxed, and the pedals entered the detent position.
2. The TRIM RELEASE button on the cyclic stick top was pressed and held. This disengaged the trim actuator clutch, allowing the spring to 'unwind' without driving the pedals. The speed at which the spring unwound was limited by the friction damper in the trim actuator, and the TRIM RELEASE button had to be pressed and held until the force was no longer apparent.

The manufacturer recreated the runaway scenario on another Bell 429 helicopter and, after reviewing the design, concluded that it was a feature of the AFCS logic (Figure 9).

Automatic pedal trim runaway scenario

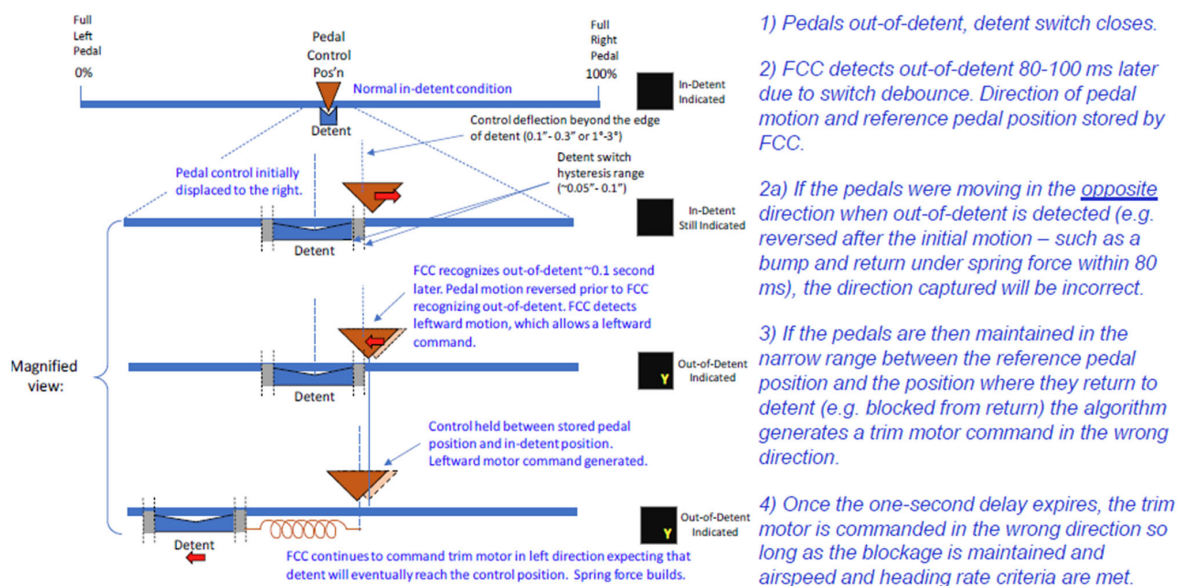
Figure 10

Additional analysis of the system logic identified another scenario that could occur if the pedals changed direction within 80 ms of initially being displaced. This would result in the AFCS detecting an out-of-detent condition but capturing the wrong direction of pedal movement. If the pedals were subsequently held in a very narrow range, automatic trim would attempt to drive the pedals in the wrong direction and the force at the pilot's feet would increase. The manufacturer was able to induce this scenario on a test platform but was unable to recreate it on a helicopter (Figure 10).

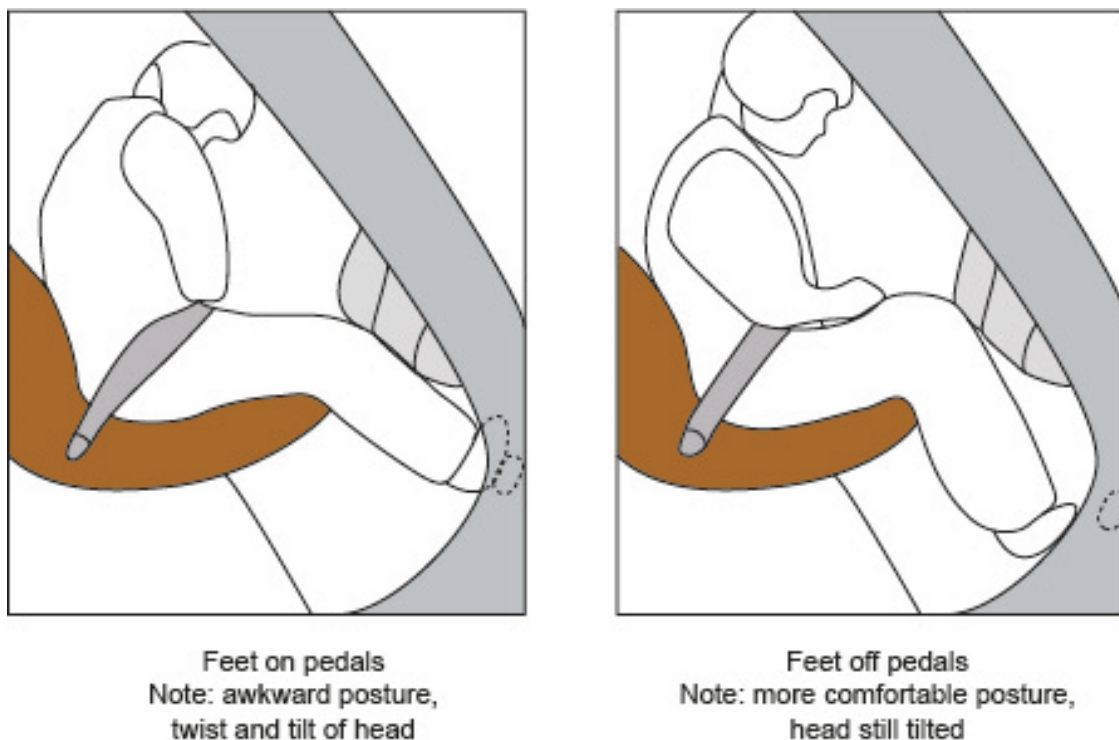
The pilot of G-WLTS did not think the helicopter would become light on its skids or lift off during a PAC, and several of the operator's pilots stated it was common practice to do the PAC with their feet off the pedals. The pilot was right handed and used a chinagraph pencil to record the necessary figures onto the flying suit's left kneepad (to avoid the writing being rubbed off while flying). The pilot found it more comfortable to do this with feet off the pedals. Figure 11 is a diagram created by tracing the pilot's outline from photographs when performing this task with feet on and off the pedals of G-WLTS. It shows that having feet off the pedals resulted in a more aligned posture with less twist and tilt of the head. In either case, however, the pilot would have been looking down into the cockpit while writing meaning their head would have been tilted in relation to the axis of the yawing movement.

Pilot body posture while writing with feet on and off the pedals
