SERIOUS INCIDENT

Aircraft Type and Registration:	Boeing 747-436, G-BNLN	
No & Type of Engines:	4 Rolls-Royce RB211-524G2-T-19 turbofan engines	
Year of Manufacture:	1990	
Date & Time (UTC):	9 June 2019 at 1559 hrs	
Location:	In flight from London Heathrow Airport to Phoenix International Airport, USA	
Type of Flight:	Commercial Air Transport (Passenger)	
Persons on Board:	Crew - 18	Passengers - 320
Injuries:	Crew - None	Passengers - None
Nature of Damage:	None	
Commander's Licence:	Airline Transport Pilot's Licence	
Commander's Age:	57 years	
Commander's Flying Experience:	23,465 hours (of which 2,537 were on type) Last 90 days - 211 hours Last 28 days - 77 hours	
Information Source:	AAIB Field Investigation

Synopsis

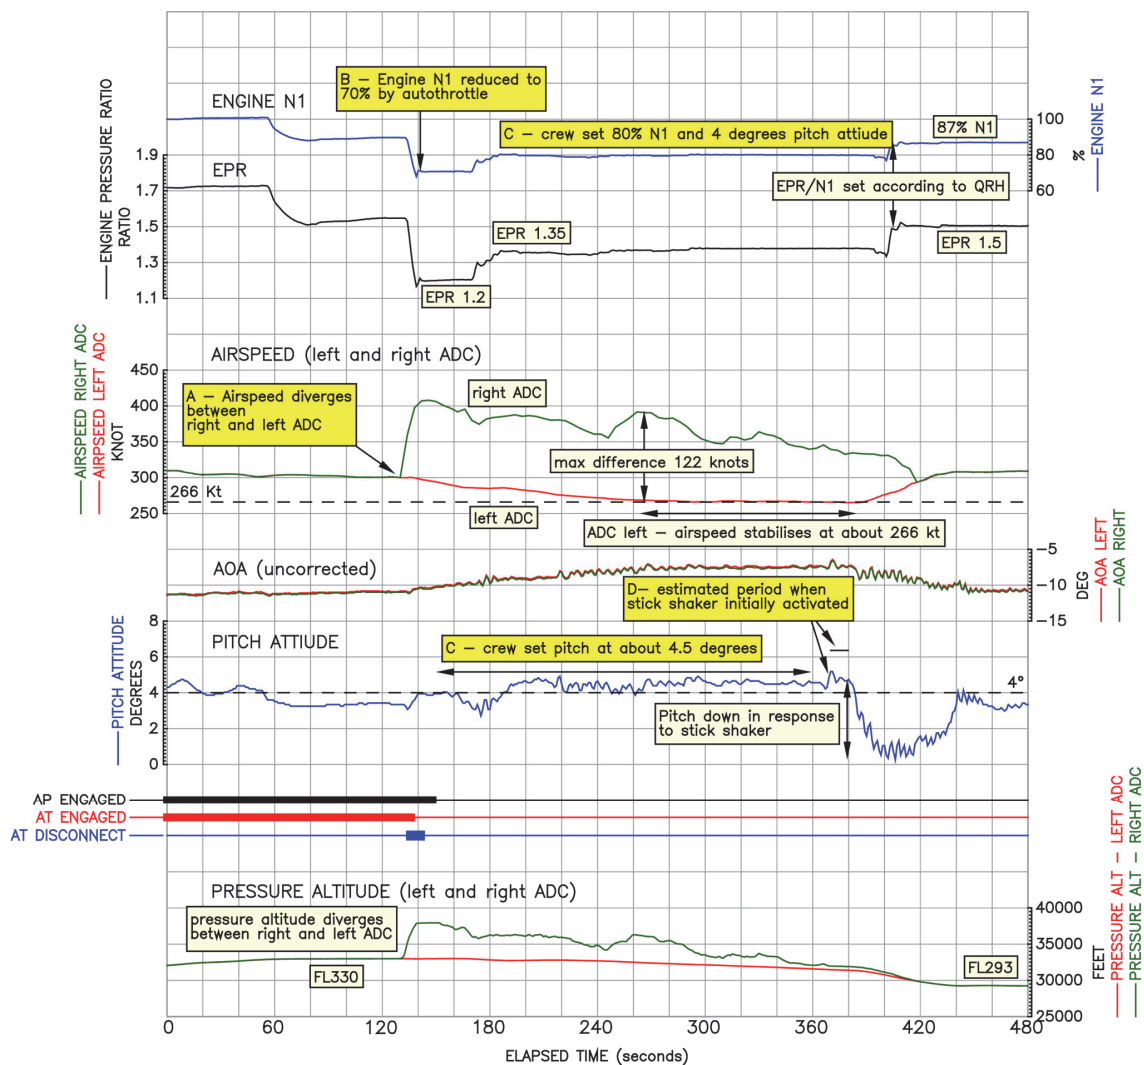
Figure 1

Shortly after the aircraft reached the top of climb and levelled at FL330, data started to deviate between the left and right ADC (Point A, Figure 1). Over about 12 seconds, airspeed from the right ADC increased from 300 kt to 407 kt, whilst airspeed from the left ADC remained at 300 kt. In response to the increase in airspeed from the right ADC, the engine thrust was automatically reduced from 89% N1 (1.54 EPR) to 70% N1 (1.2 EPR) (Point B, Figure 1). Thus, whilst data from the right ADC indicated that the airspeed had increased and the aircraft had climbed, data from the left ADC showed that the aircraft's actual airspeed and altitude were gradually reducing due to the reduction in engine thrust.

The autothrottle and autopilot were then disconnected by the crew and the engine thrust manually increased from 70% to 80% N1 and the pitch set to approximately 4.5° nose-up (Points C, Figure 1). After a further 80 seconds, the airspeed from the left ADC stabilised at about 266 kt as the aircraft continued to gradually descend. During this period, airspeed and altitude from the right ADC had continued to deviate from the left ADC by as much as 122 kt and 500 ft.

The engine power was maintained at 80% and pitch at approximately 4.5° nose-up, but there were small variations in pitch consistent with hand flying the aircraft. After a further 90 seconds (Point D, Figure 1), there was a slight increase in pitch to just over 5° nose-

up with a corresponding increase in angle of attack. The airspeed and Mach number were 266 kt / 0.73 Mach respectively from the left ADC and 340 kt / 0.92 Mach from the right ADC. At about this time (Point D, Figure 1) the stick shakers were activated by the right stall warning computer. When the flight crew carried out the stall recovery manoeuvre the pitch was reduced to about 0.5° nose-up and engine thrust increased to 87% N1 (1.5 EPR). The pitch was then gradually increased to 4° nose-up, during which the airspeed and altitude deviation between the left and right ADC reduced to approximately zero. The aircraft was subsequently levelled at FL293 where the air data source was changed and the autopilot and autothrottle re-engaged.

Discrepancy between the right and left ADC

The malfunction of the right ADC was not identified despite extensive functional testing. It is likely that the false warnings had been generated erroneously as a result of an incorrect Mach number being supplied by the right ADC. This would then also have caused the stall warning system to operate erroneously at a safe airspeed.
