AAIB Bulletin S1/2020

SPECIAL

SERIOUS INCIDENT

Aircraft Type and Registration:	Airbus A321-211, G-POWN	
No & Type of Engines:	2 CFM CFM56-5B3/3 turbofan engines	
Year of Manufacture:	2009 (Serial no: 3830)	
Date & Time (UTC):	26 February 2020 at 0009 hrs	
Location:	London Gatwick Airport	
Type of Flight:	Commercial Air Transport (Non-Revenue)	
Persons on Board:	Crew - 7	Passengers - None
Injuries:	Crew - None	Passengers - N/A
Nature of Damage:	Fuel system contamination	
Commander's Licence:	Airline Transport Pilot's Licence	
Commander's Age:	28 years	
Commander's Flying Experience:	5,059 hours (of which 4,855 were on type) Last 90 days - 87 hours Last 28 days - 17 hours	
Information Source:	AAIB Field Investigation

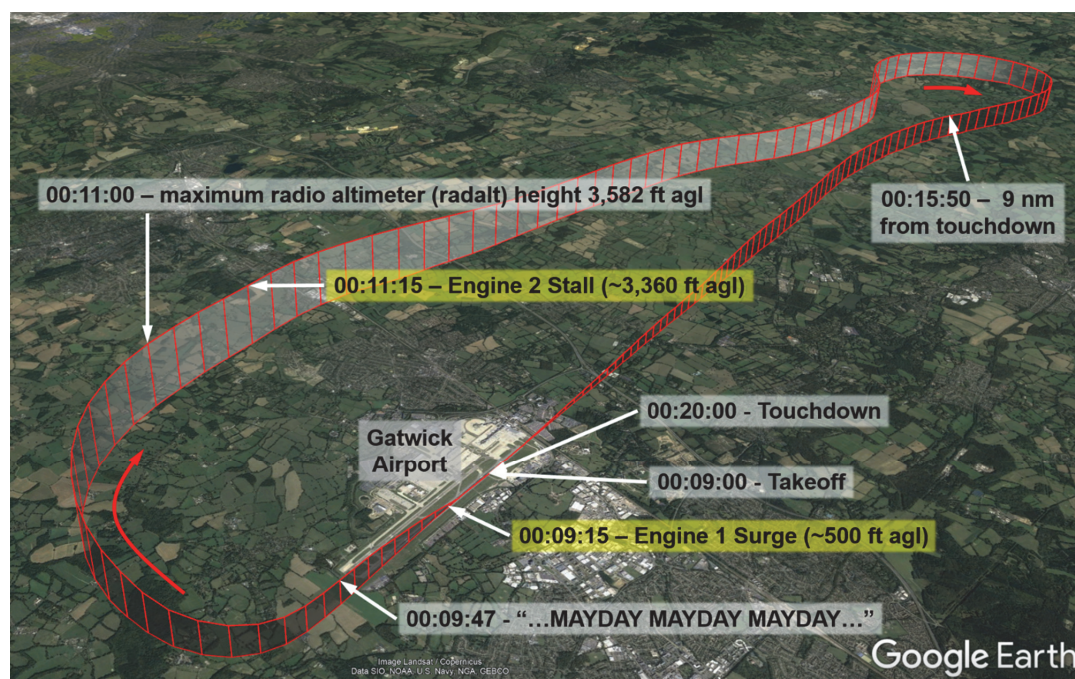
Figure 1

At around 500 ft agl, the No 1 engine began banging and surging. Commander A recalled that the engine's control indications were fluctuating, and the aircraft was "yawing... and fishtailing... all over the place". There was no accompanying ECAM message. Data recorded on the flight data recorder subsequently showed that the No 1 engine N_1 reduced below 40% for a period of approximately 25 seconds despite the thrust levers remaining in the FLEX/MCT⁷ detent.

Radar track of G-POWN with timing of significant events highlighted

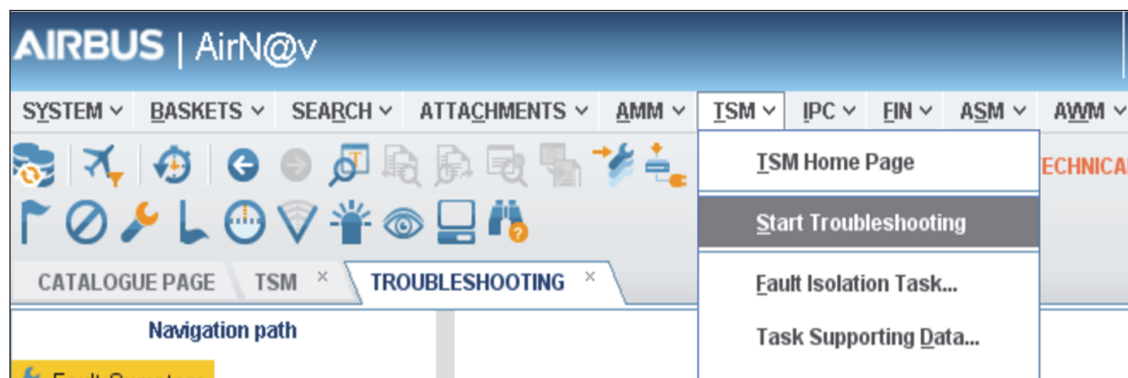
Figure 2

Airbus recommended that the TSM must always be filtered for a specific aircraft registration, fleet serial number or effectivity and that the TSM should be accessed using the '*Start Troubleshooting*' function in *AirN@v* (Figure 2) and the '*Troubleshooting*' tab in *airnav^x* (Figure 3).

Airbus recommended way to access the TSM in AirN@v v3, 'Start Troubleshooting' function

In consultation with the manufacturer, the operator granted the Gatwick AMO access to the airnav^x system.

The Gatwick AMO issued a safety and compliance notice highlighting the importance of filtering maintenance data to the specific aircraft.

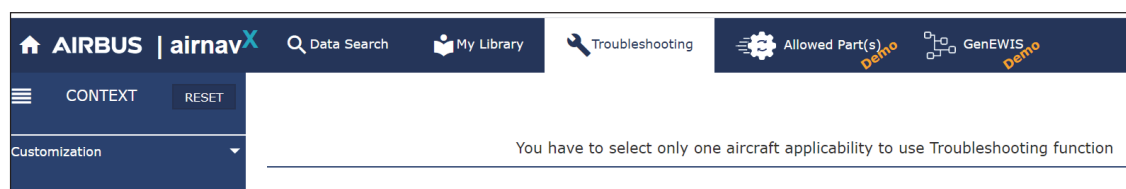
Figure 3

Airbus recommended way to access the TSM in airnavX, 'Troubleshooting' tab

When using the computer-based aircraft manual for troubleshooting, the Gatwick engineer did not filter the TSM for the aircraft he was working on and accessed troubleshooting procedures using the table of contents. This differed from the manufacturer's recommended method of using the TSM. Consequently, the engineer selected a procedure for a different type of engine to that fitted to G-POWN. The Gatwick AMO did not have access to the manufacturer's most recent computer based application for manuals, *airnav*^x, which is designed to ensure engineers filter the TSM for a specific aircraft. This later application would have reduced the chance of the engineer selecting the wrong procedure.

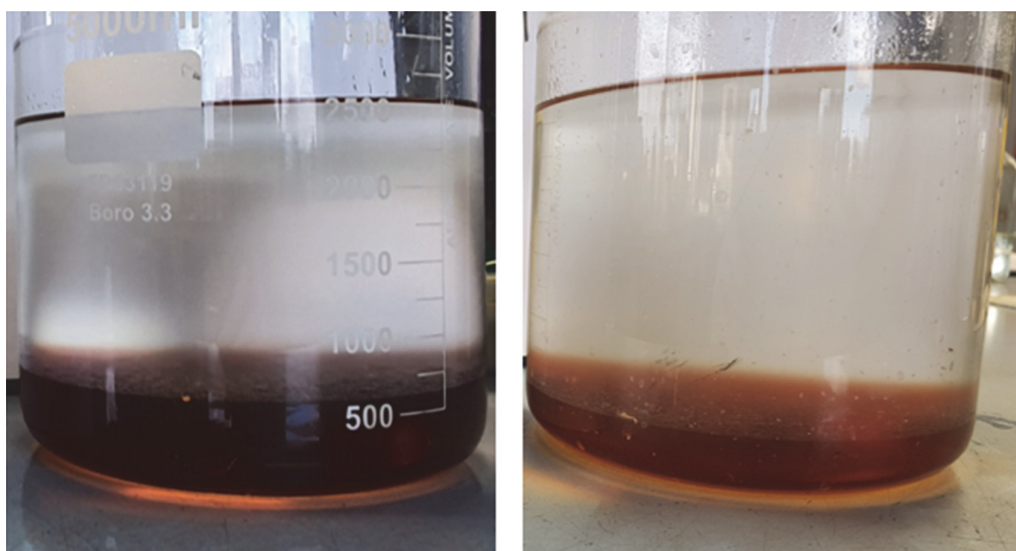
Figure 4

and water separation characteristics (MSEP¹⁵). The fuel samples, once the contents had settled out under gravity, contained a separate brown liquid layer beneath the main fuel layer (Figure 4). Trace element results of the fuel and the bottom brown layer showed similar spectra to a reference Kathon sample, but with a higher water content. The laboratory that conducted the fuel testing commented that:

'The results indicate contamination with undissolved Kathon. It was noted that the bottom layer that is mostly Kathon plus some unknown products and water, suspected to be causing the darker colour than the reference Kathon sample. This is likely due to the glycol type solvent used in Kathon product dissolving polar materials from the fuel and fuel tank surfaces. This may be analogous to observations with another similar glycol additive, FSII (Fuel System Icing Inhibitor), which is used in military jet fuels. It is colourless but forms brown additive/water layer in tank bottoms.'

Fuel samples drained from left and right wing fuel tanks

During biocidal shock treatment, an excessive quantity of Kathon biocide was introduced into the aircraft's wing fuel tanks, equating to 37 times the maximum permitted dosage in the AMM. The AMO engineer who carried out this task had not performed it before and did not recognise that he was using an excessive quantity of biocide. The task had not been designated as a critical task, and therefore no additional measures were used to check that it was performed in accordance with the AMM Task. The reasons for this and the impact on the sequence of events in the subsequent serious incident will be investigated. No control measures were in place at the AMO stores or planning departments to prevent unusually large quantities of chemicals being issued to AMO staff. In addition, the AMM task instructions used the term 'ppm' for which there was no definition within the AMM glossary, and no additional guidance was provided of how to perform the biocide fuel dosing calculation.

The EASA issued Safety Information Bulletin SIB 2020-06¹⁶ on 20 March 2020, to notify affected stakeholders of recent air safety-related events involving Kathon biocide and to remind aircraft owners and operators to ensure that the correct method and dosage is used for approved biocide treatment of aircraft fuel systems. The FAA issued Special Airworthiness Information Bulletin SAIB NE-20-04¹⁷ on 25 March 2020 that contained similar regulatory guidance.

The manufacturer of Kathon discontinued the use of its product for aviation fuel applications on 10 March 2020.

On 16 March 2020, CFM, the manufacturer of the G-POWN's engines, issued Alert Service Bulletin 73-A0296 recommending that operators of CFM56-5B engines suspend the use of Kathon during aircraft fuel system biocide treatments. Similar instructions were issued for other variants of the CFM56 engine family, as well as all General Electric turbofan engines.

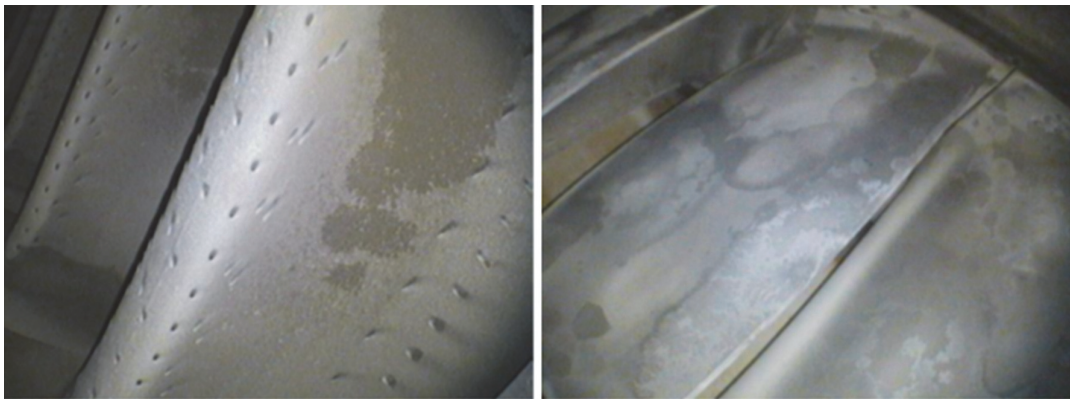
Figure 5

The aircraft's engines were examined visually using a borescope and both exhibited similar findings. There was no significant damage evident to the fan, low-pressure compressor or high-pressure compressor components, and any minor defects that were identified were within AMM damage limits. The combustion chambers, and high-pressure and low-pressure turbine blades were coated in a thin layer of white material that was observed on the turbine blades' convex surfaces (Figure 5). The high-pressure turbine nozzle guide vanes were also coated in the white material.

White material deposits on No 2 engine high-pressure turbine blades
(No 1 engine similar)

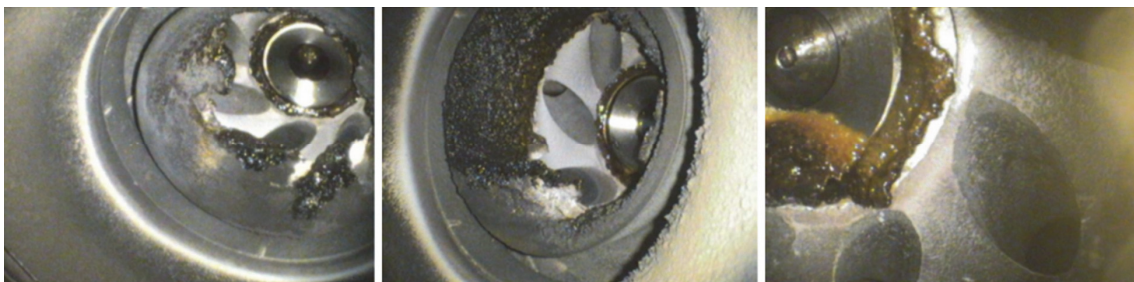
Figure 6

Significant deposits of a brown material were evident on all the combustion chamber swirl cups, adjacent to the fuel spray nozzles, in both engines (Figure 6).

Brown material deposits in No 2 engine combustion chamber swirl cups
(No 1 engine similar)

The excessive level of Kathon in the aircraft's fuel system is suspected to have caused the subsequent problems with the aircraft's engines, including those experienced during the incident flight. The AAIB is also aware of other events where engine performance was affected by over-dosing of fuel with biocide. Visual inspection confirmed the presence of abnormal deposits within both engines downstream of the fuel spray nozzles. The influence of the over-dosed fuel on the engines' HMUs and other fuel system components is subject to the ongoing AAIB investigation.
