**SERIOUS INCIDENT**

<b>Aircraft Type and Registration:</b>	Embraer E55P Phenom, D-COLT	
<b>No &amp; Type of Engines:</b>	2 Pratt & Whitney Canada PW535E turbofan engines	
<b>Year of Manufacture:</b>	2014	
<b>Date &amp; Time (UTC):</b>	12 March 2019 at 1505 hrs	
<b>Location:</b>	Runway 23R, Manchester Airport	
<b>Type of Flight:</b>	Private	
<b>Persons on Board:</b>	Crew - 1	Passengers - 3
<b>Injuries:</b>	Crew - None	Passengers - None
<b>Nature of Damage:</b>	None reported	
<b>Commander's Licence:</b>	Airline Transport Pilot's Licence	
<b>Commander's Age:</b>	44 years	
<b>Commander's Flying Experience:</b>	4,933 hours (of which 746 were on type) Last 90 days - 22 hours Last 28 days - 11 hours	
<b>Information Source:</b>	Aircraft Accident Report Form submitted by the pilot and further enquiries made by the AAIB

**Synopsis**

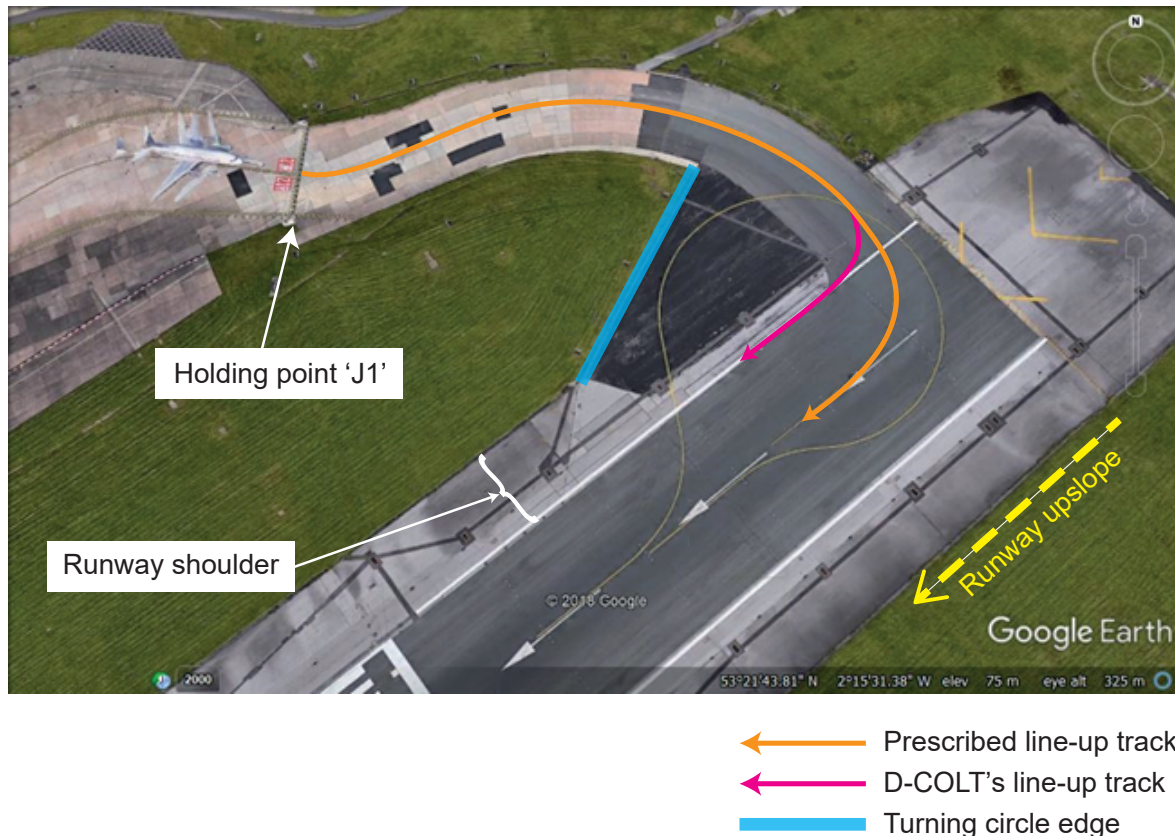
**Figure 1**

The pilot reported rain and gusty conditions. While he was lining up, the sun breaking through the clouds caused glare from the wet runway, making it difficult to see. As he taxied past the angled edge of the turning circle, he perceived it to be the edge of the runway shoulder<sup>2</sup> (Figure 1). Then on sensing that the aircraft was running over runway lights, he thought the aircraft was on the centreline. He turned the aircraft accordingly and was facing the low sun as he began the takeoff roll.

J1 intersection showing D-COLT's line-up track

J1 was already a hot spot for runway incursions because of its obtuse orientation to, and distance from, the runway centreline. The shape of the turning circle, the 23 m widened runway shoulders, the lit runway edge lights and the unlit lead-on lights, may have contributed to the pilots' mis-perception of the centreline position. Furthermore, the relatively small size of both aircraft would have caused increased difficulty for the pilots seeing over the runway's convex profile, along its full length.

The aircraft began taking off on the edge stripe of Runway 23R at Manchester after lining up via intersection J1. The sun's glare on the wet runway, and the orientation, dimensions and slope of the intersection and runway surfaces, contributed to the pilot misidentifying the centreline. The rolling takeoff reduced his opportunity to check the aircraft's position.

As a result of the two occurrences the airport authority has undertaken to instate a 'runway excursion' hotspot at J1, in addition to the incursion-related hotspot 2. It is reconfiguring its lighting so that J1's lead-on lights will always illuminate when its stopbar is lowered, regardless of the ambient light conditions. It intends to apply green paint to the areas of the J1 turning circle outside of the runway edge lighting, giving the impression of grass.

- Instate a 'runway excursion' hotspot at J1.
- Reconfigure J1's lead-on lights so that they will always illuminate when its stopbar is lowered.
- Apply green paint to the areas of the J1 turning circle outside of the runway edge lighting, giving the impression of grass.

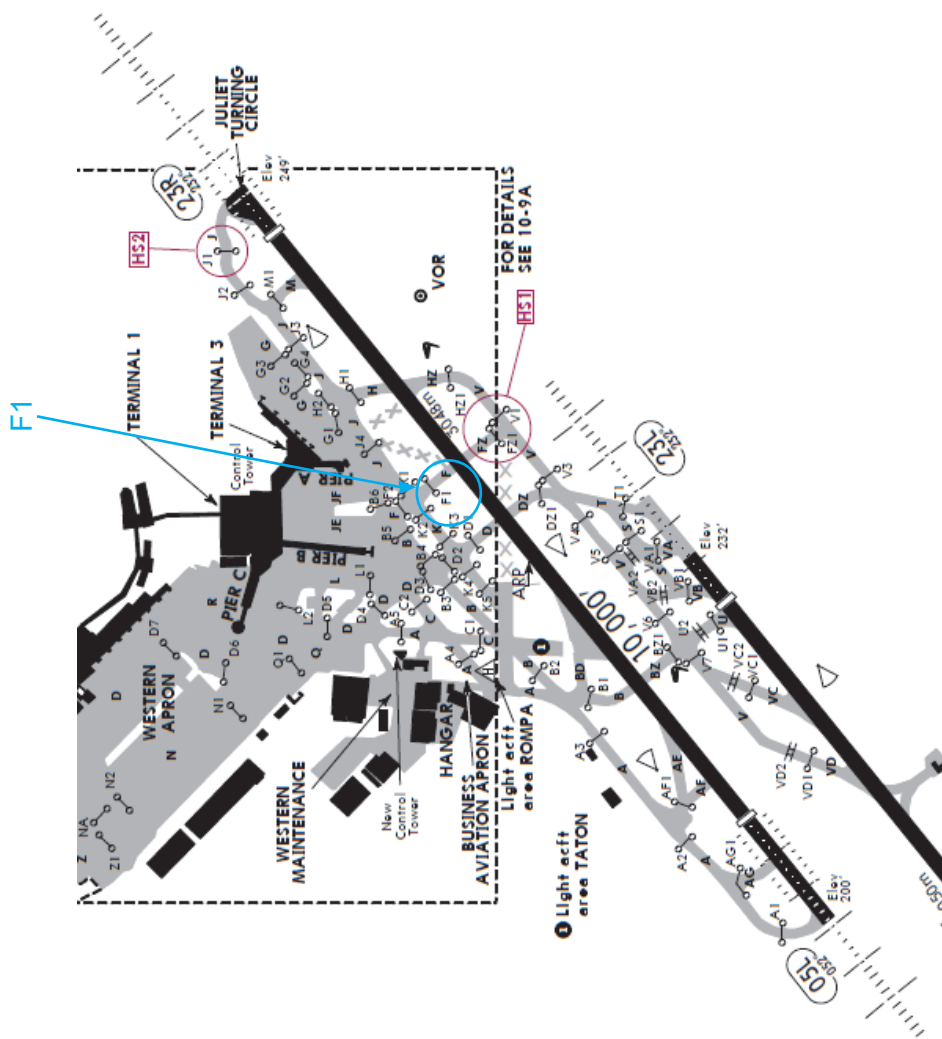
Figure 2  
Excerpt from chart 10-9

**HS2** Hold J1 faces 23R approach and is located 200m from the runway centerline.

The pilot used chart 10-9 during taxiing (Figure 2). Following is an excerpt of that plate, including Runway 05L/23R; Juliet turning circle; Hot Spot 2<sup>10</sup> and its definition; and HZ.

The ATCO stated that upon realising D-COLT was tracking the runway edge stripe, he considered its airspeed as being in the mid-range of its takeoff roll. Given the runway shoulder's lower load bearing strength, he was concerned about potential debris from it, so he instructed the aircraft to stop. He recalled it was in the vicinity of M1 (Figures 2 and 3) when he did so.

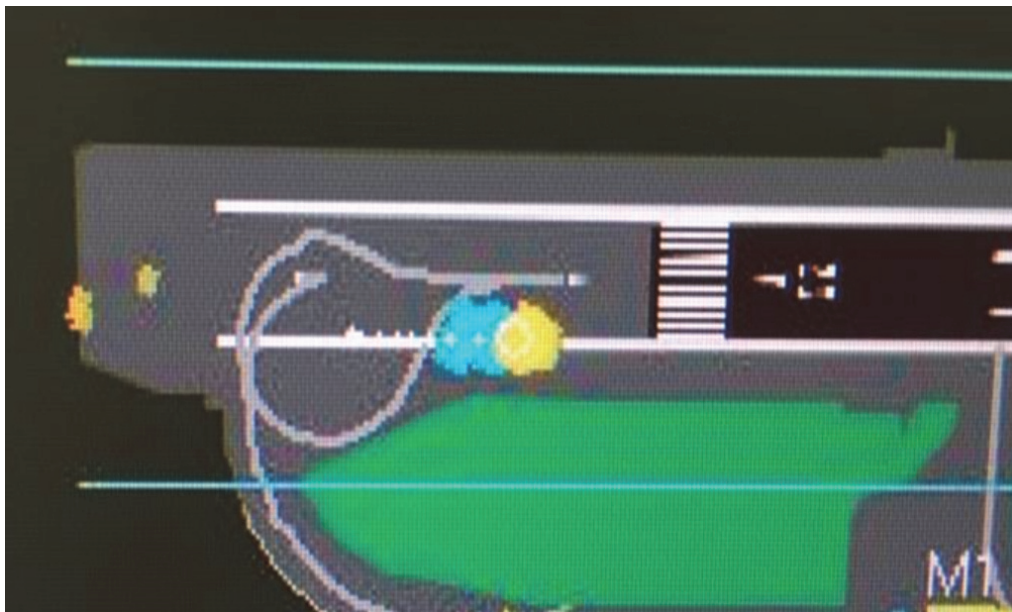
**Figure 3**

The ATCO, watching from the visual control room (VCR), realised the takeoff didn't look "right". He checked the surface movement radar (SMR) which showed D-COLT tracking the right runway side stripe, so instructed the aircraft to stop and cancelled its takeoff clearance. He instructed the aircraft on final approach to go around.

The ATCO reported that while he saw D-COLT moving on to the runway he was also monitoring the aircraft vacating the runway and the aircraft on final approach. The General Manager of the air traffic services unit (ATSU) reported that it can be difficult to determine the precise position of aircraft entering the runway at J1, which is some distance from the VCR and involves a large expanse of tarmac. The ATCO stated that in both occurrences he used SMR to confirm the aircrafts' positions (Figure 3).

Image of SMR at the commencement of D-COLT's takeoff roll

The ANSP confirmed it is undertaking safety action to promulgate the lessons from both occurrences across all its airport units, by including them in its upcoming annual refresher training course for ATCOs and otherwise. This will highlight the use of SMR for monitoring aircraft lining up, particularly small aircraft on large runways with wide shoulders.

- Promulgate the lessons learned from both occurrences across all its airport units, by including them in its upcoming annual refresher training course for ATCOs and otherwise; and by highlighting the use of SMR for monitoring aircraft lining up, particularly small aircraft on large runways with wide shoulders.

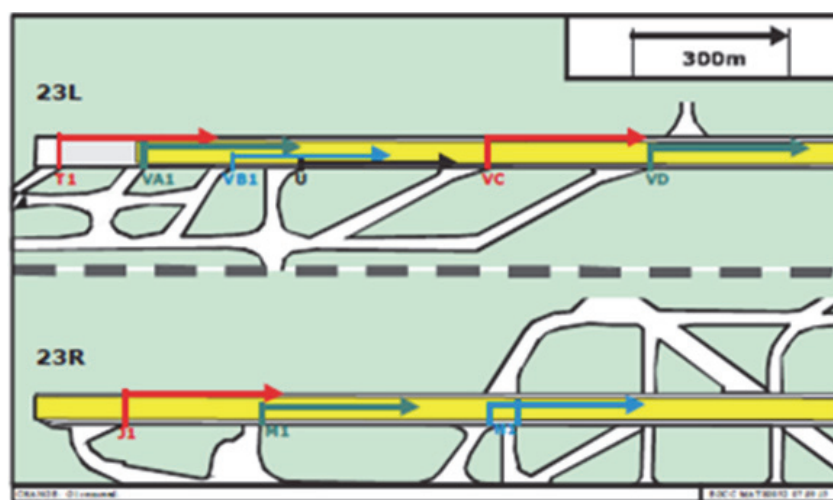
Figure 7 Cancellation of Take-Off Clearance map - Westerlies

*There are very few circumstances in which it is appropriate to cancel a take-off clearance when an aircraft is travelling at significant speed. The following maps<sup>14</sup> present a guide to controllers on the points beyond which it is likely that an aircraft taking off will be travelling in excess of 80kt. If the aircraft has passed the appropriate point, the cancellation of a take-off clearance should only occur when the aircraft is in serious and imminent danger.'*

In the D-COLT event, although the ATCO could not see any debris, he was concerned about the risk of it from the lower-strength runway shoulder, so instructed the aircraft to stop. The aircraft was in the vicinity of M1 – which is around the '80 KIAS' point described by MATS 2 – with a reported airspeed in the vicinity of 80 KIAS, when he did so. The aircraft stopped safely and taxied back for a second departure without delay.
