ACCIDENT

Aircraft Type and Registration:	Guimbal Cabri G2, G-CILR	
No & Type of Engines:	1 Lycoming O-360-J2A piston engine	
Year of Manufacture:	2015 (Serial no: 1090)	
Date & Time (UTC):	22 July 2019 at 1730 hrs	
Location:	Wycombe Air Park	
Type of Flight:	Private	
Persons on Board:	Crew - 1	Passengers - None
Injuries:	Crew - None	Passengers - N/A
Nature of Damage:	Destroyed	
Commander's Licence:	Private Pilot's Licence (Helicopters)	
Commander's Age:	21 years	
Commander's Flying Experience:	174 hours (of which 110 were on type) Last 90 days - 22 hours Last 28 days - 9 hours	
Information Source:	AAIB Field Investigation

Synopsis

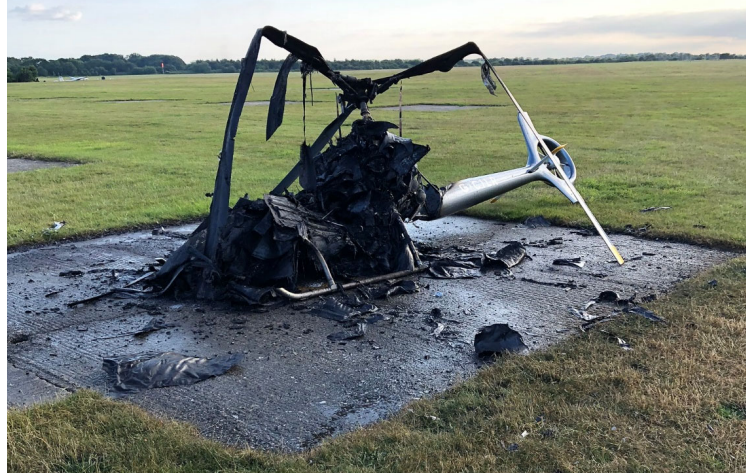
Figure 1

The helicopter was located at helicopter landing pad 10 at Wycombe Air Park. The entire helicopter, except the tail boom had been consumed by fire (Figure 1).

G-CILR prior to being moved

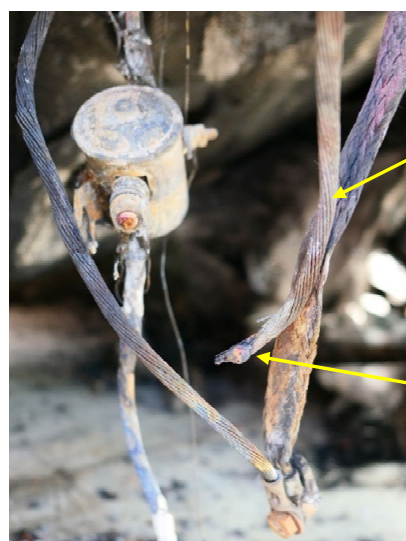
Figure 2

The engine remained attached to its support frame. The battery had been destroyed, however the electrical cables that had been connected to the battery were present. The insulation on the cables had been consumed by fire. The cable connecting the alternator output to the starter relay in the battery compartment was found to be in two pieces. Where it had broken the cable material had fused together, creating a globule of re-solidified molten material (Figure 2). Both ends of the broken cable was removed from the wreckage and taken to the AAIB for further assessment. A section of the helicopter's power generation and distribution circuit diagram can be found in Figure 3.

Alternator to starter
relay cable – starter
relay end

Re-solidified molten
material at break

Helicopter cables within the wreckage

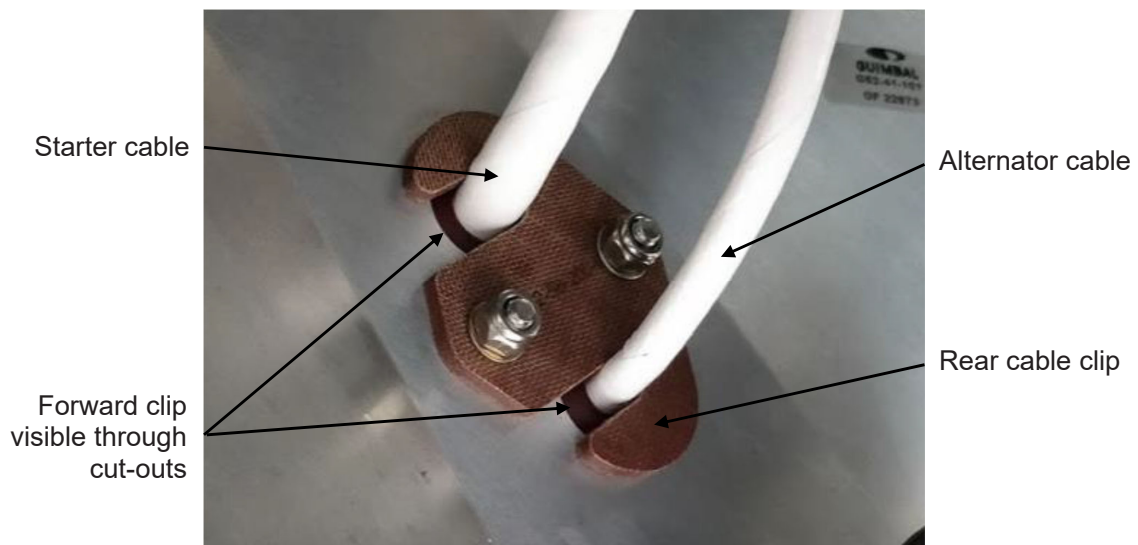
Figure 4

An aluminium baffle is mounted to the front of the engine to aid cooling around the engine. The starter and alternator cables, which run from the battery compartment, on the left of the aircraft behind the firewall, to the engine mounted starter and alternator, pass through the baffle and are held in place by two cotton impregnated phenolic clips either side of the baffle. (Figures 4 and 5)

Starter and alternator cables passing through engine baffle (viewed from rear)

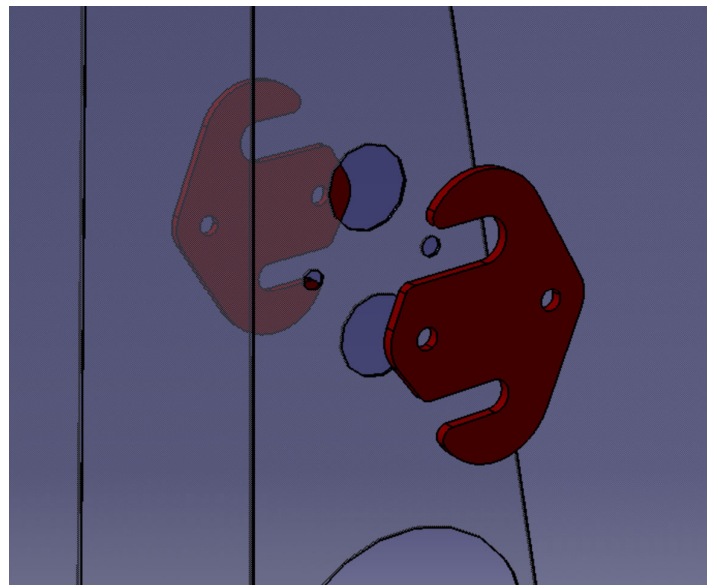
Figure 5

Exploded view of correct installation of cable clips

The clips are designed to hold the cables centrally within the pre-drilled holes in the baffle. The clips themselves are identical and should be fitted in opposition to each other, so they retain the cables between the bottom of each cut out.

An assessment of the clip design identified that it was possible to fit the clips in the same orientation, rather than in opposition, resulting in the cable not being retained as intended. In this situation the cable has sufficient freedom of movement to contact the unprotected edge of the pre-drilled hole in the baffle.

A Service Bulletin was issued by the helicopter manufacturer to inspect the clips to ensure correct installation.

The helicopter manufacturer has completed a redesign of the clipping system to ensure the cable clipping cannot be installed incorrectly. The new design of clip is being fitted to new production helicopters and will be available via service bulletin from the manufacturer.

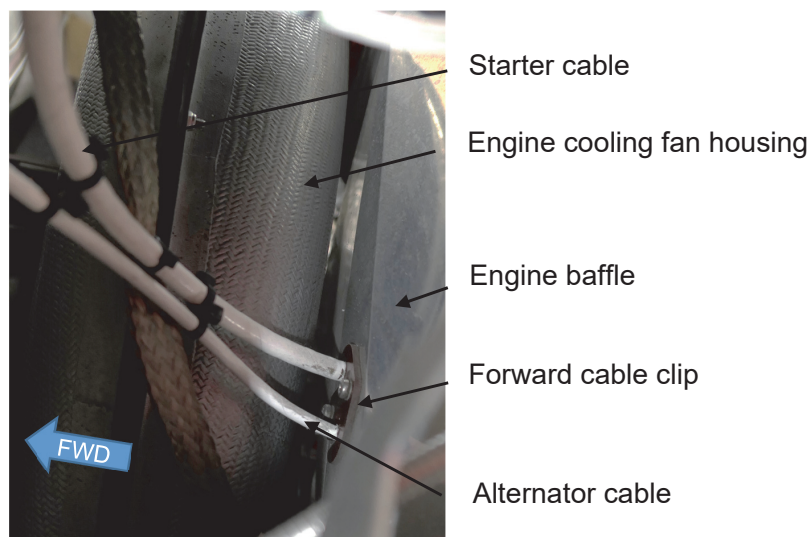
Figure 6

A cooling fan, with a carbon fibre housing, is mounted in front of the engine baffle (Figure 6).

Starter and alternator cables passing through front of engine baffle (view from below)

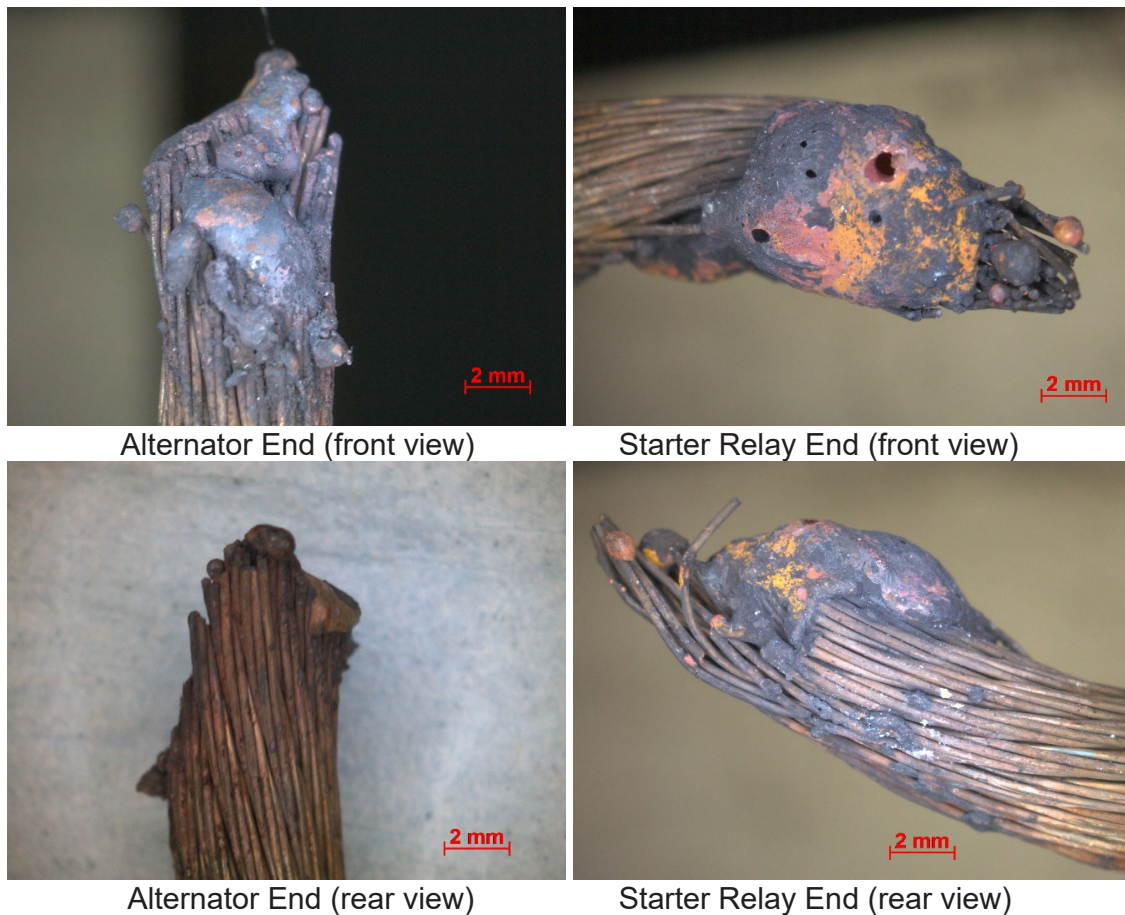
Figure 7

Laboratory analysis of the cable removed from the aircraft found that the re-solidified molten material (Figure 7) was predominantly copper and nickel, the material of the cable itself. The cause of the fusing was as a result of extreme localised heating associated with electrical arcing. There were no traces of any other metallic elements within the re-solidified molten material to identify the component that the cable had arced against.

Measurement of the cable fragments against a cable of the same part number from another Guimbal Cabri G2 identified that the location of the break was coincident with the location that the wire passed through the aluminium baffle. The baffle on G-CILR had been destroyed in the fire and therefore could not be examined as part of the investigation.

Alternator cable break location
