ACCIDENT

Aircraft Type and Registration:	Sikorsky S-61N Sea King, G-ATBJ	
No & Type of Engines:	2 General Electric Co CT58-140-2 turboshaft engines	
Year of Manufacture:	1965 (Serial no: 61269)	
Date & Time (UTC):	1 February 2018 at 1100 hrs	
Location:	Marchwood, Hampshire	
Type of Flight:	Commercial Air Transport (Non-Revenue)	
Persons on Board:	Crew - 2	Passengers - None
Injuries:	Crew - None	Passengers - N/A
Nature of Damage:	Damaged beyond economical repair	
Commander's Licence:	Air Transport Pilot's Licence	
Commander's Age:	60 years	
Commander's Flying Experience:	11,233 hours (of which 1,501 ¹ were on type) Last 90 days - 26 hours Last 28 days - 0 hours	
Information Source:	AAIB Field Investigation

Synopsis

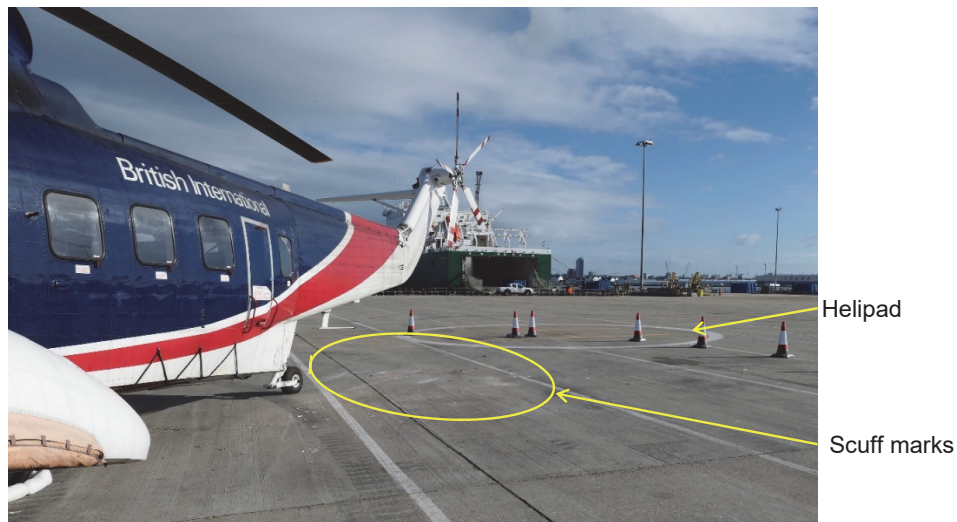
Figure 2

G-ATBJ impact mark (note: cones positioned after accident)

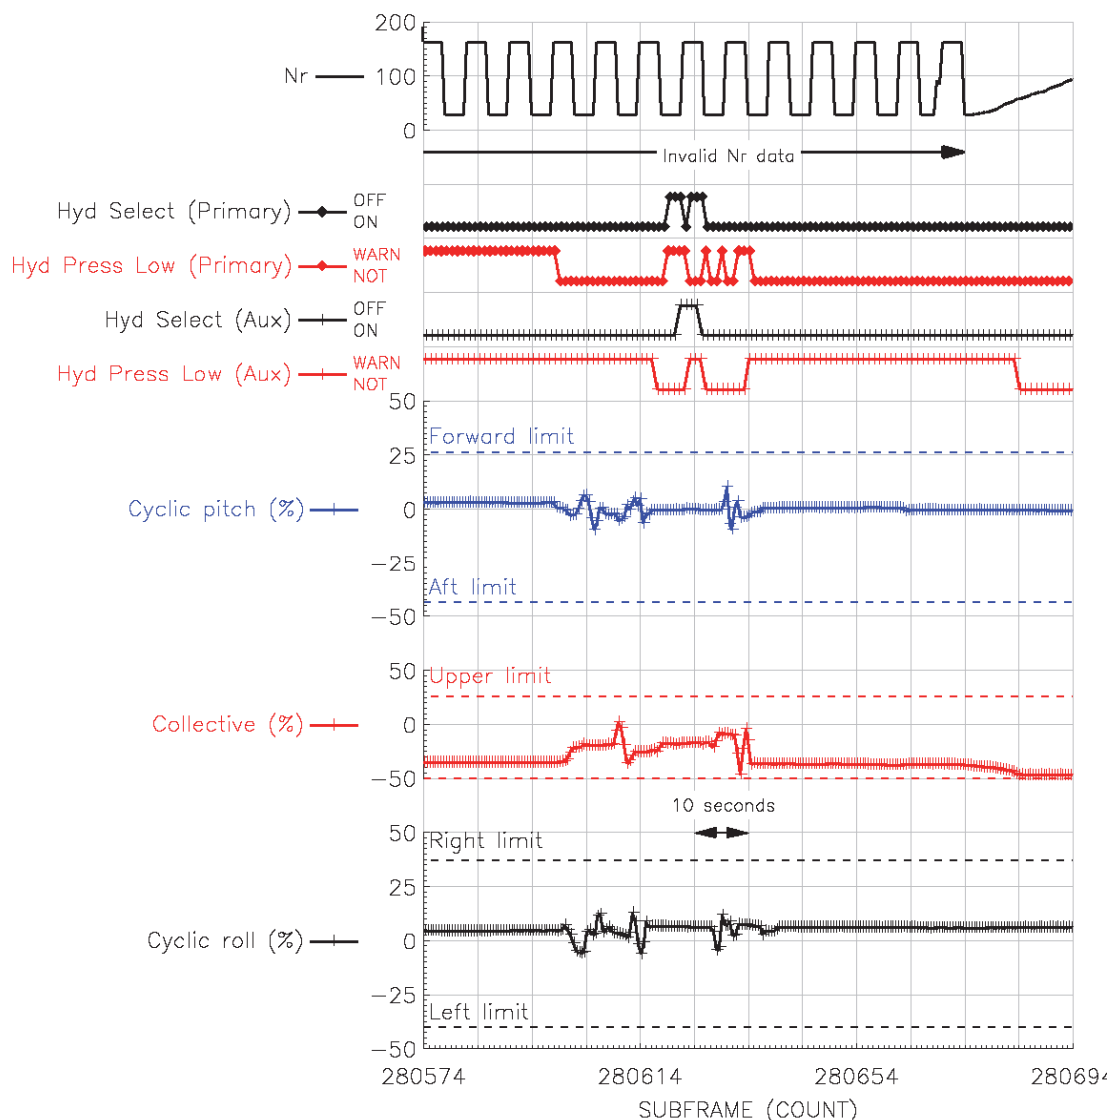
Figure 3 shows the limited extent of the cyclic inputs made by the crew during the pre-flight *Flight control servo system check*.

Flight control servo system check from the accident flight

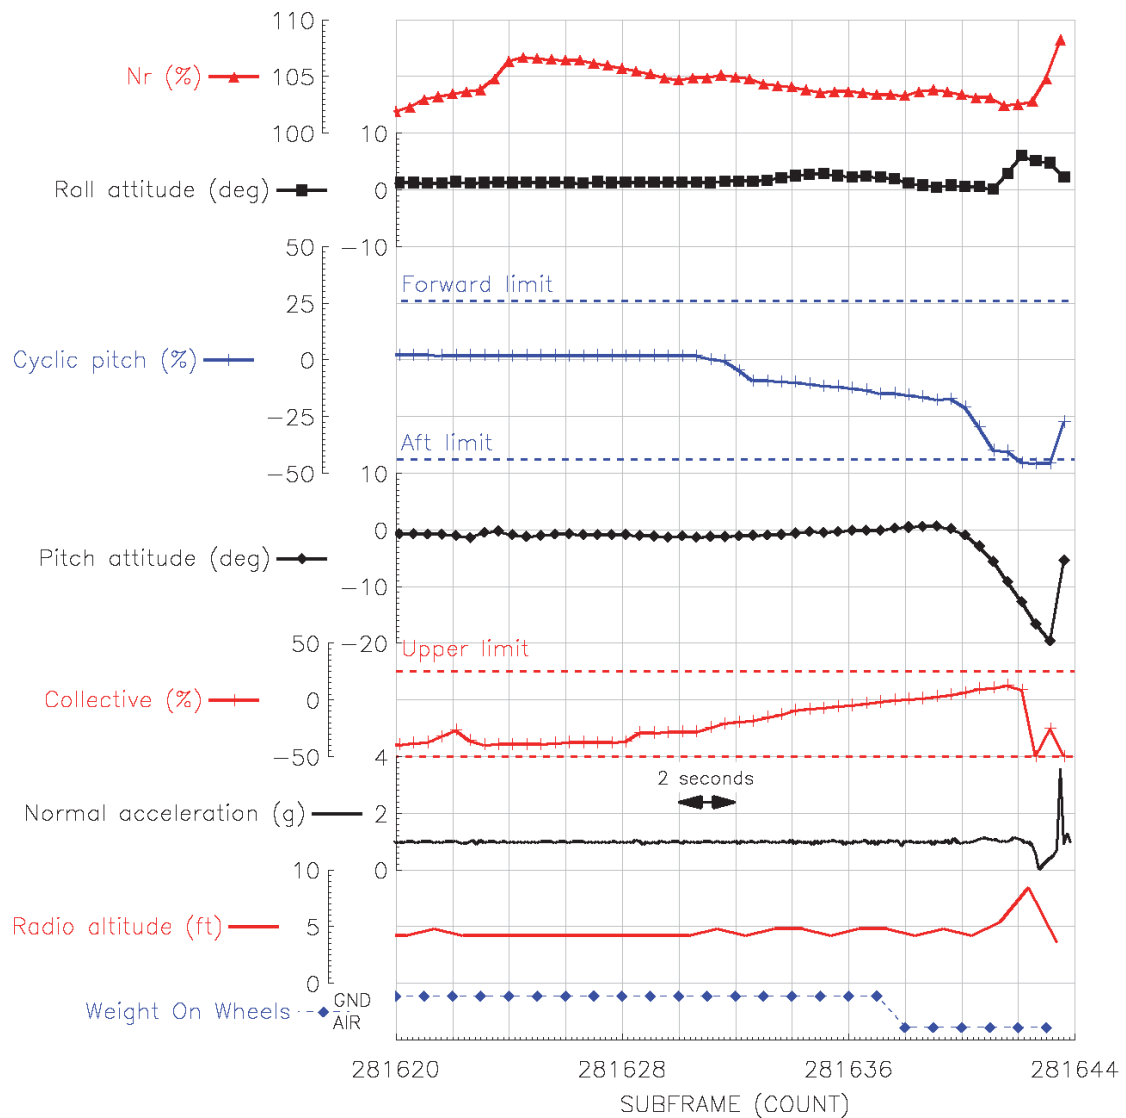
Figure 4 is a plot of pertinent parameters recorded during the takeoff. Just after takeoff, the helicopter started to pitch nose-down, reaching a pitch rate of approximately $-7^\circ/\text{s}$. The commander applied aft cyclic but, even at the full aft limit, there was no significant effect on the pitch rate. He rapidly lowered the collective and the helicopter struck the ground at a pitch attitude of approximately 20° nose-down.

Pertinent recorded parameters for the accident flight

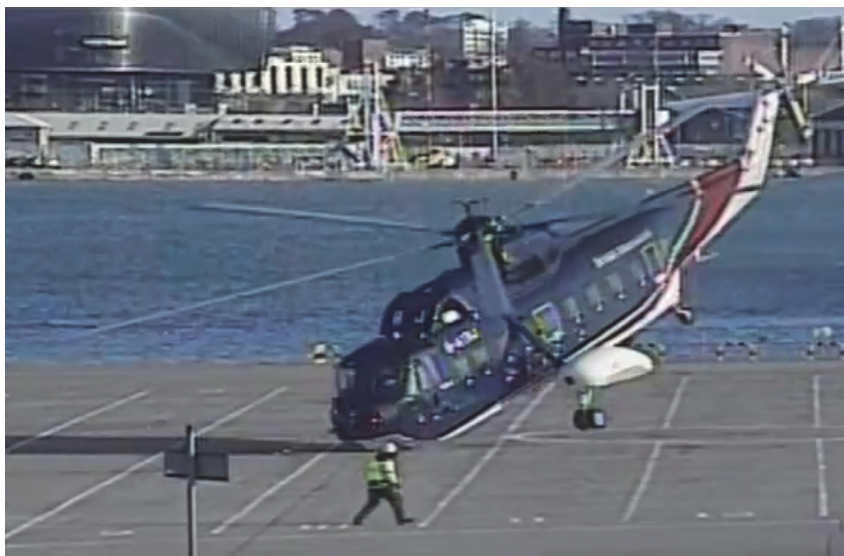
Figure 5 is a snapshot from the CCTV recording. This shows the main rotor disk did not appear to have any significant rearward component given the full aft cyclic input which was being made at that time.

CCTV snapshot at the point of impact

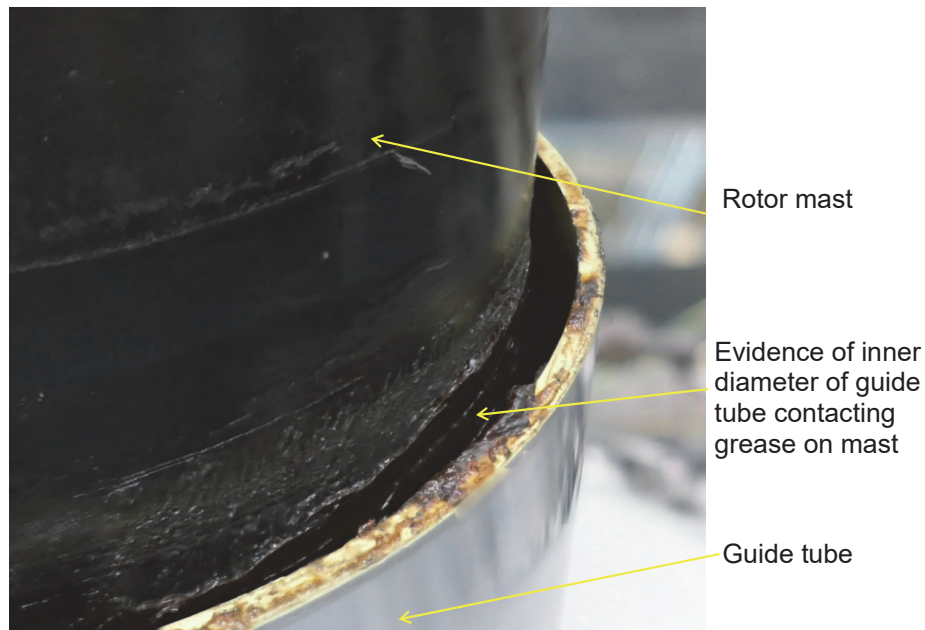
Figure 9

deflected during operation as grease on the mast had come into contact with the inner surface of the guide tube (Figure 9); however, there was no evidence of metal-to-metal contact between the mast and guide tube. Once it had been removed, examination of the swashplate assembly confirmed that the spherical bearing could not articulate in any direction. The swashplate (Figure 10) was transported to the manufacturer's facility for further disassembly.

Flattening of grease between rotor mast and guide tube

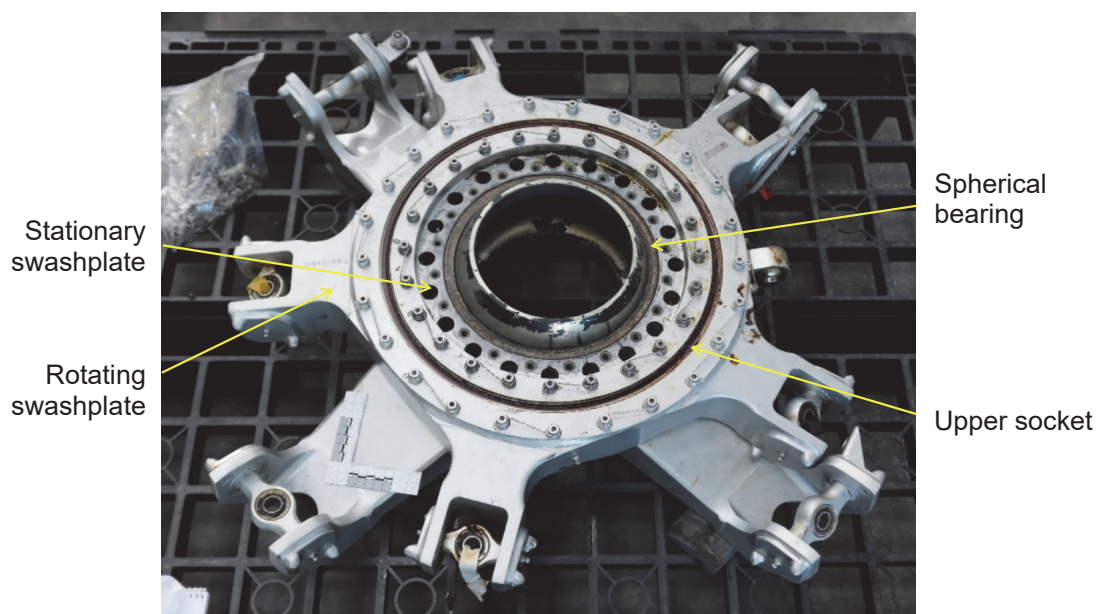
Figure 10

During the removal of the primary servos it was identified that the spherical bearing within the stationary swashplate assembly was seized. The swashplate was able to translate up and down the guide tube but could not tilt. There was evidence that the guide tube had

G-ATBJ swashplate after removal from the helicopter
(retainer, shim and spacer already removed in this image)

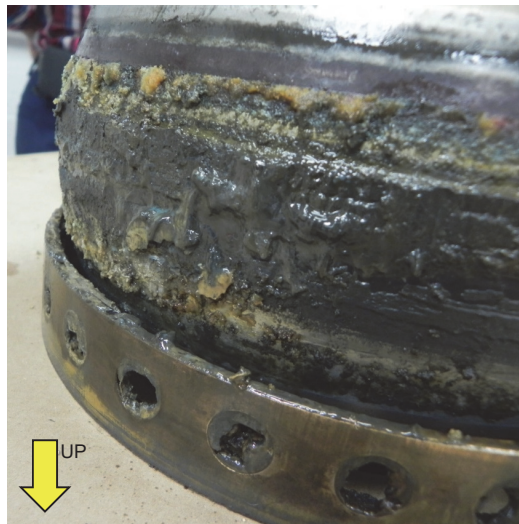
Figure 11

The grease between the sockets and the spherical bearings was in very poor condition, with crystalline deposits within it (Figures 11 and 12). Elemental analysis of the deposits found them to contain aluminium, chlorine, sodium, copper, tin and oxygen. This indicates that the aluminium spherical bearing had corroded, and deposits had been retained within the grease. A section of the grease was cleaned from the bearing to reveal areas of corrosion pitting to a depth of 0.018 in (Figure 13). A build-up of plaque-like material was adhered to the bearing. Analysis of this material found it to be bronze material that had released from the socket, combined with the grease and adhered to the bearing surface.

G-ATBJ spherical bearing once removed from swashplate

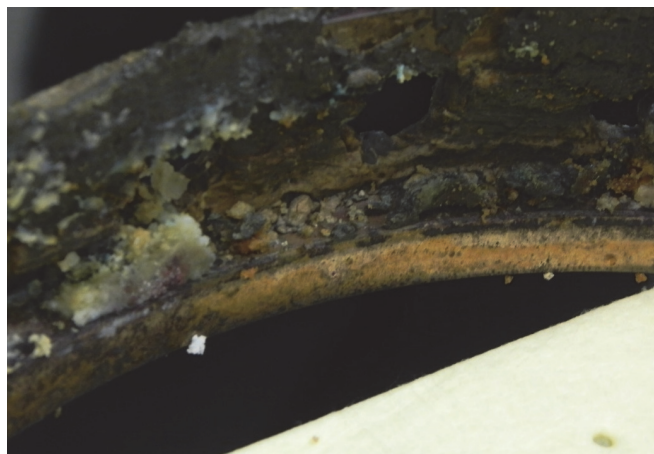
Figure 12

G-ATBJ upper spherical bearing socket showing corrosion product adjacent to bearing surface

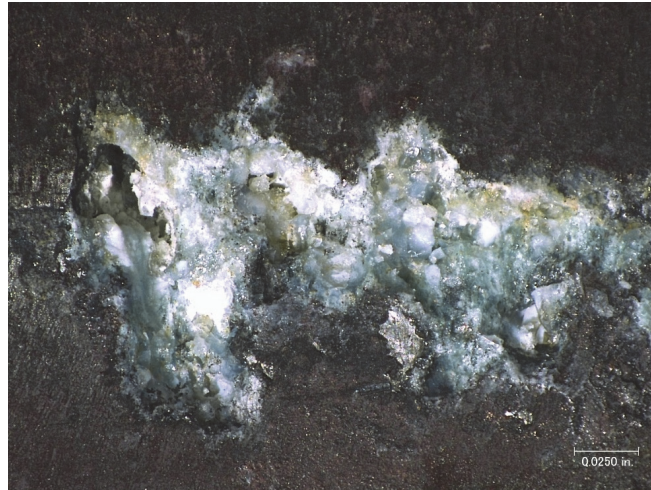
Figure 13

G-ATBJ example of spherical bearing corrosion pit

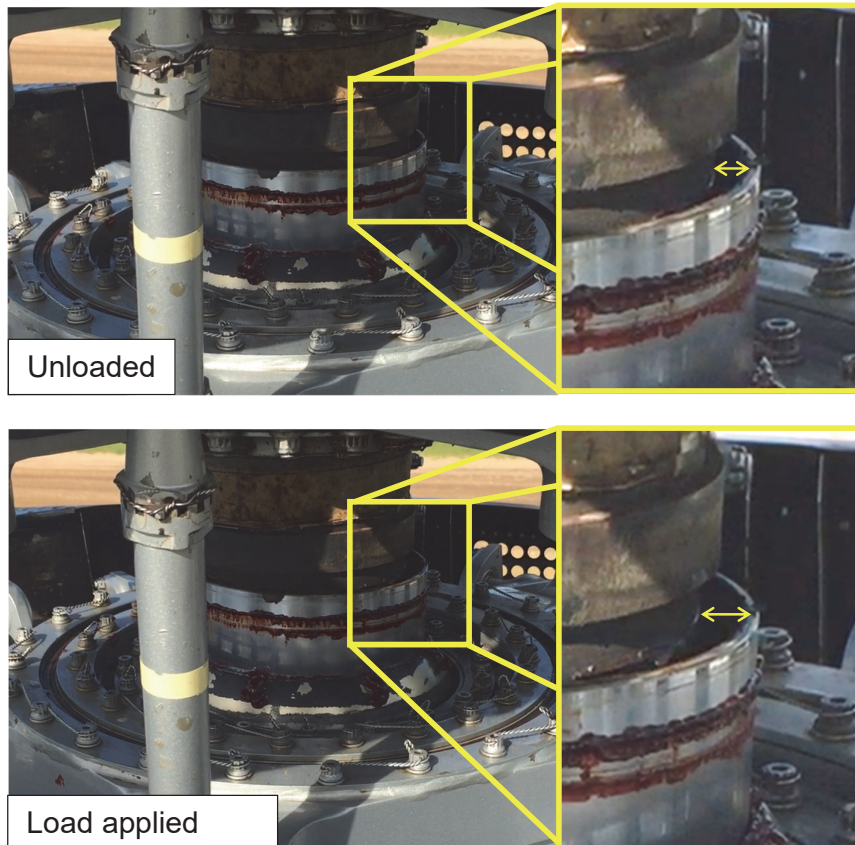
Figure 15

The manufacturer conducted an analysis of the control system geometry to determine whether a full back stick input could be applied without any apparent movement of the swashplate. The calculations were based on a simple model of guide tube flexing and hydraulic actuator sloppy link movement, with stalled servos, and was able to account for most, but not all, of the aft cyclic input range being available to the pilot. The level of flex in the control runs was not known. As discussed, this would yield some blade movement in the right sense by virtue of the guide tube flexing but with a significantly restricted range.

Stills from video of another S-61 showing levels of guide tube deflection when cyclic was applied to a seized swashplate
