SERIOUS INCIDENT

Aircraft Type and Registration:	Airbus A319-131, G-EUOG	
No & Type of Engines:	2 International Aero Engine V2522-A5 turbofan engines	
Year of Manufacture:	2001 (Serial no: 1594)	
Date & Time (UTC):	2 October 2019 at 0736 hrs	
Location:	London Heathrow Airport	
Type of Flight:	Commercial Air Transport (Passenger)	
Persons on Board:	Crew - 6	Passengers - 96
Injuries:	Crew - None	Passengers - None
Nature of Damage:	None	
Commander's Licence:	Airline Transport Pilot's Licence	
Commander's Age:	59 years	
Commander's Flying Experience:	17,341 hours (of which 5,887 were on type) Last 90 days - 101 hours Last 28 days - 18 hours	
Information Source:	Aircraft Accident Report Form submitted by the pilot

Synopsis

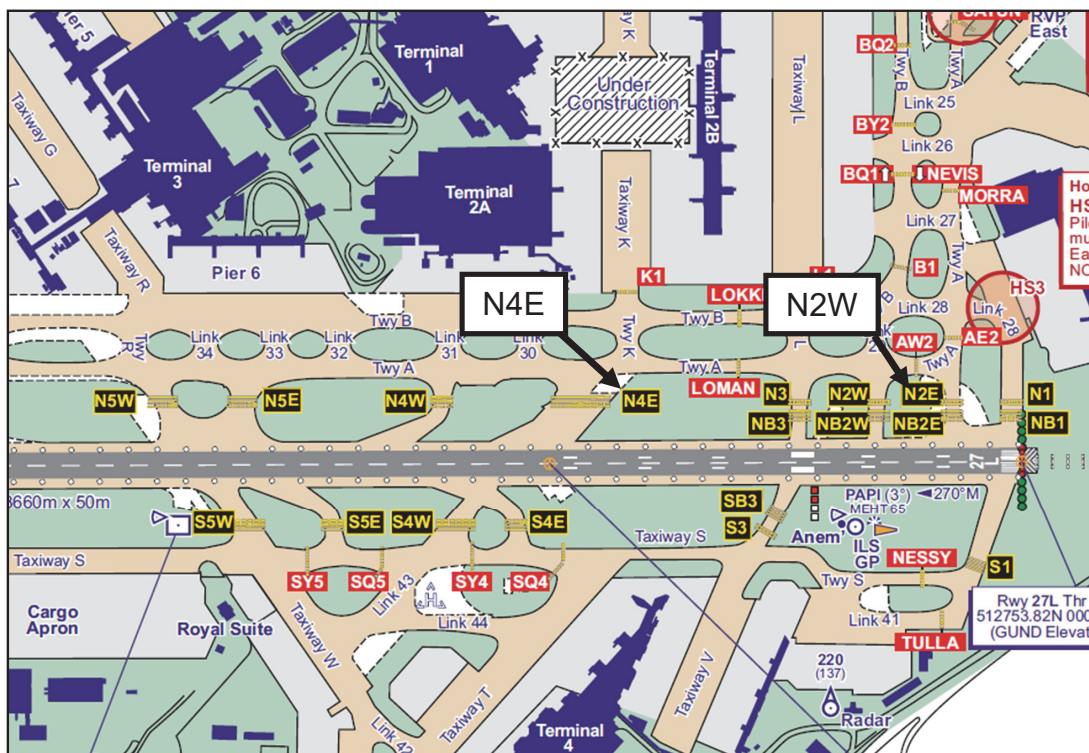
Figure 1

The aircraft taxied out using a single engine for a departure from Runway 27L at Heathrow. The figures for the takeoff performance had been calculated from N2W. During the taxi out, the PM mistakenly requested N4E for departure which gave a TORA 678 m shorter than from N2W. Both intersections are shown in Figure 1. This was not intentional from the PM. The new intersection was rapidly approved by ATC leaving the crew little time

Holding points for Heathrow Runway 27L
