ACCIDENT

Aircraft Type and Registration:	Airbus A340-642, G-VFIT
No & Type of Engines:	4 Rolls-Royce RB211 Trent 556-61 turbofan engines
Year of Manufacture:	2006 (Serial no: 753)
Date & Time (UTC):	21 August 2019 at 1230 hrs
Location:	En route from New Delhi Airport, India to London Heathrow Airport
Type of Flight:	Commercial Air Transport (Passenger)
Persons on Board:	Crew - 15 Passengers - 305
Injuries:	Crew - 1 (Minor) Passengers - 1 (Serious)
Nature of Damage:	None
Commander's Licence:	Airline Transport Pilot's Licence
Commander's Age:	54 years
Commander's Flying Experience:	18,062 hours (of which 5,722 were on type) Last 90 days - 162 hours Last 28 days - 62 hours
Information Source:	Aircraft Accident Report Form submitted by the pilot and further enquires by the AAIB

Synopsis

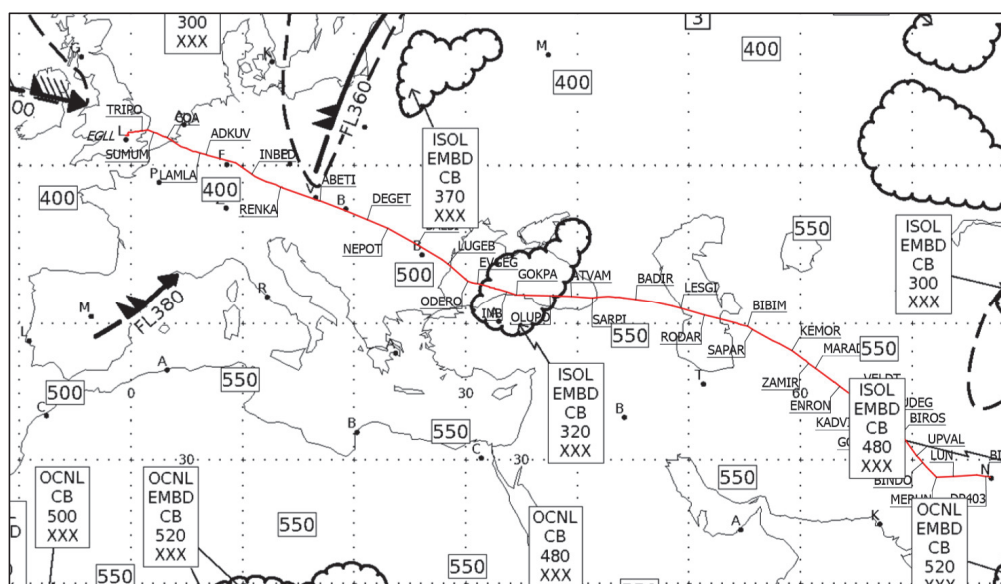
Figure 2

Parts of the significant weather and wind charts issued to the flight crew prior to the flight are shown in Figures 2 and 3. The significant weather chart shows an area of isolated embedded cumulonimbus clouds with tops at FL320 in the area where the turbulence occurred. There was no clear air turbulence forecast in this area. The wind chart shows the wind circulating round a low pressure centred in north-west Turkey.

Segment of the significant weather chart valid at 1200 hrs on 21 August 2019

The significant weather chart included a note that cumulonimbus cloud implies moderate or severe turbulence. However, these clouds were below the cruise level of G-VFIT and the commander reported that the aircraft was clear of cloud when the turbulence occurred.

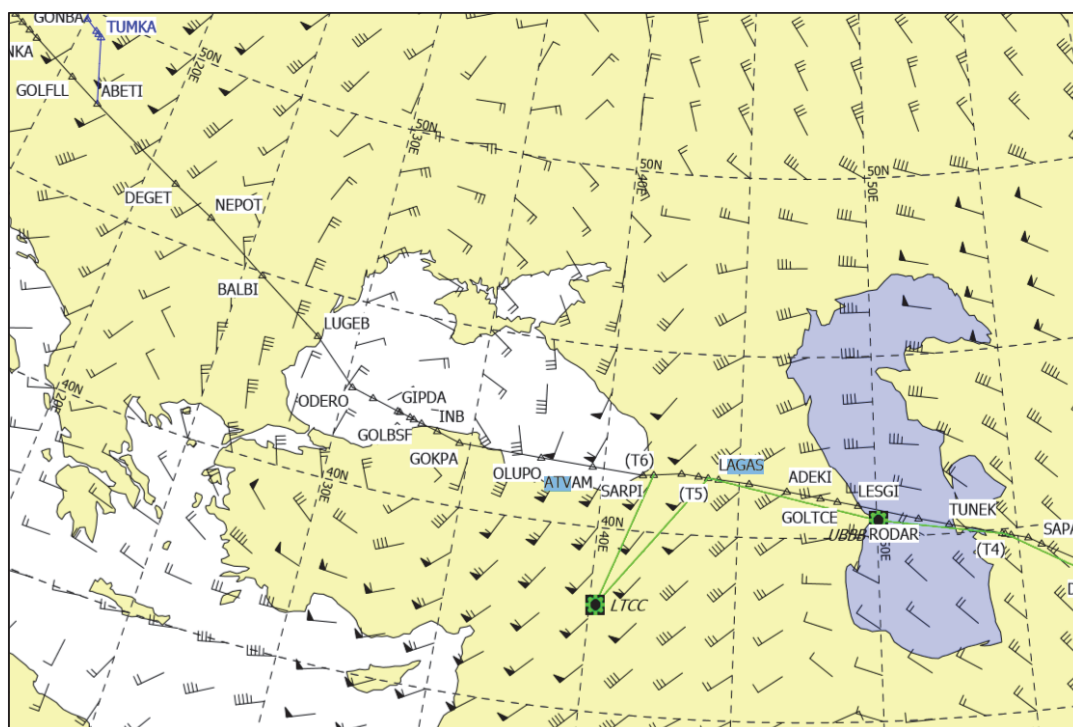
Figure 3

Segment of the wind chart valid at 1151 hrs on 21 August 2019

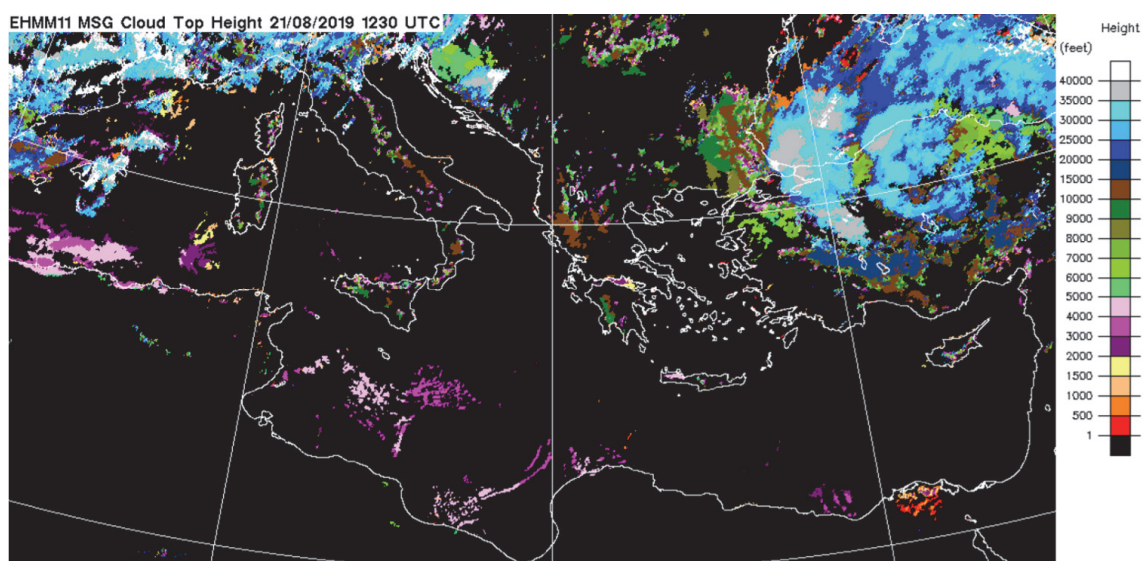
Figure 4 shows a derived satellite image showing cloud top heights at the time of the incident, produced by the Met Office after the accident. The image indicates there was a large area of cloud with tops between 30,000 ft and 35,000 ft across the area in question.

Derived Satellite Image showing Cloud Top Heights
valid at 1230 hrs on 21 August 2019
